1984 Corvette: Recall: Rear Axle Differential Cross Shaft Retention

Subject: REAR AXLE DIFFERENTIAL CROSS SHAFT RETENTION

Model and Year: 1984 CHEVROLET CORVETTE MODELS

Bulletin Number: 84-C-25 - (09/20/1985)

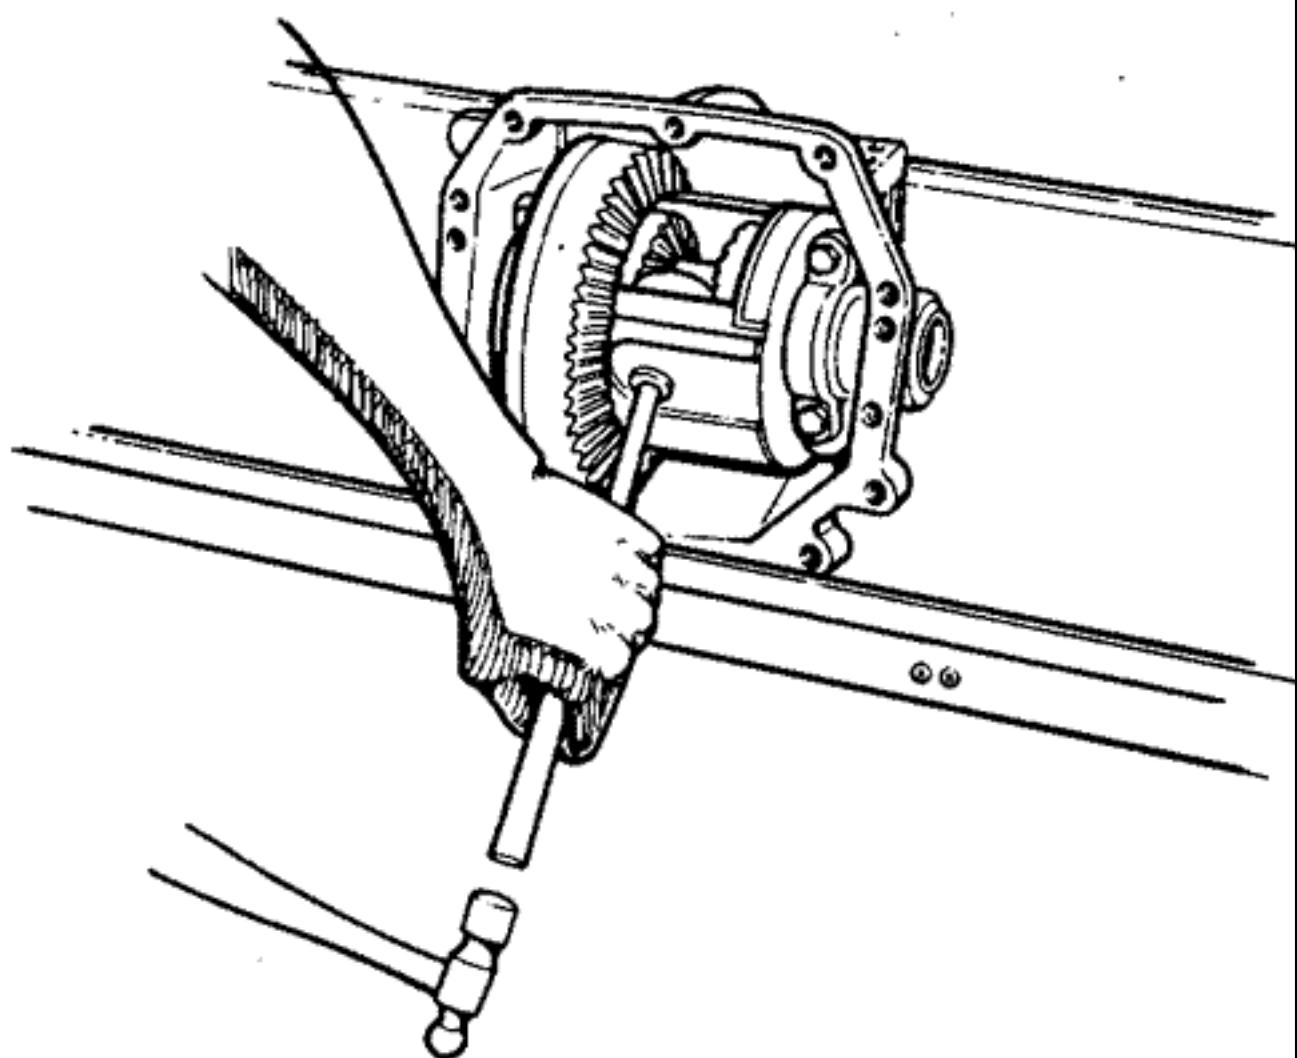
FIGURE 1

5. Rotate case assembly to position illustrated in Figure 1. With appropriate size drift and small mallet, lightly tap on cross shaft to determine if movement of shaft can be achieved.

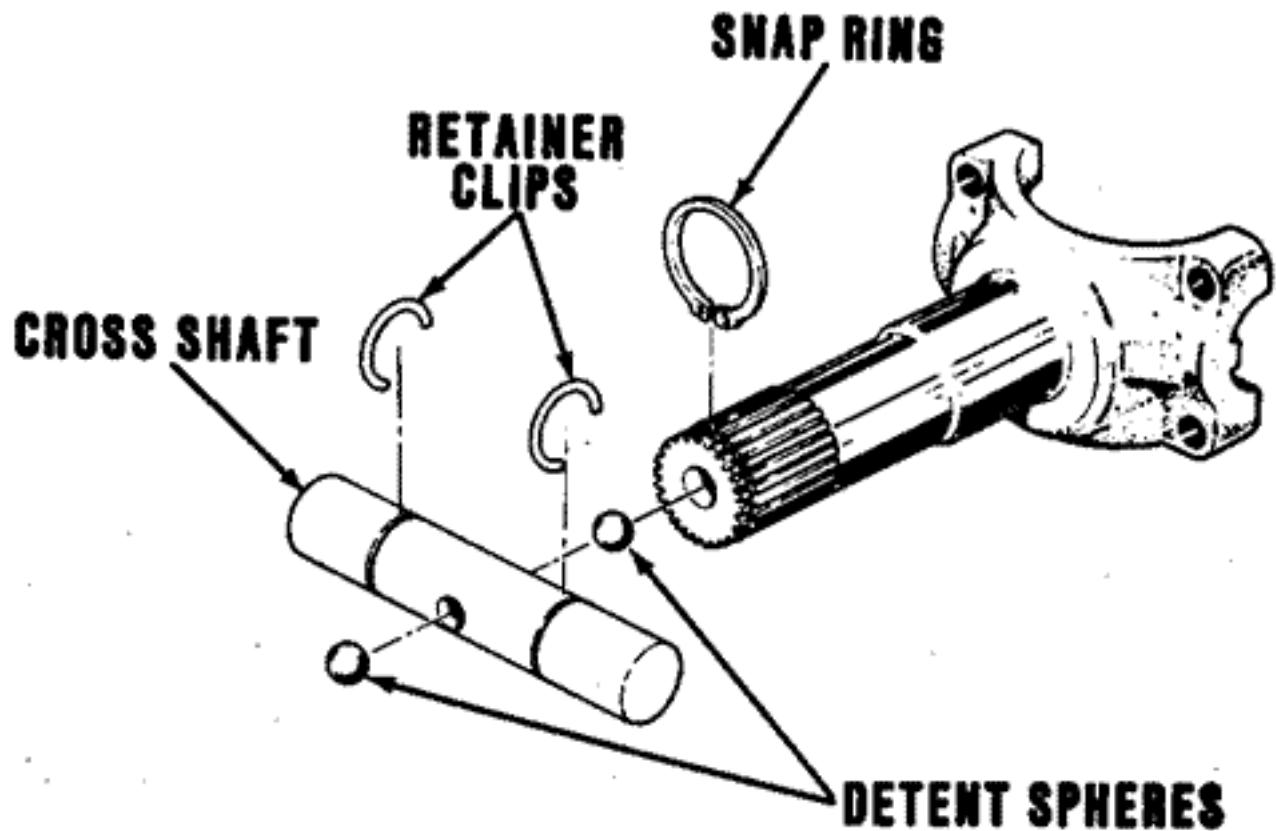
FIGURE 2

Tap cross shaft inboard approximately 1 1/4 inches and rotate case 180 DEG. Utilizing vise grips and a back and forth motion, remove shaft. Install new cross shaft insuring detents in the shaft are positioned properly to accept spheres (balls) to be installed, between shaft and output yokes as illustrated in Figure 2.

Remove case assembly from carrier following appropriate procedure in 1985 Corvette Shop Manual. Press existing cross shaft out of case and install new cross shaft insuring detents in the shaft are positioned properly to accept spheres (balls) to be installed between shaft and output yokes as illustrated in
