# 1992 Corvette: Service Bulletin: Brake Pedal Not Fully Returning / Stop Lights Stay On and/or Roughness/Vibration From Rear of Vehicle

**Model and Year:** 1992 CHEVROLET CORVETTE

**Bulletin Number:** 92-71A-5 - (01/31/1992)

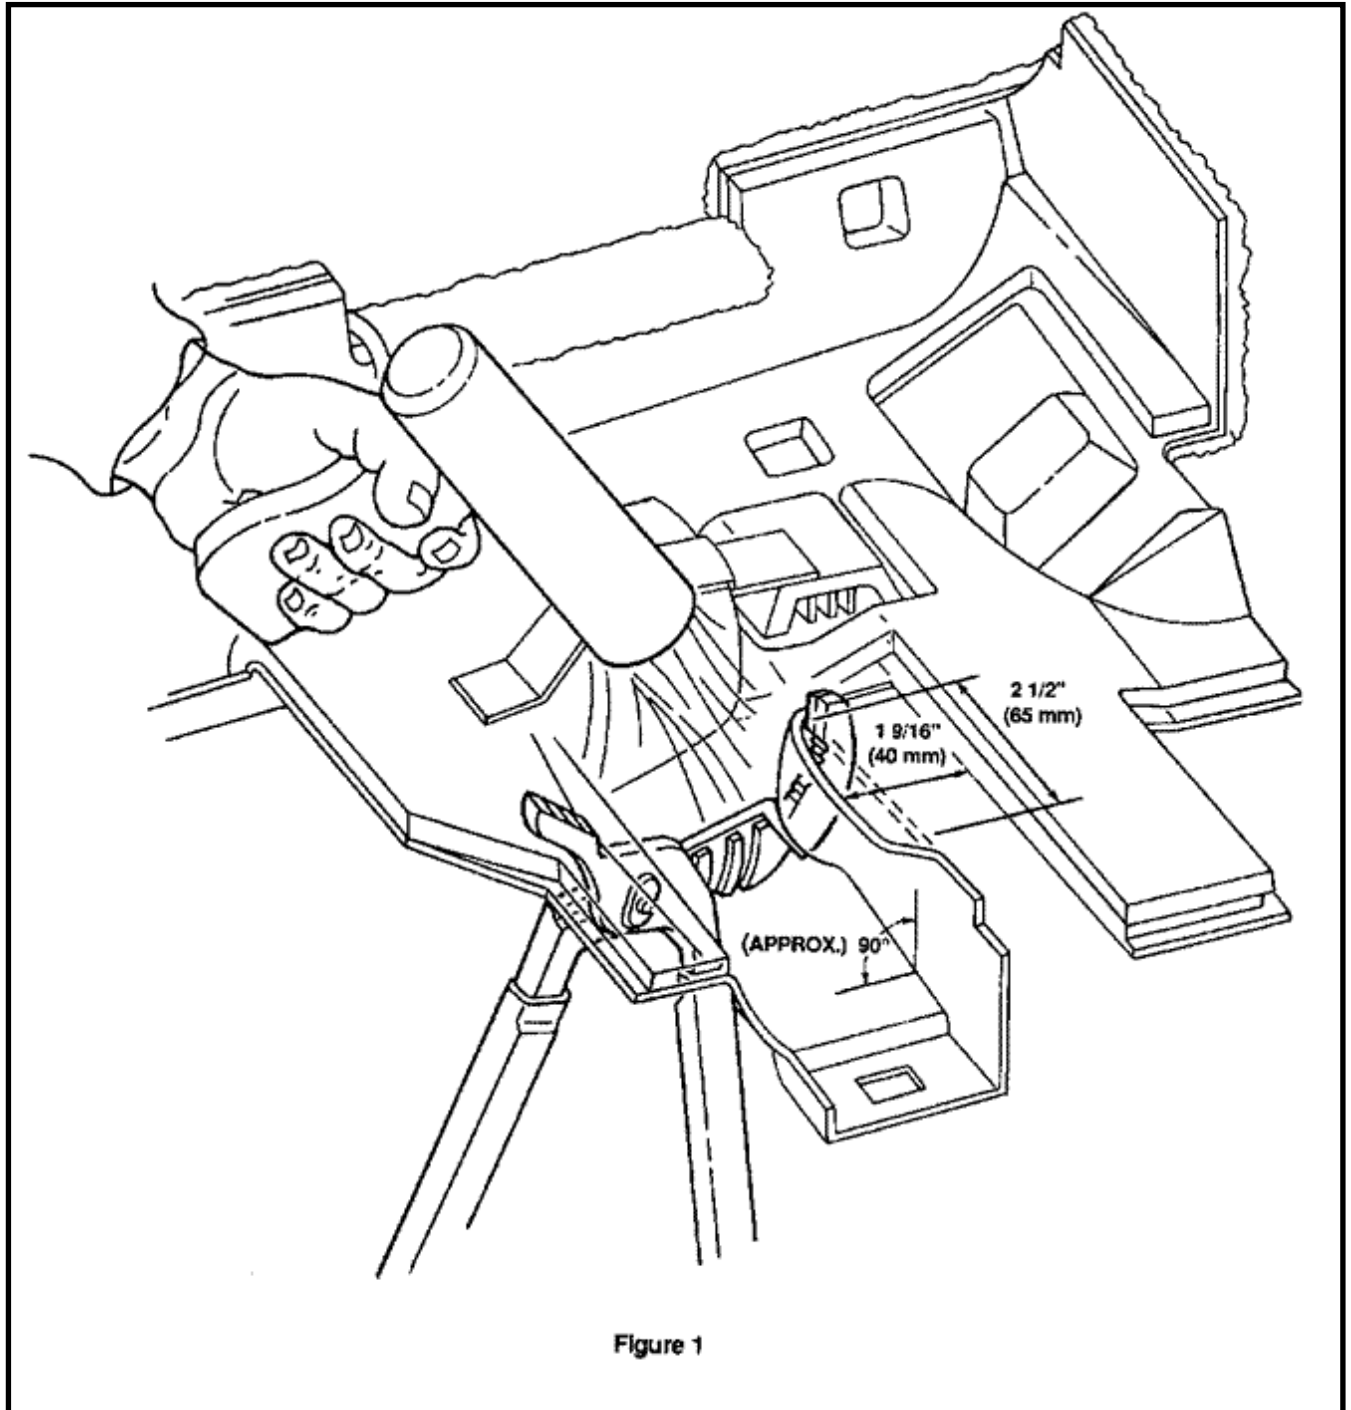
Some 1992 Y-car base Corvettes built from SOP to VIN breakpoint 104324 and ZR1's built from SOP to VIN breakpoint 800193 may exhibit inadequate clearance between the brake service pedal arm and the I/P lower trim panel.

1. Remove LH lower trim panel (per Service Manual, Section 8C-33).
2. Lift away the foam sound deadener from area shown in Figure #1, and tape out of the way.
3. Using a heat gun, warm the trim panel area shown in Figure #1 (USE CARE TO WARM COMPLETE AREA EVENLY).
4. Using Channel Locks (R) size 16 or larger, place near the upper LH corner of the I/P lower trim panel as shown in Figure 1. Quickly reform the brake pedal opening to configuration and dimensions indicated in illustration. If necessary Channel Locks may be moved downward during initial reforming and/or Steps 3 and 4 may be repeated to obtain minimum clearance of 2mm between the brake service pedal arm and the I/P trim panel.

**Note: To lessen Channel Lock imprint, place smooth shim stock or aluminum face cover between the Channel Lock face and the warmed surface on the trim panel.**
