# 1992 Corvette: Service Bulletin: Brake Pedal Not Fully Returning / Stop Lights Stay On and/or Roughness/Vibration From Rear of Vehicle

**Model and Year:** 1992 CHEVROLET CORVETTE

**Source:** Chevrolet Service Bulletin

**Bulletin Number:** 92-71A-5 - (01/31/1992)

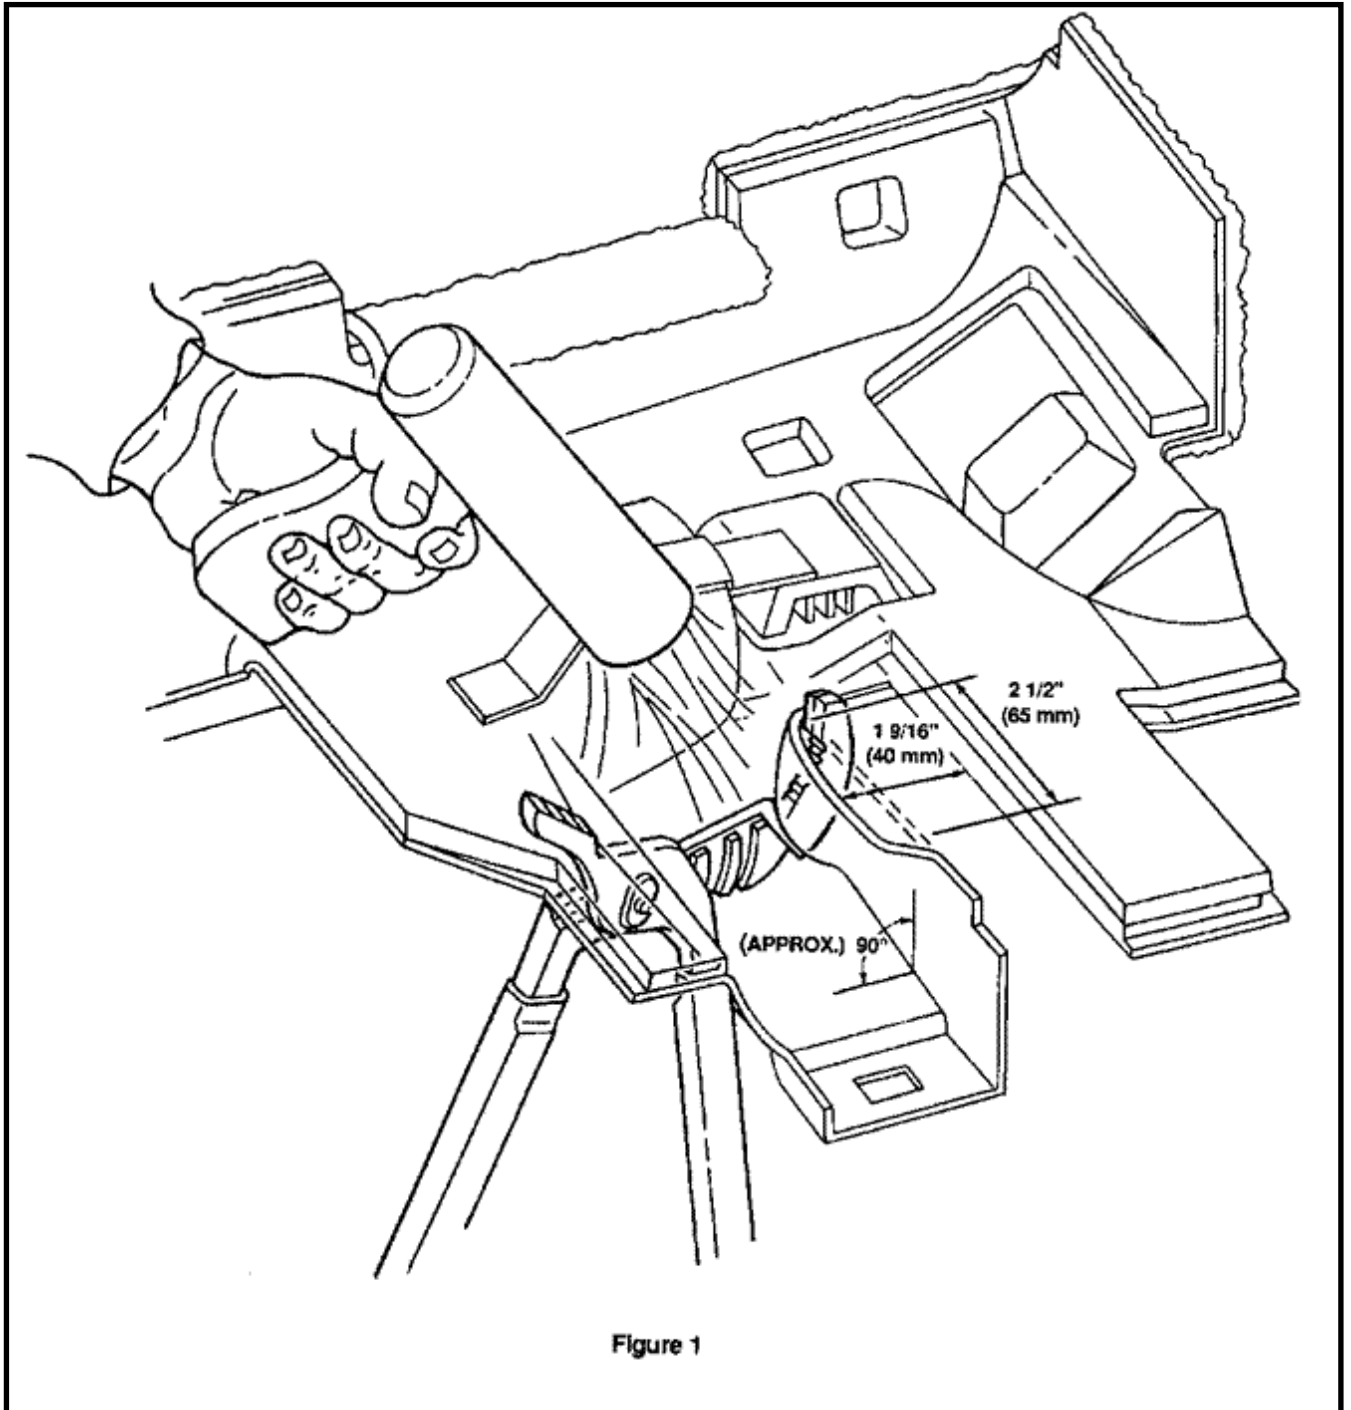
Figure 1

Some 1992 Y-car base Corvettes built from SOP to VIN breakpoint 104324 and ZR1's built from SOP to VIN breakpoint 800193 may exhibit inadequate clearance between the brake service pedal arm and the I/P lower trim panel.

1. Remove LH lower trim panel (per Service Manual, Section 8C-33).
2. Lift away the foam sound deadener from area shown in Figure #1, and tape out of the way.
3. Using a heat gun, warm the trim panel area shown in Figure #1 (USE CARE TO WARM COMPLETE AREA EVENLY).
4. Using Channel Locks (R) size 16 or larger, place near the upper LH corner of the I/P lower trim panel as shown in Figure 1. Quickly reform the brake pedal opening to configuration and dimensions indicated in illustration. If necessary Channel Locks may be moved downward during initial reforming and/or Steps 3 and 4 may be repeated to obtain minimum clearance of 2mm between the brake service pedal arm and the I/P trim panel.

**Note: To lessen Channel Lock imprint, place smooth shim stock or aluminum face cover between the Channel Lock face and the warmed surface on the trim panel.**

5. Reinstall lower trim panel. Remeasure the clearance between trim panel and the brake pedal arm, using method stated in correction above.
6. If contact still exists, phone Action Center #1 -800-457-8388.
