1992 Corvette: Service Bulletin: Brake Pedal Not Fully Returning / Stop Lights Stay On and/or Roughness/Vibration From Rear of Vehicle

Model and Year: 1992 CHEVROLET CORVETTE

Source: Chevrolet Service Bulletin

Bulletin Number: 92-71A-5 - (01/31/1992)

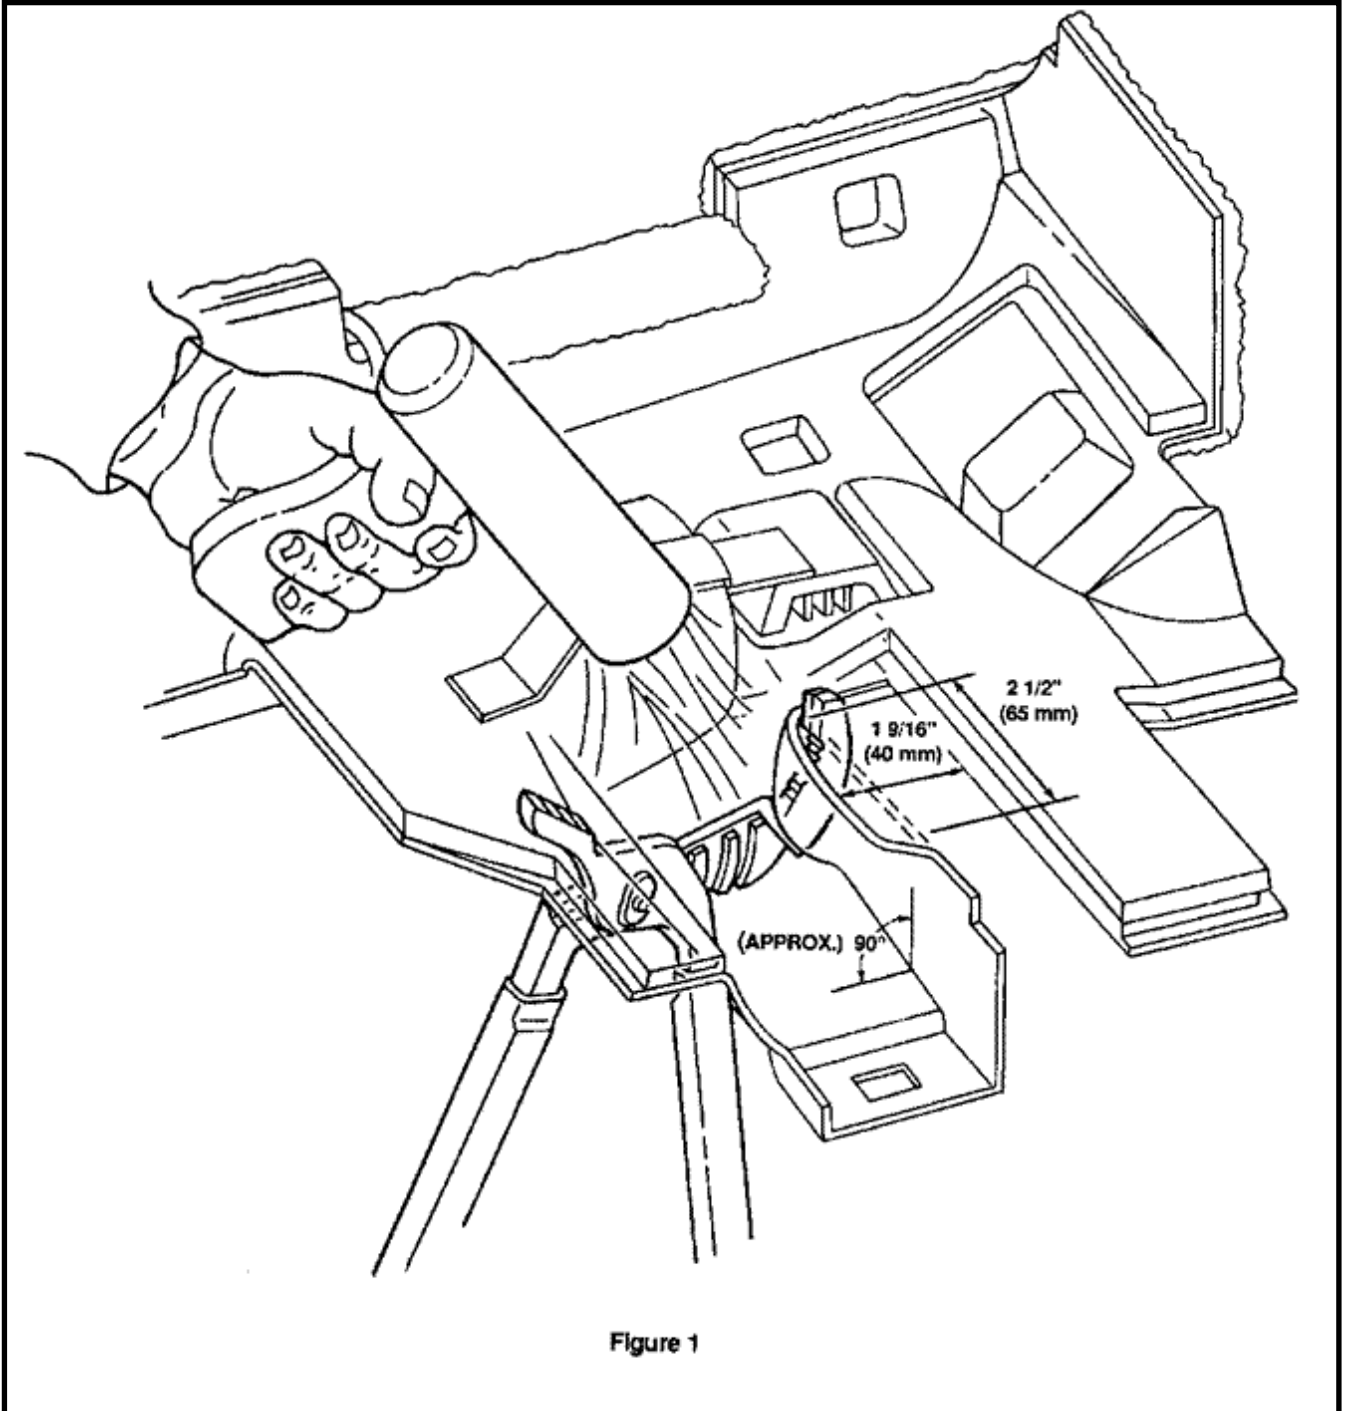
Figure 1

Some 1992 Y-car base Corvettes built from SOP to VIN breakpoint 104324 and ZR1's built from SOP to VIN breakpoint 800193 may exhibit inadequate clearance between the brake service pedal arm and the I/P lower trim panel.

1. Remove LH lower trim panel (per Service Manual, Section 8C-33).
2. Lift away the foam sound deadener from area shown in Figure #1, and tape out of the way.
3. Using a heat gun, warm the trim panel area shown in Figure #1 (USE CARE TO WARM COMPLETE AREA EVENLY).
4. Using Channel Locks (R) size 16 or larger, place near the upper LH corner of the I/P lower trim panel as shown in Figure 1. Quickly reform the brake pedal opening to configuration and dimensions indicated in illustration. If necessary Channel Locks may be moved downward during initial reforming and/or Steps 3 and 4 may be repeated to obtain minimum clearance of 2mm between the brake service pedal arm and the I/P trim panel.

Note: To lessen Channel Lock imprint, place smooth shim stock or aluminum face cover between the Channel Lock face and the warmed surface on the trim panel.
