1992 Corvette: Service Bulletin: Brake Pedal Not Fully Returning / Stop Lights Stay On and/or Roughness/Vibration From Rear of Vehicle

Model and Year: 1992 CHEVROLET CORVETTE

Source: Chevrolet Service Bulletin

Bulletin Number: 92-71A-5 - (01/31/1992)

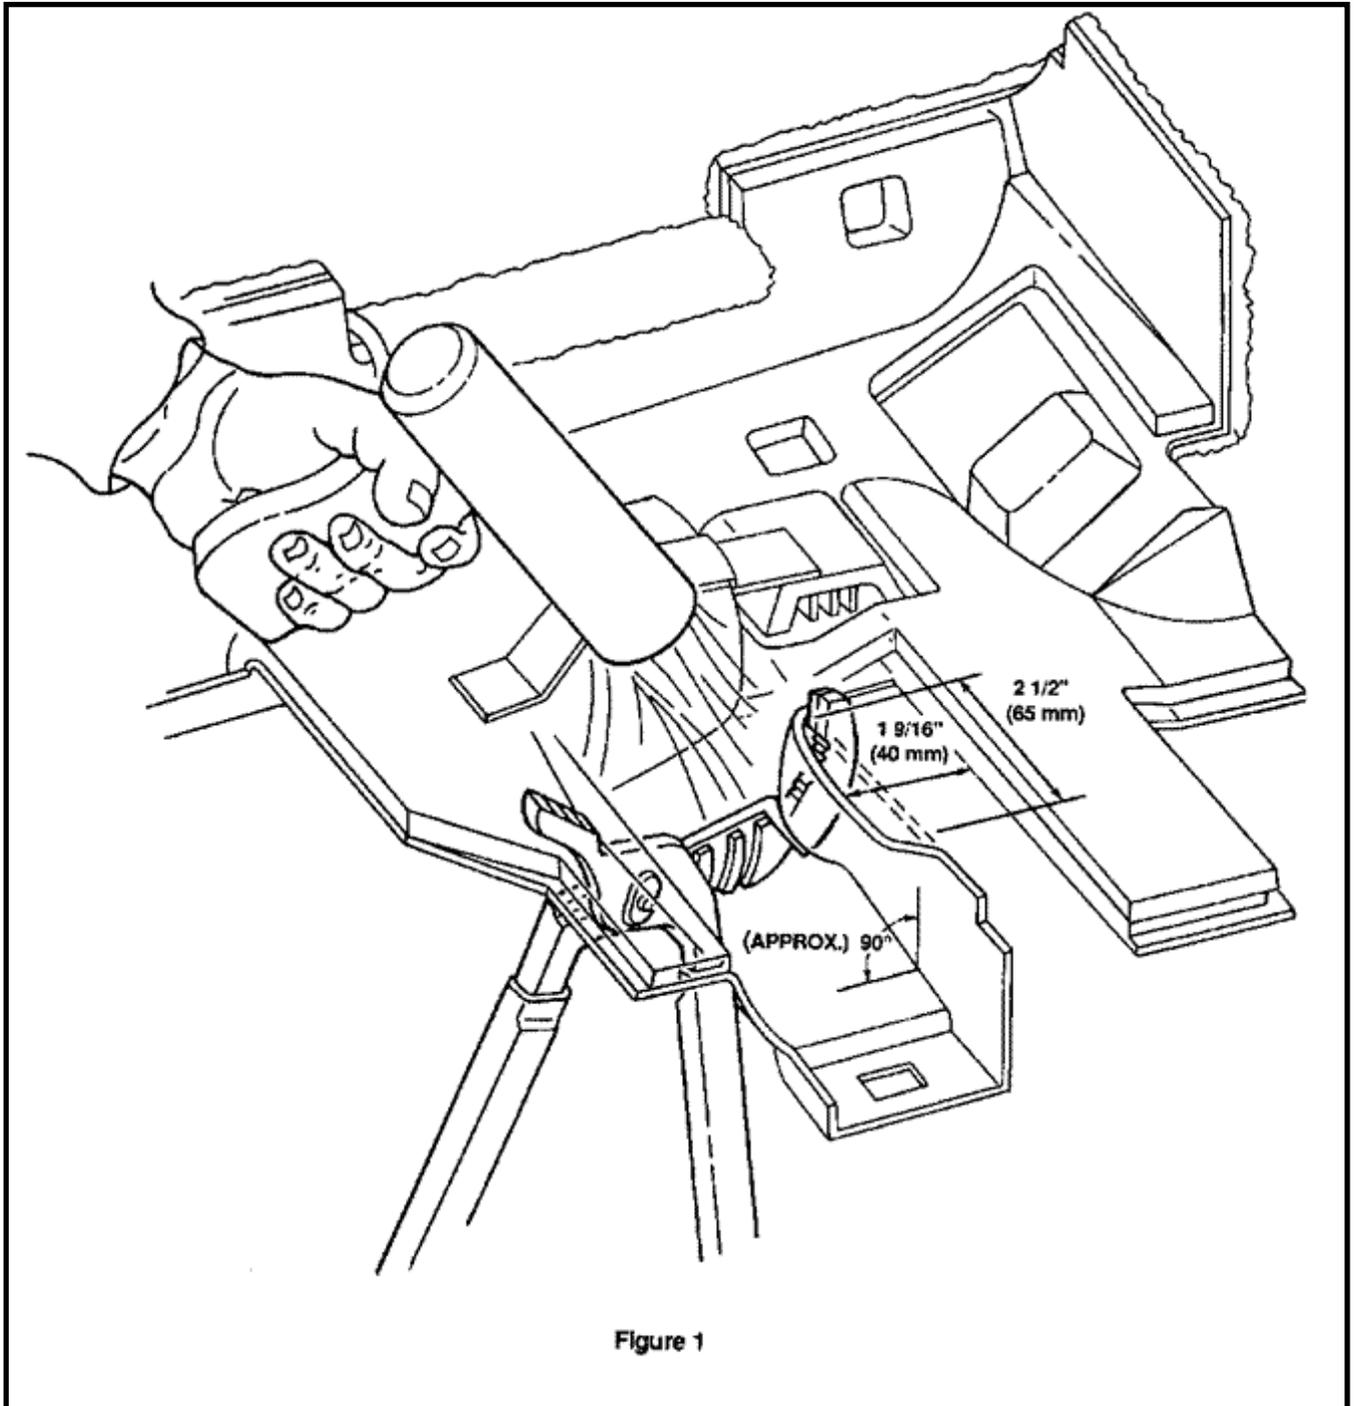
Figure 1

Some 1992 Y-car base Corvettes built from SOP to VIN breakpoint 104324 and ZR1's built from SOP to VIN breakpoint 800193 may exhibit inadequate clearance between the brake service pedal arm and the I/P lower trim panel.

1. Remove LH lower trim panel (per Service Manual, Section 8C-33).
2. Lift away the foam sound deadener from area shown in Figure #1, and tape out of the way.
3. Using a heat gun, warm the trim panel area shown in Figure #1 (USE CARE TO WARM COMPLETE AREA EVENLY).
4. Using Channel Locks (R) size 16 or larger, place near the upper LH corner of the I/P lower trim panel as shown in Figure 1. Quickly reform the brake pedal opening to configuration and dimensions indicated in illustration. If necessary Channel Locks may be moved downward during initial reforming and/or Steps 3 and 4 may be repeated to obtain minimum clearance of 2mm between the brake service pedal arm and the I/P trim panel.

Note: To lessen Channel Lock imprint, place smooth shim stock or aluminum face cover between the Channel Lock face and the warmed surface on the trim panel.

5. Reinstall lower trim panel. Remeasure the clearance between trim panel and the brake pedal arm, using method stated in correction above.
6. If contact still exists, phone Action Center #1 -800-457-8388.
