# 1993 Corvette: Service Bulletin: Right Door Glass Binds, Insufficient Travel, Unable to Contact Weatherstrips

**Model and Year:** 1993 Corvette

**Source:** Chevrolet Dealer Service Bulletin

**Bulletin Number:** 93-192-10, Section 10

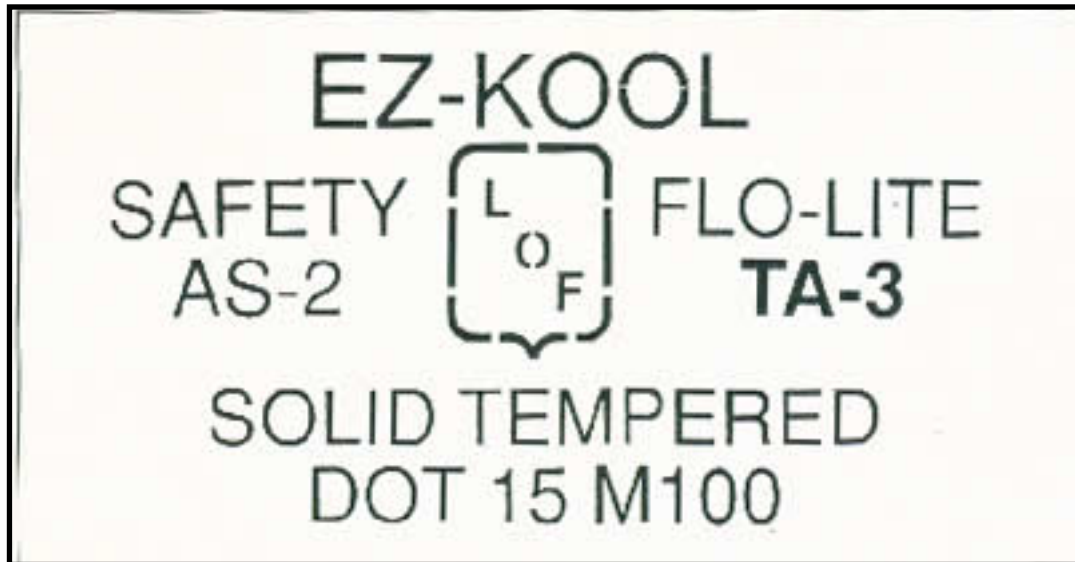
Right door glass that binds, won't travel to full up position and presents difficulty in sealing to all weather strip surfaces on early build Corvettes with date codes of TA-3 on door glass as indicated in the illustration.

Glass has incorrect contour.

If the door glass has the date code of TA-3 as shown in the illustration, **REPLACE THE RIGHT DOOR GLASS ONLY** using the procedure found in the body portion of the Service Manual.

**NOTE:** Only glass with the date code of TA-3 has this condition. Do not replace the left door glass or glass with other date codes for this condition.

**NOTE:** Due to an in-plant modification, some vehicles with VIN's between P5103330 and P5103622 may have right side glass that still does not track properly after glass replacement. These vehicles may require replacement of the right door window regulator in addition to the door glass.
