1992 - 1993 Corvette: Service Bulletin: Cracks/Damage to Cowl Surface

Subject: CRACKS OR DAMAGE TO COWL SURFACE

Model and Year: 1992-93 CORVETTE WITH RPO LT1 ENGINES ONLY

Bulletin Number: 93-134-10

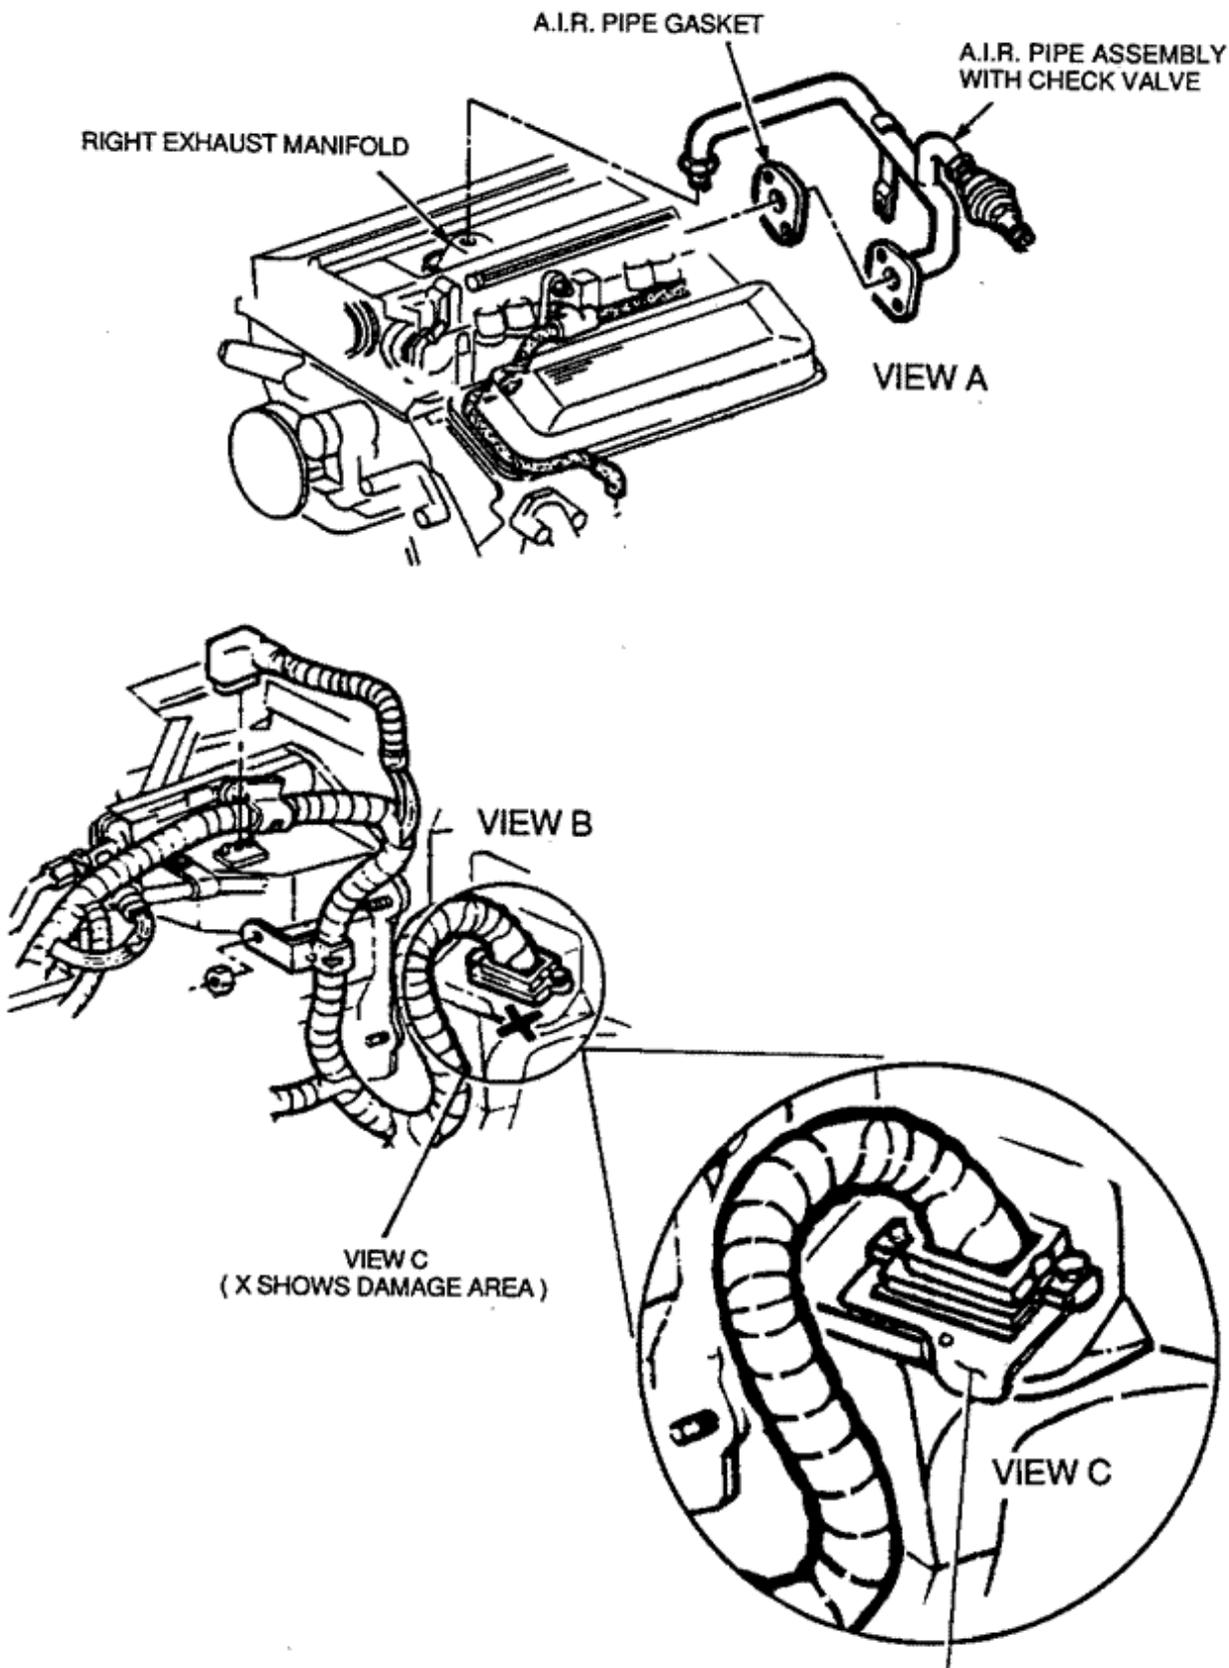
FIGURE 1

Some 1992-93 Y-cars with LT1 engines may have cracks or damage to the cowl surface:

- Behind the right cylinder head, - Below the wiring harness connector.

Rear of engine may contact the cowl surface when removing transmission or engine from vehicle.

NEW PART IN POSITION OVER DAMAGED AREA

6. Apply enough seam sealing material to fill or cover the damaged area. Paddle material into place, if required.
7. Loosen the harness connector attaching bolts, position GM P/N 10231336 - Spacer, over the damaged area and under the attaching bolt heads and tighten the attaching bolts. The spacer has slots to aid in installation (See View C).
