# 1992 - 1993 Corvette: Service Bulletin: Cracks/Damage to Cowl Surface

**Subject:** CRACKS OR DAMAGE TO COWL SURFACE

**Model and Year:** 1992-93 CORVETTE WITH RPO LT1 ENGINES ONLY

**Bulletin Number:** 93-134-10

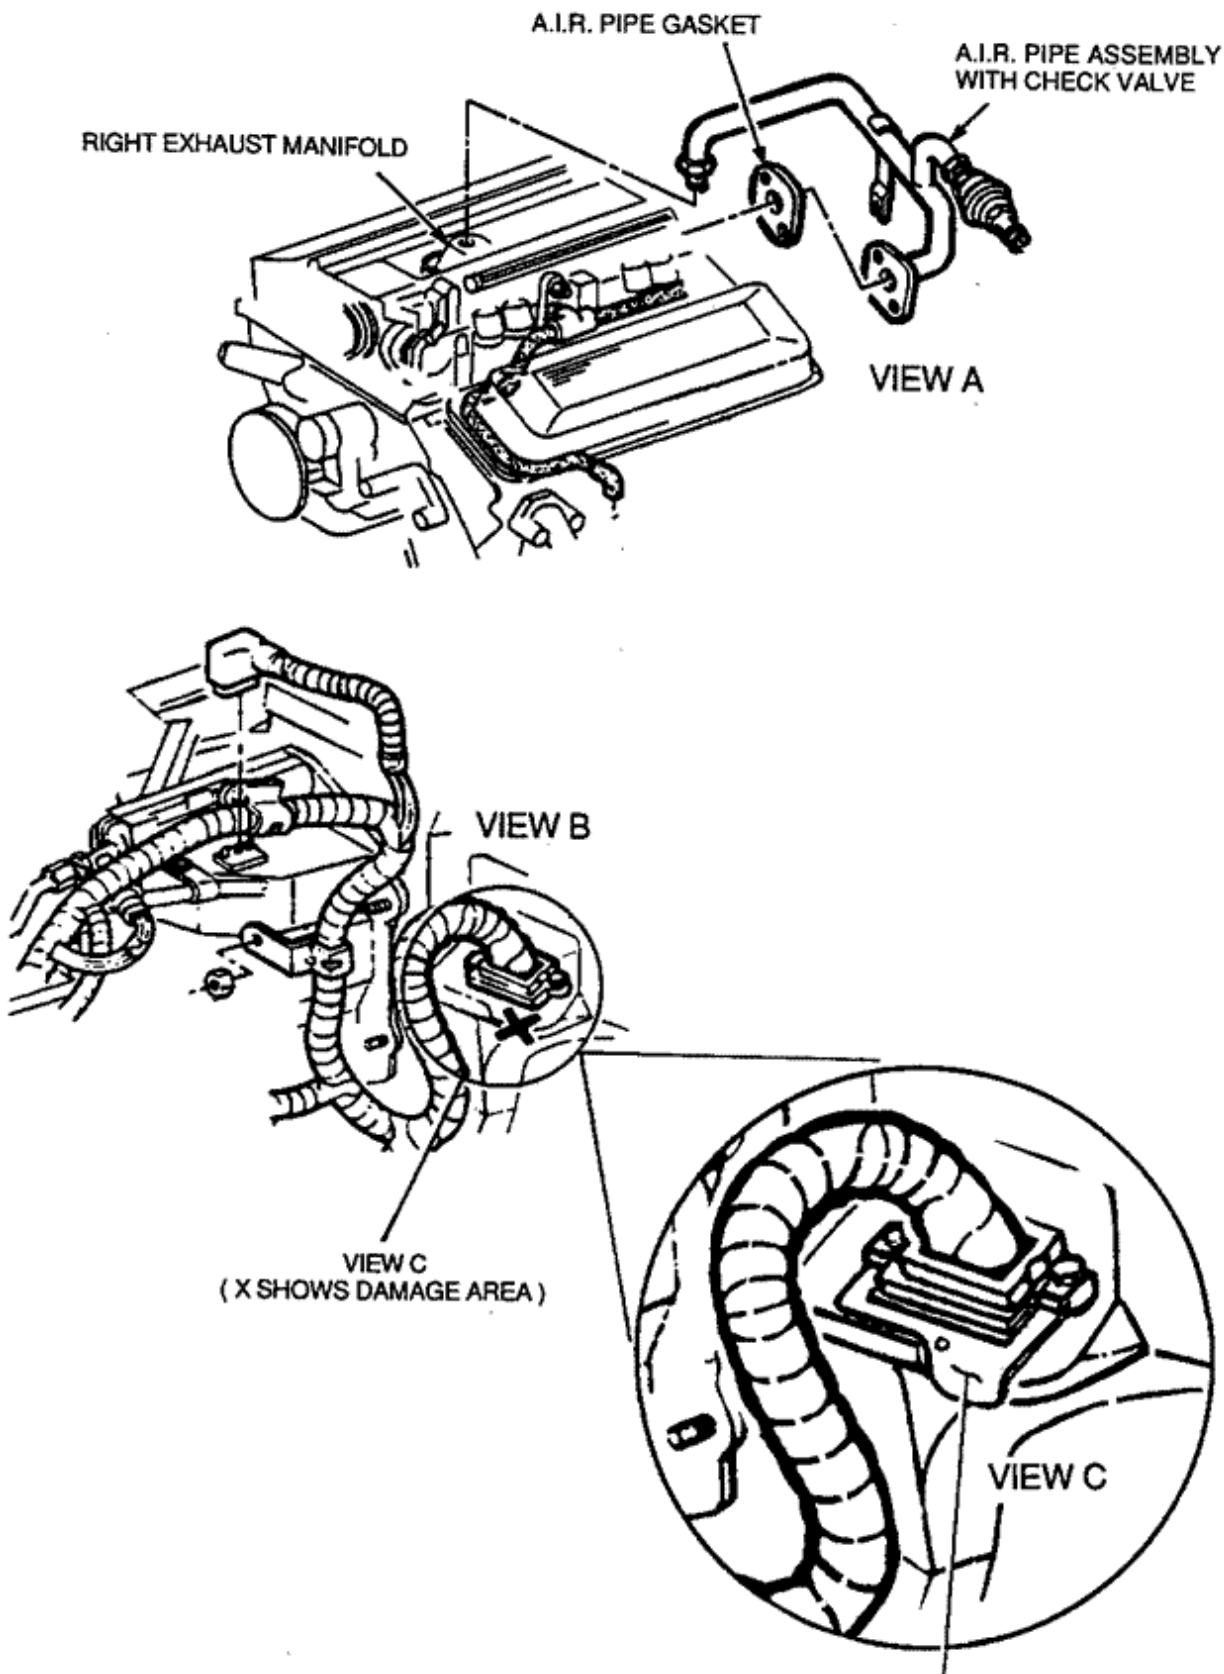
FIGURE 1

Some 1992-93 Y-cars with LT1 engines may have cracks or damage to the cowl surface:

- Behind the right cylinder head, - Below the wiring harness connector.

Rear of engine may contact the cowl surface when removing transmission or engine from vehicle.

NEW PART IN POSITION  
OVER DAMAGED AREA

6. Apply enough seam sealing material to fill or cover the damaged area. Paddle material into place, if required.
7. Loosen the harness connector attaching bolts, position GM P/N 10231336 - Spacer, over the damaged area and under the attaching bolt heads and tighten the attaching bolts. The spacer has slots to aid in installation (See View C).
