1992 - 1993 Corvette: Service Bulletin: Cracks/Damage to Cowl Surface

Subject: CRACKS OR DAMAGE TO COWL SURFACE

Model and Year: 1992-93 CORVETTE WITH RPO LT1 ENGINES ONLY

Bulletin Number: 93-134-10

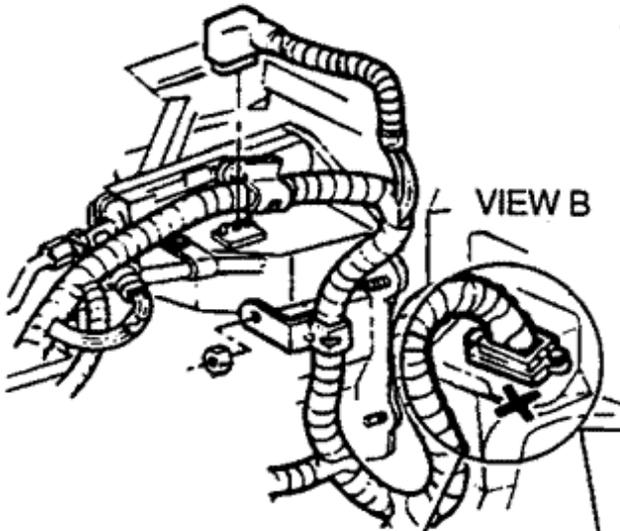
VIEW B

Some 1992-93 Y-cars with LT1 engines may have cracks or damage to the cowl surface:

- Behind the right cylinder head, - Below the wiring harness connector.

Rear of engine may contact the cowl surface when removing transmission or engine from vehicle.

- c. Remove bolts on rear of intake manifold, use 10 mm 1/4" drive socket and flex extension.
 - d. Remove hose and plastic clamp from check valve.
5. Clean damaged area (See View B) with a wax and grease remover and use V.O.C. approved materials where required.

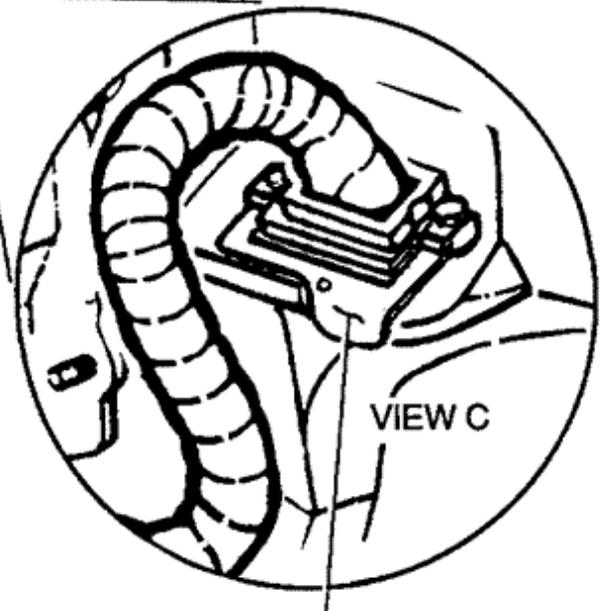
VIEW C

NEW PART IN POSITION
OVER DAMAGED AREA

6. Apply enough seam sealing material to fill or cover the damaged area. Paddle material into place, if required.
7. Loosen the harness connector attaching bolts, position GM P/N 10231336 - Spacer, over the damaged area and under the attaching bolt heads and tighten the attaching bolts. The spacer has slots to aid in installation (See View C).
