1992 - 1993 Corvette: Service Bulletin: Cracks/Damage to Cowl Surface

Subject: CRACKS OR DAMAGE TO COWL SURFACE

Model and Year: 1992-93 CORVETTE WITH RPO LT1 ENGINES ONLY

Bulletin Number: 93-134-10

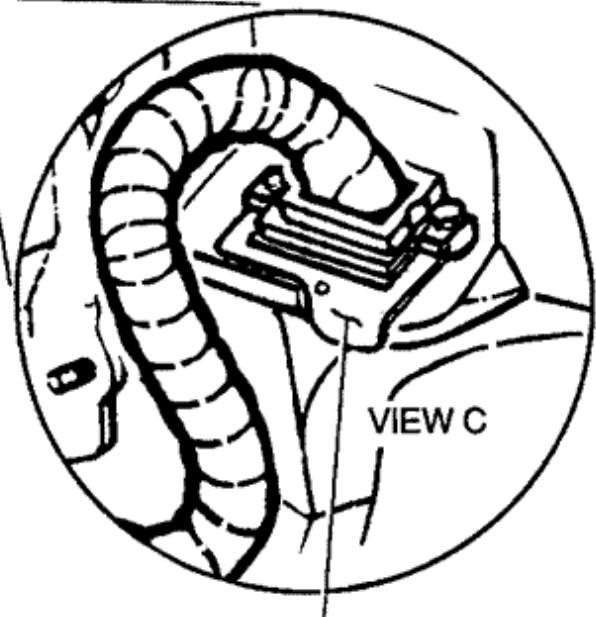
VIEW C
(X SHOWS DAMAGE AREA)

Some 1992-93 Y-cars with LT1 engines may have cracks or damage to the cowl surface:

- Behind the right cylinder head, - Below the wiring harness connector.

Rear of engine may contact the cowl surface when removing transmission or engine from vehicle.

NEW PART IN POSITION
OVER DAMAGED AREA

6. Apply enough seam sealing material to fill or cover the damaged area. Paddle material into place, if required.
7. Loosen the harness connector attaching bolts, position GM P/N 10231336 - Spacer, over the damaged area and under the attaching bolt heads and tighten the attaching bolts. The spacer has slots to aid in installation (See View C).
