1992 - 1993 Corvette: Service Bulletin: Cracks/Damage to Cowl Surface

Subject: CRACKS OR DAMAGE TO COWL SURFACE

Model and Year: 1992-93 CORVETTE WITH RPO LT1 ENGINES ONLY

Bulletin Number: 93-134-10

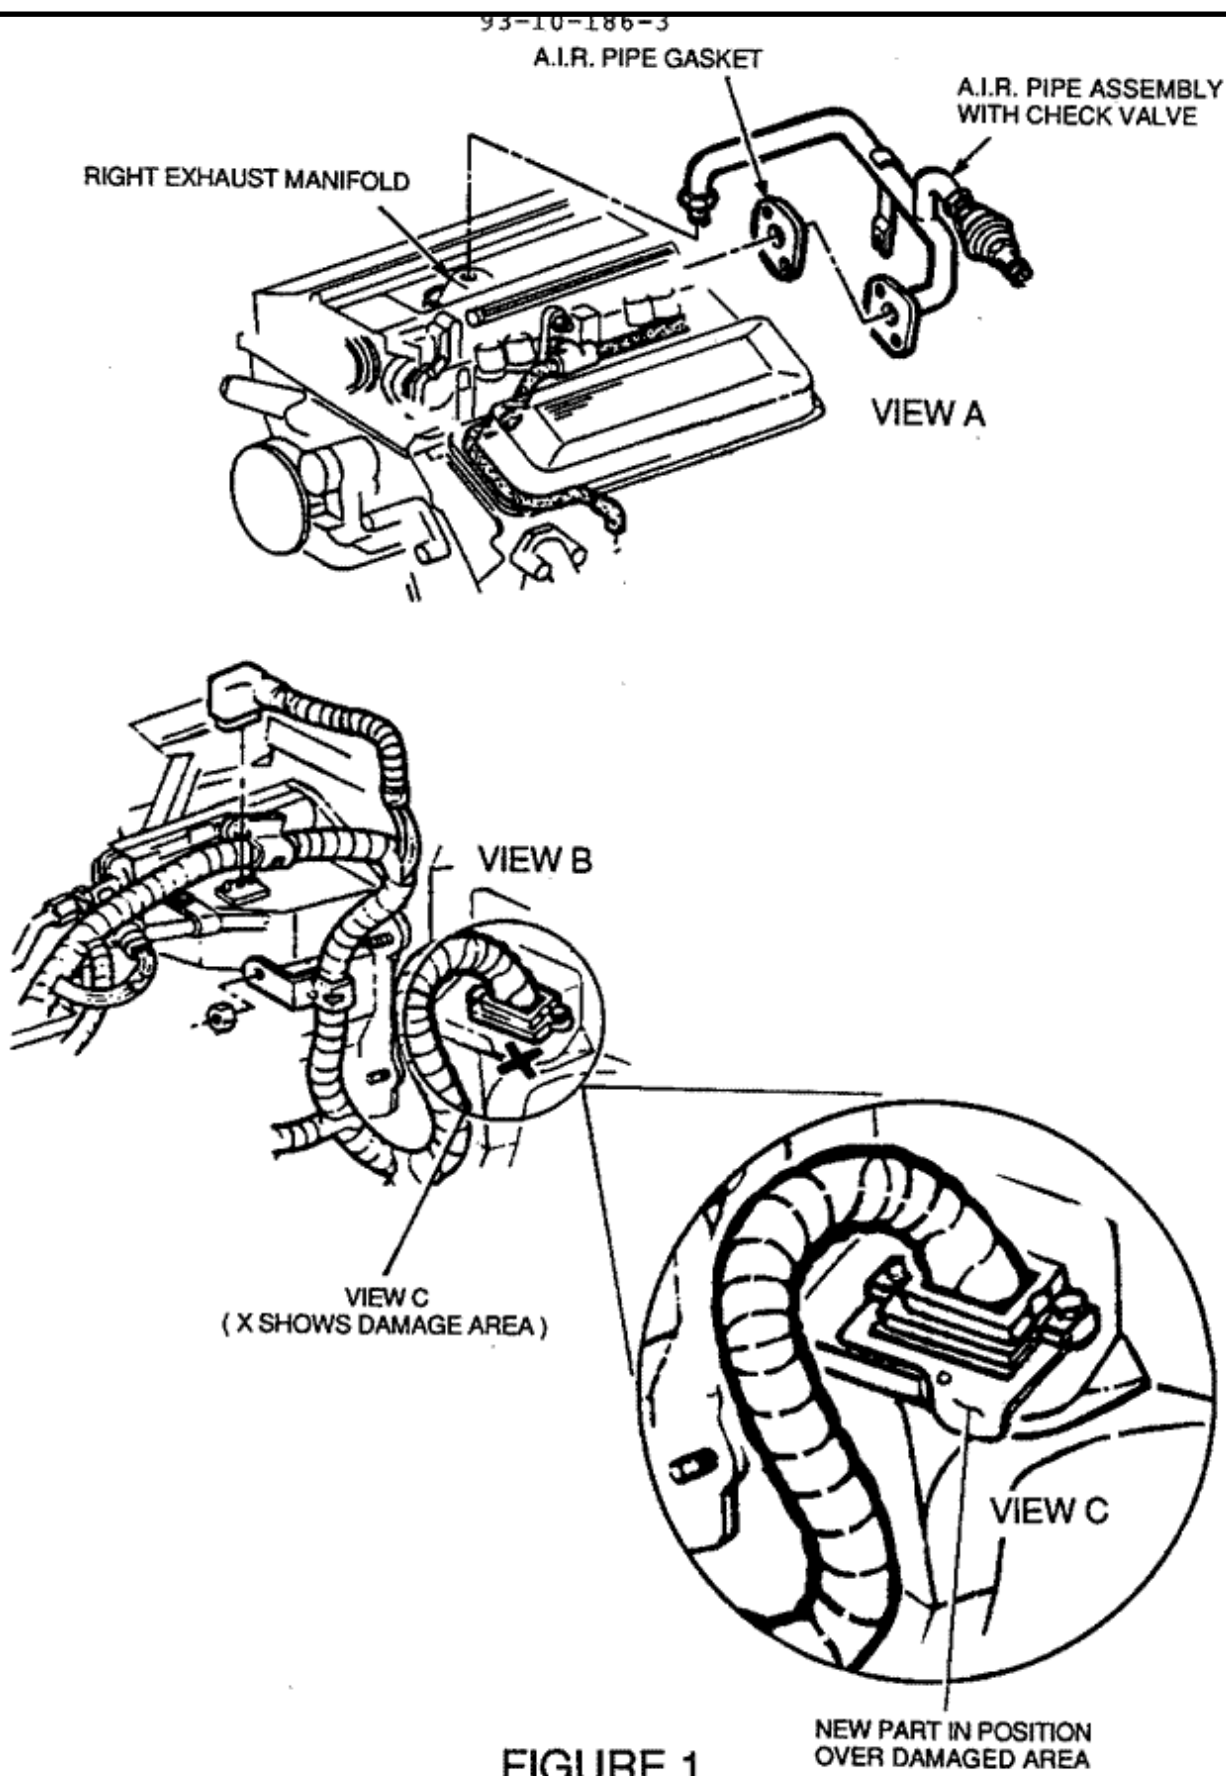
FIGURE 1

Some 1992-93 Y-cars with LT1 engines may have cracks or damage to the cowl surface:

- Behind the right cylinder head, - Below the wiring harness connector.

Rear of engine may contact the cowl surface when removing transmission or engine from vehicle.

4. Remove right side A.I.R. pipe from engine (See View A);
 - a. Remove nut at exhaust manifold, use 22 mm "crow foot" wrench.
 - b. Loosen bolt on rear of head, using long 9/16" open end wrench.

- c. Remove bolts on rear of intake manifold, use 10 mm 1/4" drive socket and flex extension.
 - d. Remove hose and plastic clamp from check valve.
5. Clean damaged area (See View B) with a wax and grease remover and use V.O.C. approved materials where required.

6. Apply enough seam sealing material to fill or cover the damaged area. Paddle material into place, if required.
7. Loosen the harness connector attaching bolts, position GM P/N 10231336 - Spacer, over the damaged area and under the attaching bolt heads and tighten the attaching bolts. The spacer has slots to aid in installation (See View C).
