1989 - 1990 Corvette: Service Bulletin: Convertible: Mounting Bracket Rattle at Rear of Hardtop

Number: 90-203-10

Subject: Mounting Bracket Rattle at Rear of Hardtop

Model Year: 1989-1990 Y Car Convertible

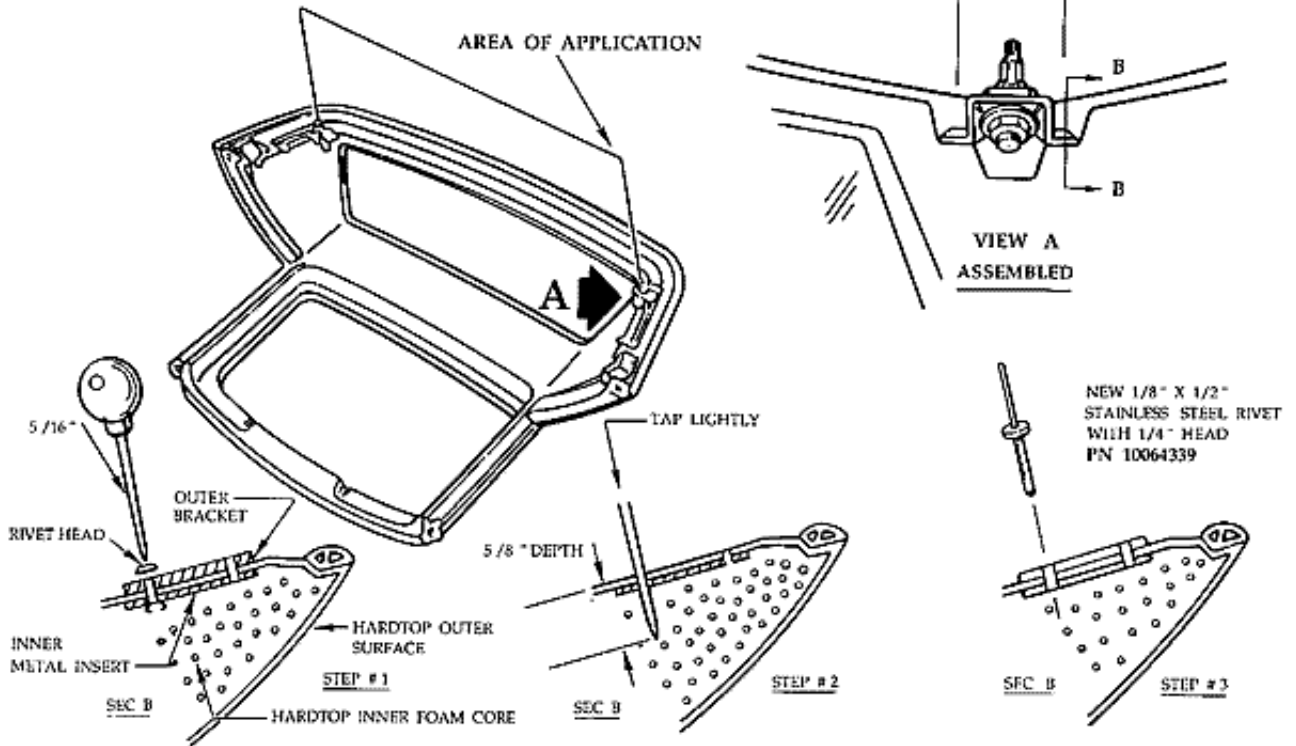
CORVETTE HARDTOP
BRACKET REAR PIN MOUNTING R/L
 (SERVICE PROCEDURE)

Some 1989 and early 1990 Chevrolet Corvettes (before VIN 106253) equipped with the convertible hardtop option (CC2) may exhibit a rattle at the rear of the hardtop caused by loose hardtop mounting brackets.

Some of these brackets were mounted with rivets which were not long enough to provide enough retention to prevent the rattle.

- STEP #1 DRILL OFF RIVET HEADS, USING A 5/16" DRILL BIT, AND REMOVE BRACKET. (4 RIVETS PER ASM.)
- STEP #2 TAP PREVIOUS RIVET BODIES AND MANDREL 5/8" DOWN INTO HARDTOP INNER FOAM CORE AREA. (4 RIVETS)
- STEP #3 REPOSITION BRACKET AND RE-ATTACH USING NEW RIVET (PN 10064339)
