# 1989 - 1990 Corvette: Service Bulletin: Convertible: Mounting Bracket Rattle at Rear of Hardtop

**Number:** 90-203-10

**Subject:** Mounting Bracket Rattle at Rear of Hardtop

**Model Year:** 1989-1990 Y Car Convertible

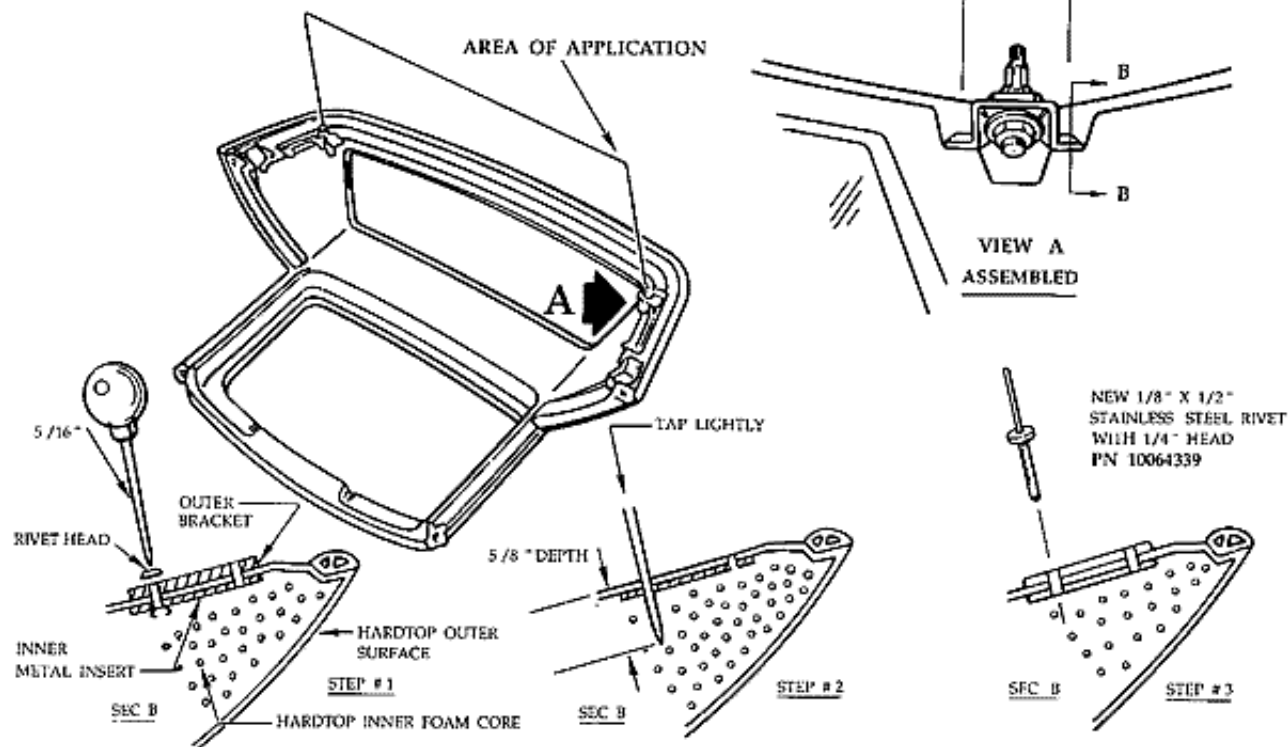
**CORVETTE HARDTOP**  
**BRACKET REAR PIN MOUNTING R / L**  
 ( SERVICE PROCEDURE )

Some 1989 and early 1990 Chevrolet Corvettes (before VIN 106253) equipped with the convertible hardtop option (CC2) may exhibit a rattle at the rear of the hardtop caused by loose hardtop mounting brackets.

Some of these brackets were mounted with rivets which were not long enough to provide enough retention to prevent the rattle.

- STEP #1 DRILL OFF RIVET HEADS, USING A 5/16" DRILL BIT, AND REMOVE BRACKET. (4 RIVETS PER ASM.)
- STEP #2 TAP PREVIOUS RIVET BODIES AND MANDREL 5/8" DOWN INTO HARDTOP INNER FOAM CORE AREA. (4 RIVETS)
- STEP #3 REPOSITION BRACKET AND RE-ATTACH USING NEW RIVET (PN 10064339)
