# 1989 - 1990 Corvette: Service Bulletin: Convertible: Mounting Bracket Rattle at Rear of Hardtop

**Number:** 90-203-10

**Subject:** Mounting Bracket Rattle at Rear of Hardtop

**Model Year:** 1989-1990 Y Car Convertible

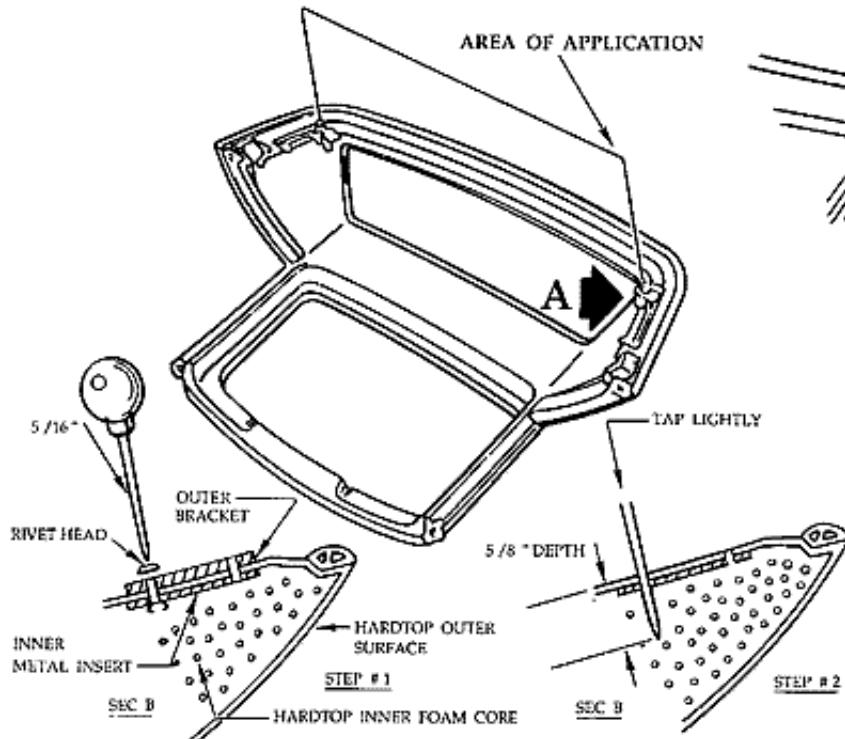
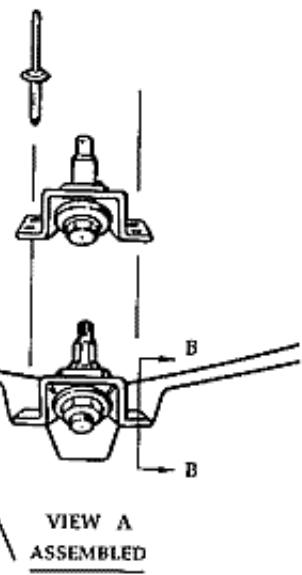
**CORVETTE HARDTOP**  
**BRACKET REAR PIN MOUNTING R / L**  
( SERVICE PROCEDURE )

Some 1989 and early 1990 Chevrolet Corvettes (before VIN 106253) equipped with the convertible hardtop option (CC2) may exhibit a rattle at the rear of the hardtop caused by loose hardtop mounting brackets.

Some of these brackets were mounted with rivets which were not long enough to provide enough retention to prevent the rattle.

STEP #1 DRILL OFF RIVET HEADS, USING A 5/16 DRILL BIT,  
AND REMOVE BRACKET. (4 RIVETS PER ASM.)

STEP #2 TAP PREVIOUS RIVET BODIES AND MANDREL 5/8"  
DOWN INTO HARDTOP INNER FOAM CORE AREA.  
(4 RIVETS)

STEP #3 REPOSITION BRACKET AND RE-ATTACH USING  
NEW RIVET ( PN 10064339 )
