1989 - 1990 Corvette: Service Bulletin: Convertible: Mounting Bracket Rattle at Rear of Hardtop

Source: Chevrolet Dealer Service Bulletin

Number: 90-203-10

Subject: Mounting Bracket Rattle at Rear of Hardtop

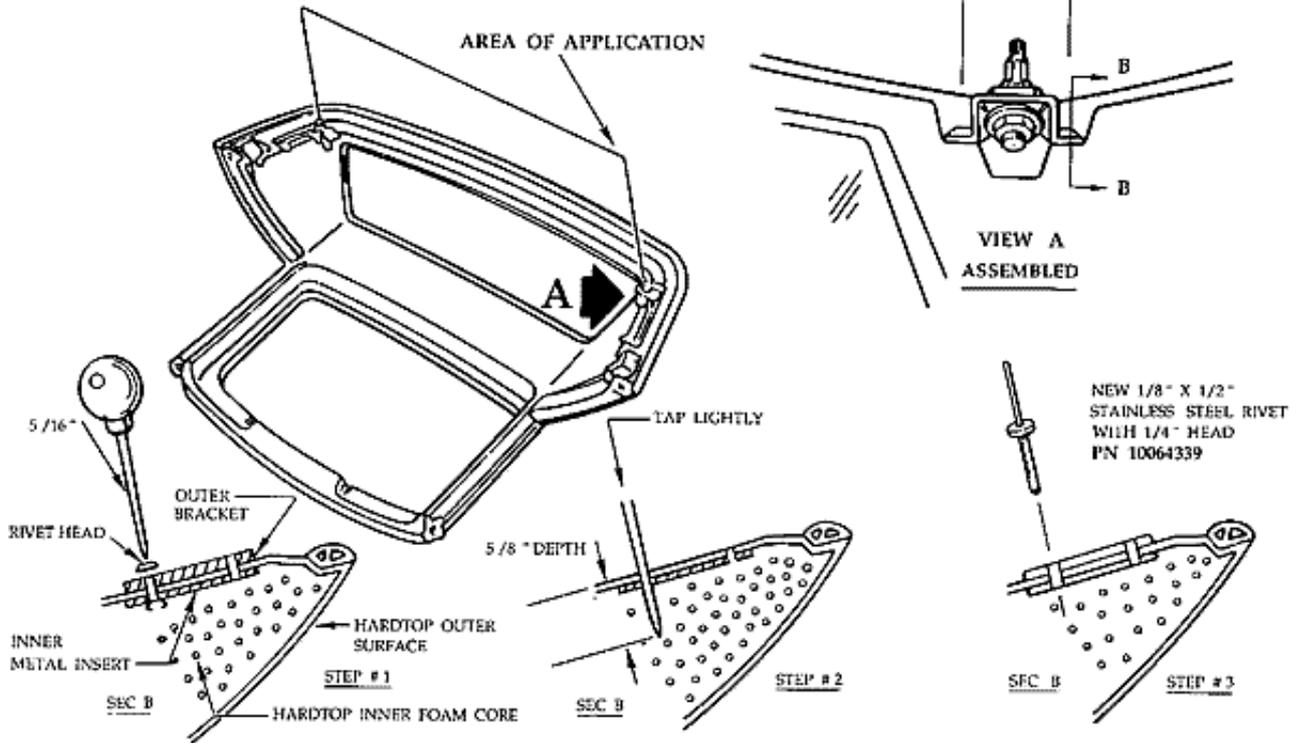
CORVETTE HARDTOP
BRACKET REAR PIN MOUNTING R/L
 (SERVICE PROCEDURE)

Some 1989 and early 1990 Chevrolet Corvettes (before VIN 106253) equipped with the convertible hardtop option (CC2) may exhibit a rattle at the rear of the hardtop caused by loose hardtop mounting brackets.

Some of these brackets were mounted with rivets which were not long enough to provide enough retention to prevent the rattle.

- STEP #1 DRILL OFF RIVET HEADS, USING A 5/16" DRILL BIT, AND REMOVE BRACKET. (4 RIVETS PER ASM.)
- STEP #2 TAP PREVIOUS RIVET BODIES AND MANDREL 5/8" DOWN INTO HARDTOP INNER FOAM CORE AREA. (4 RIVETS)
- STEP #3 REPOSITION BRACKET AND RE-ATTACH USING NEW RIVET (PN 10064339)
