1989 - 1990 Corvette: Service Bulletin: Convertible Stowage Lid Not Flush With Rear Deck

Number: 90-183-10 - (02/20/1990)

Subject: STOWAGE LID NOT FLUSH W/REAR DECK-PROCEDURE & STEEL RIVETS

Model Year: 1989-90 Y Car Convertible

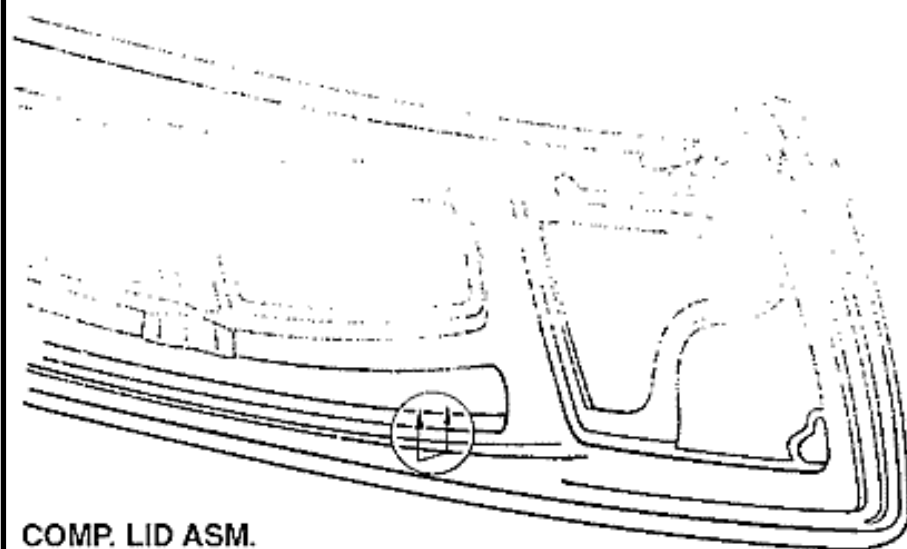
Some 1989 and early 1990 Chevrolet Corvette Convertibles may exhibit a height difference between the stowage compartment lid and the rear deck. This condition may be caused by a lack of adhesive between the steel inner reinforcement and the stowage compartment lid inner panel.

1. Remove the stowage lid as outlined in the Service Manual.
2. Drill 8 (eight) equally spaced 1/8 inch holes through the vertical surface (See Figure 1) of the stowage lid inner panel and the reinforcement.

1. REMOVE STORAGE COMPARTMENT LID FROM VEHICLE AND LAY UPSIDE DOWN ON A CLEAN PROTECTED SURFACE.
2. HOLD WEATHERSTRIP OUT OF THE WAY AND DRILL EIGHT (8) $1/8$ " HOLES IN BACK SIDE THROUGH INNER PANEL AND STEEL REINFORCEMENT (4 HOLES ON EACH SIDE OF CENTER EQUALLY SPACED).
3. INSTALL APPROPRIATE TAPPING SCREW ($5/16$ " LONG) OR STEEL RIVET ($1/8$ " X $1/4$ ").
