1989 - 1990 Corvette: Service Bulletin: Convertible Stowage Lid Not Flush With Rear Deck

Number: 90-183-10 - (02/20/1990)

Subject: STOWAGE LID NOT FLUSH W/REAR DECK-PROCEDURE & STEEL RIVETS

Model Year: 1989-90 Y Car Convertible

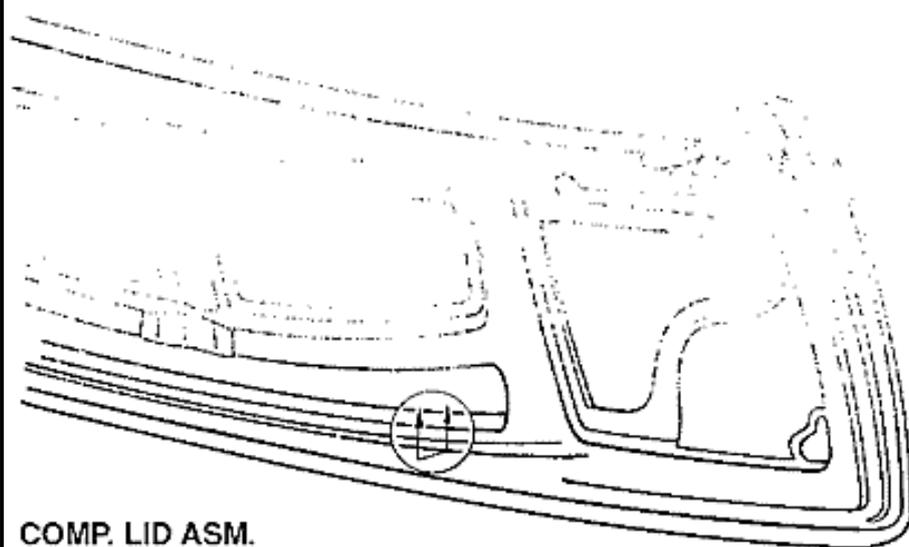
Some 1989 and early 1990 Chevrolet Corvette Convertibles may exhibit a height difference between the stowage compartment lid and the rear deck. This condition may be caused by a lack of adhesive between the steel inner reinforcement and the stowage compartment lid inner panel.

1. Remove the stowage lid as outlined in the Service Manual.
2. Drill 8 (eight) equally spaced 1/8 inch holes through the vertical surface (See Figure 1) of the stowage lid inner panel and the reinforcement.

3. Install 1/8 inch diameter X 1/4 inch long STEEL rivets in the holes.

1. REMOVE STORAGE COMPARTMENT LID FROM VEHICLE AND LAY UPSIDE DOWN ON A CLEAN PROTECTED SURFACE.
2. HOLD WEATHERSTRIP OUT OF THE WAY AND DRILL EIGHT (8) $1/8$ " HOLES IN BACK SIDE THROUGH INNER PANEL AND STEEL REINFORCEMENT (4 HOLES ON EACH SIDE OF CENTER EQUALLY SPACED).
3. INSTALL APPROPRIATE TAPPING SCREW ($5/16$ " LONG) OR STEEL RIVET ($1/8$ " X $1/4$ ").
