1986 - 1988 Corvette: Service Bulletin: Roof Panel Adjustment Procedures

Subject: Roof Panel Adjustment

1986 - 1988 Corvette Coupes

Source: GM Service Parts Operations

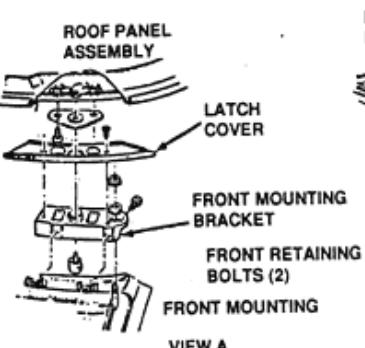
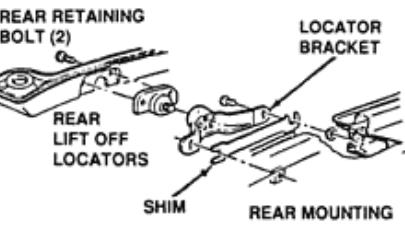
VIEW A		VIEW B		VIEW C				
INSTRUCTIONS-

3. Prior to installing the new roof panel assembly, make sure both front holding plate screws are untorqued allowing the parts to move freely but still remain in a repositioned location (View A).

4. Place the new roof panel assembly on the vehicle by engaging the locator brackets (View B). Then carefully attach the rear retaining bolts. After making sure the bolt threads are in line with the locator bracket, snug the bolts to 5 N.m. torque. Check to see if the approximate 6mm space and flush condition exists

between the roof panel and upper body rear panel. (If these conditions are met, proceed to step 5. (If not, proceed to step A).

5. Align the front retaining bolts in the front mounting brackets with the threaded hole in the "loose" front holding plates (View A). Torque the rear retaining bolts to 20 N.m., then the front retaining bolts to 15 N.m.

- Loosen these bolts, add or remove shims, or move brackets, reinstall and remove roof panel assembly to obtain the correct fit.

B. If the roof panel fit to the windshield reveal molding is not parallel or the weatherstrip is not compressed during step 5, remove the roof panel assembly and make the following corrections:

- Remove all trim panels/covers covering the front mounting bracket adjusting bolts (View C).
- Loosen these bolts to lower/raise the mounting bracket to improve weatherstrip contact, reinstall and remove roof panel to obtain correct fit.
- Add/remove shims behind the rear locator bracket, reinstall and remove roof panel until a satisfactory parallel fit is obtained.

A. If the approximate 6mm space and flush condition is not obtained during step 4, remove the roof panel assembly, and make the following corrections:

- Remove all trim panels covering the rear locator bracket adjusting bolts (View D).
