1984 - 1993 Corvette: Service Bulletin: Rear Lift Window Hard to Open/Hinge Loose to Glass

Model and Year: 1984-1993 Corvette

Source: Chevrolet Service Bulletin

Bulletin Number: 93-131-10

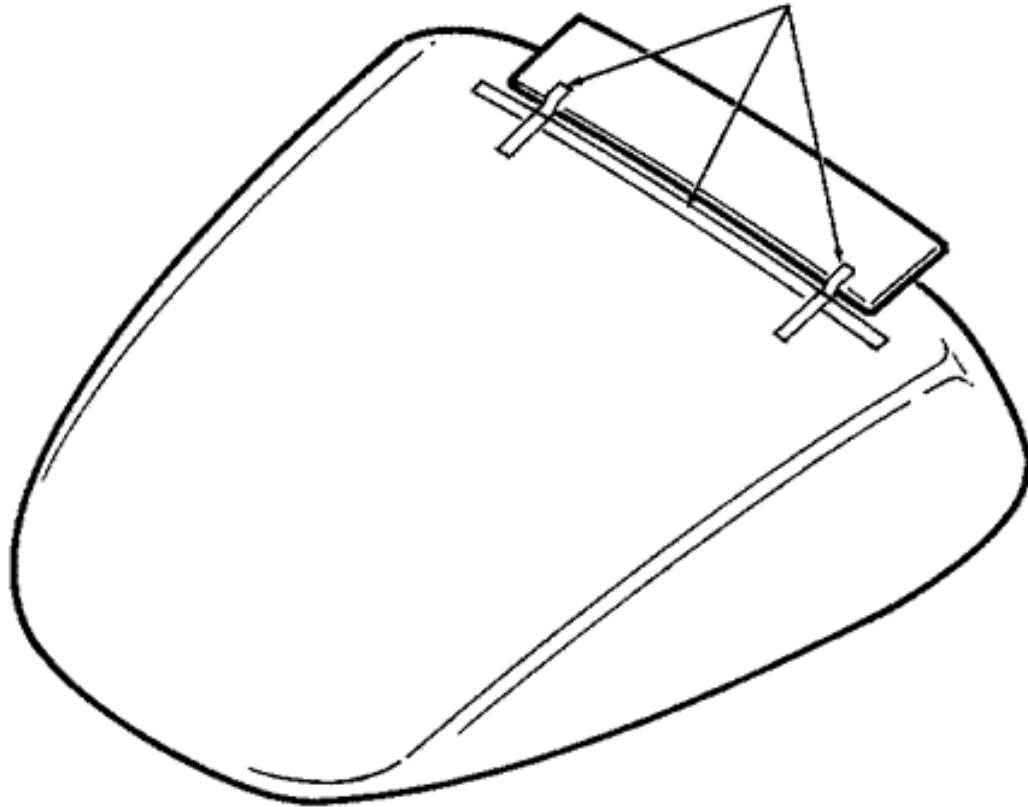
FIGURE 1

MASKING TAPE INSTALLED FOR ALIGNMENT

Apply three pieces of tape to the glass for alignment of the hinge plate to the glass after the glass is removed from the vehicle. Cut the tape spanning the glass and hinge plate as shown in Figure 1.

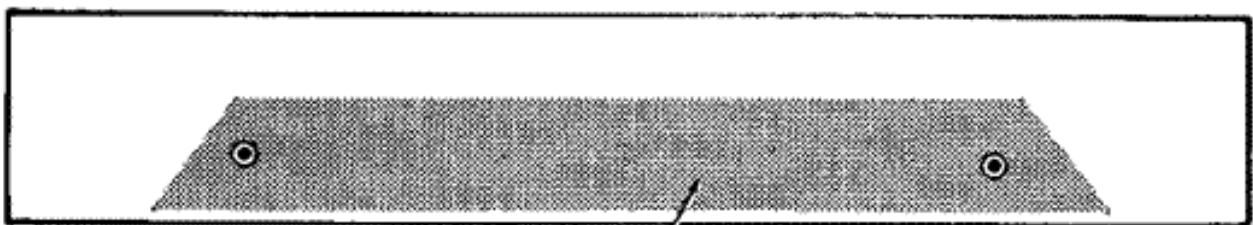
FIGURE 2

SHADED AREA SHOWS AREA TO BE SANDED

12. While primer is drying, Sand the painted surface of the hinge plate with 120 grit sand paper to remove the primer (SEE FIGURE 2). Clean hinge surface with glass cleaner and let dry.
