1982 - 1991 Corvette: Service Bulletin: Transmission Stuck in First Gear

Subject: TRANSMISSION STUCK IN FIRST GEAR

Source: Chevrolet Service Bulletin

Bulletin Number: 91-371-7A - (06/28/1991)

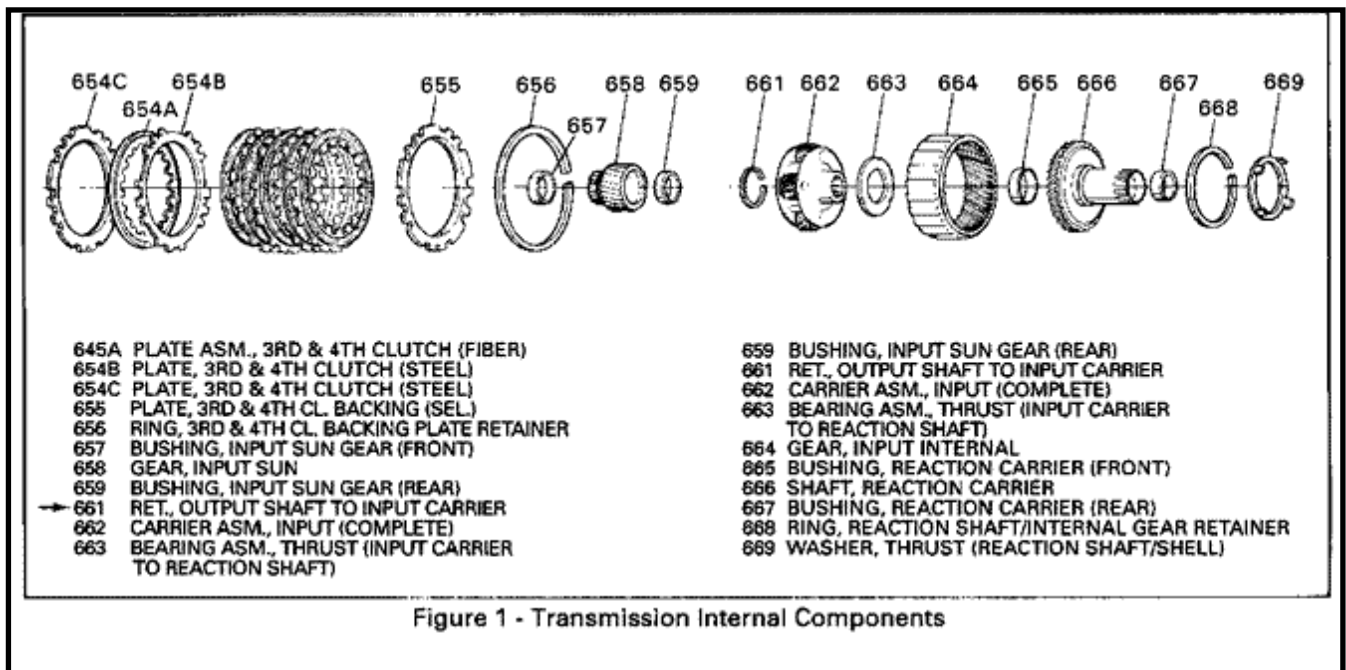
Figure 1 - Transmission Internal Components

Some HYDRA-MATIC 4L60/700-R4 transmissions may experience a "no upshift" or "stuck in first gear" condition. This may be caused by the input carrier to output shaft retaining ring coming unseated, or retaining ring omitted during assembly. This can allow the output shaft to move slightly, and cause wear on the governor gear (the governor gear ON THE GOVERNOR, not the governor drive gear on the output shaft). The governor gear wear may be described as an "apple cored" condition. If the governor gear is worn, the transmission cannot upshift out of first gear.

Remove the governor and inspect the governor gear. If it is "apple cored", disassemble the transmission and look for the presence of the input carrier to output shaft retaining ring.

- o If the retaining ring is missing, replace it, but make sure the original

retaining ring is not broken and stuck inside the transmission.

o If the retaining ring has become unseated, replace the retaining ring with a new one since the original has probably been over-expanded.

When installing a new retaining ring, be careful not to over-expand the retaining ring.
