1982 - 1991 Corvette: Service Bulletin: Transmission Stuck in First Gear

Subject: TRANSMISSION STUCK IN FIRST GEAR

Source: Chevrolet Service Bulletin

Bulletin Number: 91-371-7A - (06/28/1991)

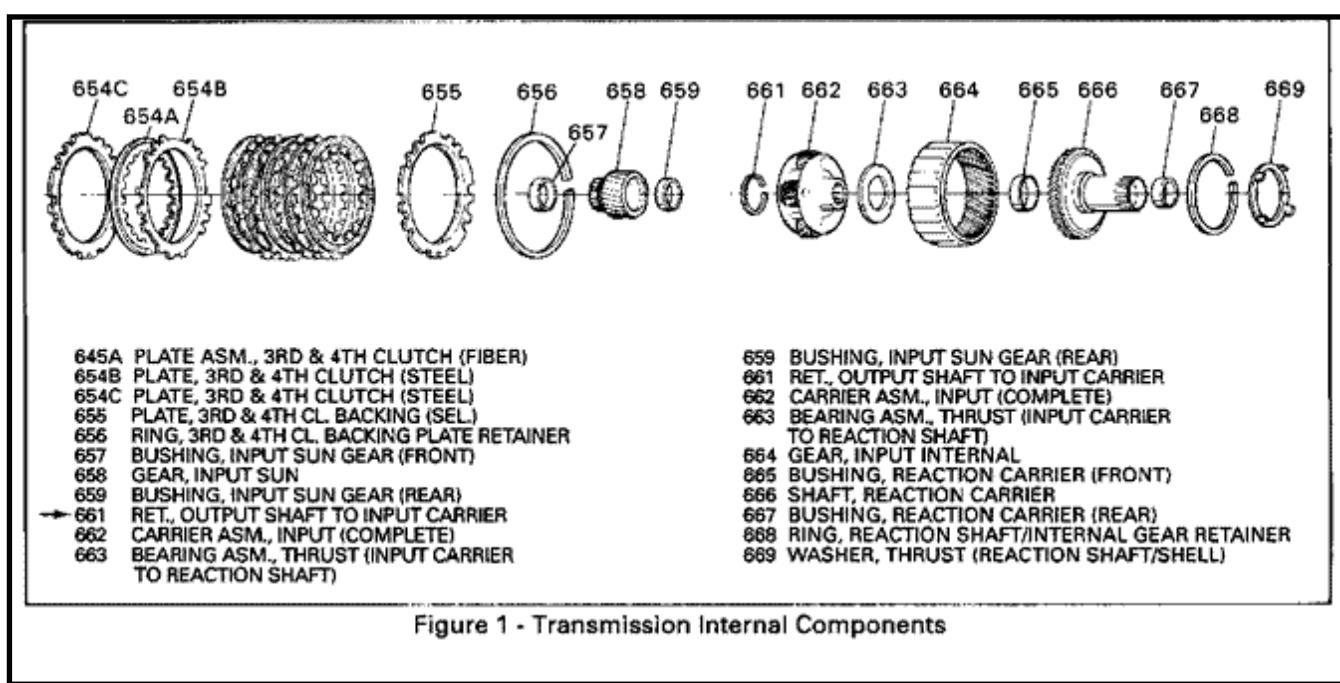
Figure 1 - Transmission Internal Components

Some HYDRA-MATIC 4L60/700-R4 transmissions may experience a "no upshift" or "stuck in first gear" condition. This may be caused by the input carrier to output shaft retaining ring coming unseated, or retaining ring omitted during assembly. This can allow the output shaft to move slightly, and cause wear on the governor gear (the governor gear ON THE GOVERNOR, not the governor drive gear on the output shaft). The governor gear wear may be described as an "apple cored" condition. If the governor gear is worn, the transmission cannot upshift out of first gear.

Remove the governor and inspect the governor gear. If it is "apple cored", disassemble the transmission and look for the presence of the input carrier to output shaft retaining ring.

o If the retaining ring is missing, replace it, but make sure the original

retaining ring is not broken and stuck inside the transmission.

- o If the retaining ring has become unseated, replace the retaining ring with a new one since the original has probably been over-expanded.

When installing a new retaining ring, be careful not to over-expand the retaining ring.
