1982 - 1991 Corvette: Service Bulletin: Transmission Stuck in First Gear

Subject: TRANSMISSION STUCK IN FIRST GEAR

Bulletin Number: 91-371-7A - (06/28/1991)

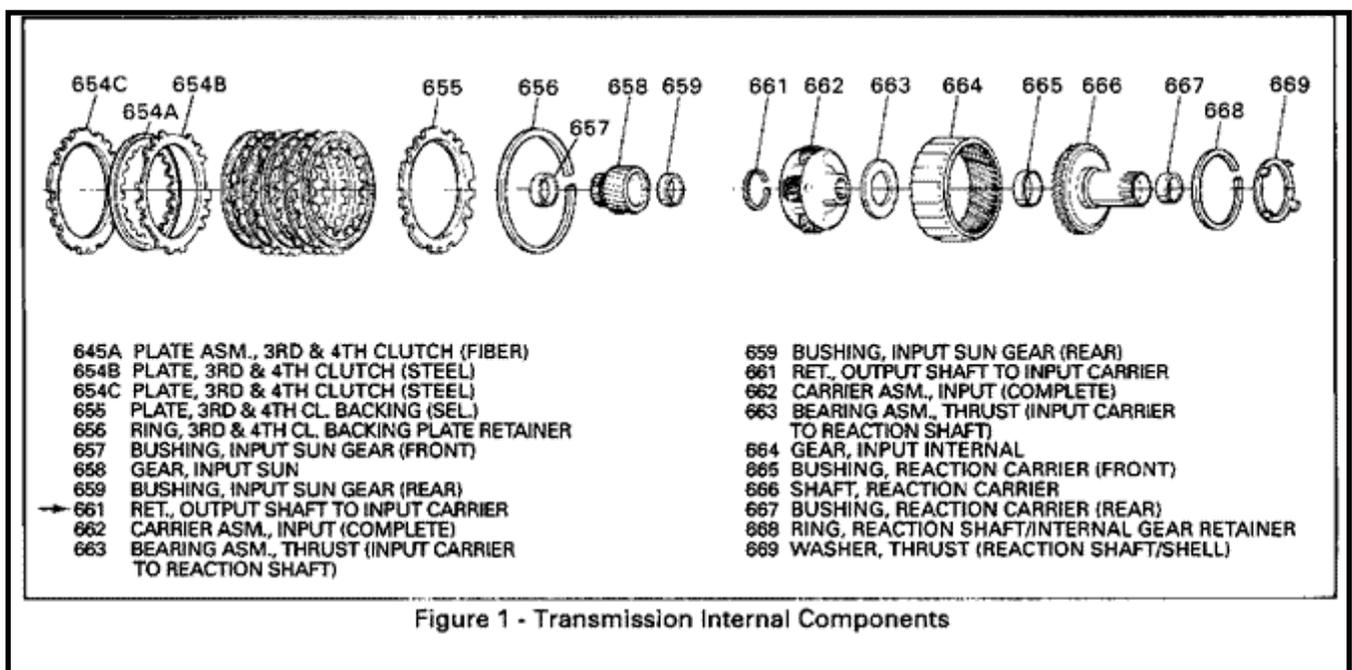
Figure 1 - Transmission Internal Components

Some HYDRA-MATIC 4L60/700-R4 transmissions may experience a "no upshift" or "stuck in first gear" condition. This may be caused by the input carrier to output shaft retaining ring coming unseated, or retaining ring omitted during assembly. This can allow the output shaft to move slightly, and cause wear on the governor gear (the governor gear ON THE GOVERNOR, not the governor drive gear on the output shaft). The governor gear wear may be described as an "apple cored" condition. If the governor gear is worn, the transmission cannot upshift out of first gear.

Remove the governor and inspect the governor gear. If it is "apple cored", disassemble the transmission and look for the presence of the input carrier to output shaft retaining ring.

- o If the retaining ring is missing, replace it, but make sure the original

retaining ring is not broken and stuck inside the transmission.

o If the retaining ring has become unseated, replace the retaining ring with a new one since the original has probably been over-expanded.

When installing a new retaining ring, be careful not to over-expand the retaining ring.
