2014 Corvette: GM TechLink Article: Blank Touch Screen after Start-up and in Reverse

Source: GM TechLink

Date: January 23, 2014

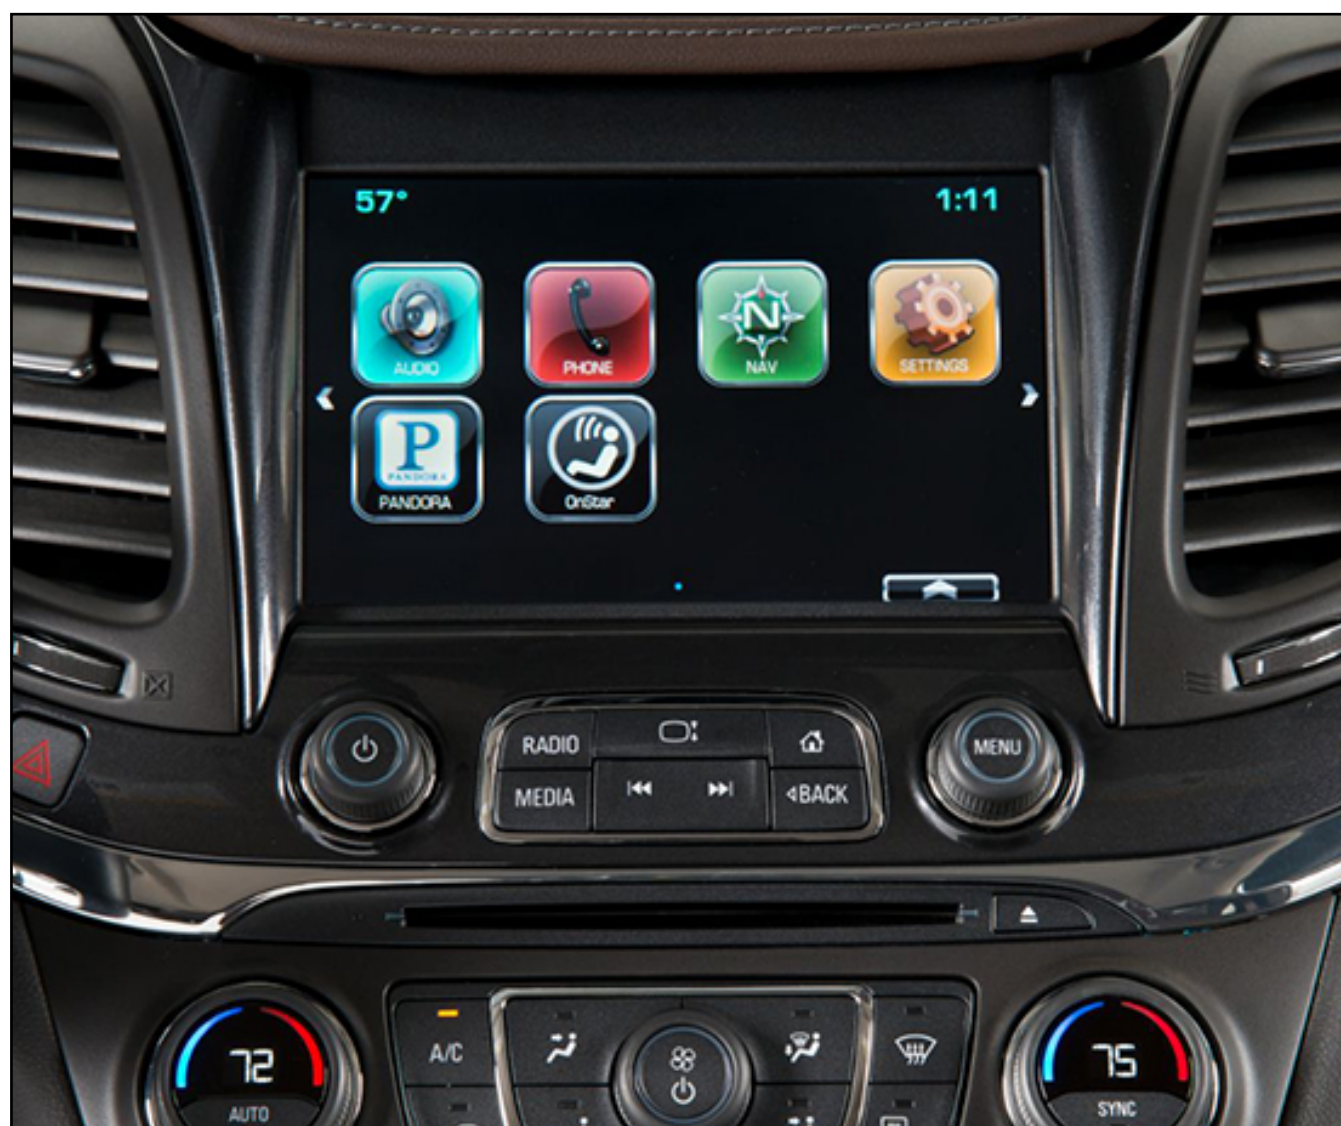
Fig. 9

The infotainment touch screen may be blank after start-up and in Reverse, a rearview camera message may be displayed, and there may be Bluetooth® and navigation system conditions on the following models equipped with radio-infotainment system RPOs IO4, IO5, IO6 or RAO (except with RPO UPF):

An updated software calibration has been released to address these conditions.

Update the Human Machine Interface (HMI) module using a USB flash drive and the Service Programming System with the files available on TIS2Web.
