# 2014 Corvette: GM TechLink Article: Blank Touch Screen after Start-up and in Reverse

**Source:** GM TechLink

**Date:** January 23, 2014

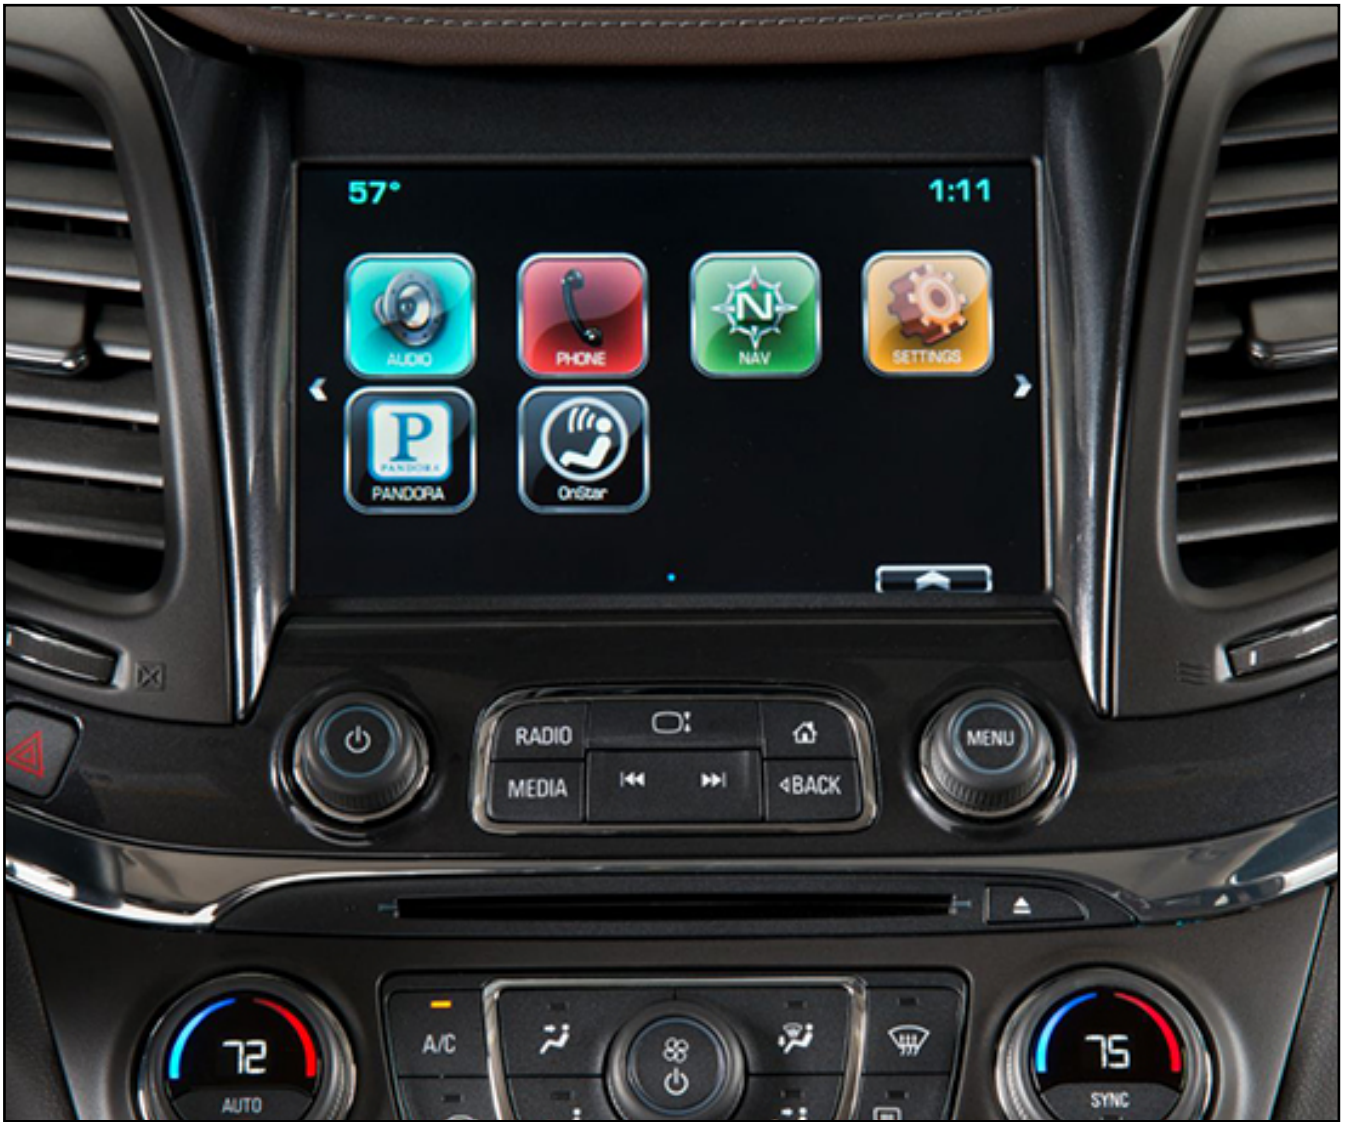
## Fig. 9

The infotainment touch screen may be blank after start-up and in Reverse, a rearview camera message may be displayed, and there may be Bluetooth® and navigation system conditions on the following models equipped with radio-infotainment system RPOs IO4, IO5, IO6 or RAO (except with RPO UPF):

Some possible Bluetooth conditions include the screen not returning to the Home screen after ending a call, cannot call contact work/mobile number for more than one contact with the same name, and issues concerning speech recognition.

Some navigation conditions include no results found after performing an address search with an incomplete address, the selection of a Point of Interest address delivers a wrong destination position, and the map freezing when panning in the 10k zoom scale.

An updated software calibration has been released to address these conditions.

Update the Human Machine Interface (HMI) module using a USB flash drive and the Service Programming System with the files available on TIS2Web.

After USB programming has been completed, reprogram the HMI module using the Service Programming System with the latest calibrations available on TIS2Web and then clear any DTCs.
