# 2006 - 2008 Corvette: GM TechLink: 6L80 or 6L90 Automatic Transmission Shift Conditions

**Source:** GM Techlink

**Date:** October 2011

**Subject:** 6L80 or 6L90 Automatic Transmission Shift Conditions

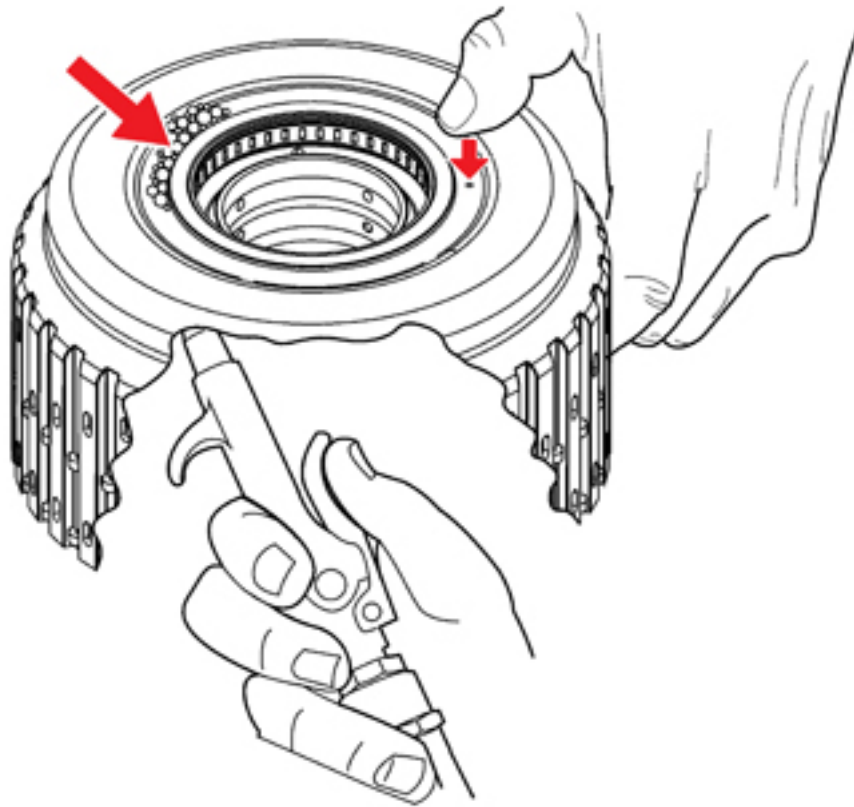
Fig. 14

A cracked 1-2-3-4/3-5-R clutch housing may cause any of the following conditions:

- Slip when Reverse is selected or no Reverse
- Delayed engagement into Reverse
- DTC P0776 set as an active or a history code in the Transmission Control Module, Malfunction Indicator Lamp (MIL) illuminated
- Harsh shifts from Second to Third

Inspect the 1-2-3-4 / 3-5-R clutch housing for a possible cracked weld by

applying soap compound to the weld area of the housing. Hold your thumb over the air bleed passage and spray compressed air into the piston housing. Inspect the weld area for bubbles. If bubbles are detected, a new housing is required. (Fig. 14)
