2006 - 2008 Corvette: GM TechLink: 6L80 or 6L90 Automatic Transmission Shift Conditions

Subject: 6L80 or 6L90 Automatic Transmission Shift Conditions

Models: 2006 - 2008 Chevrolet Corvette

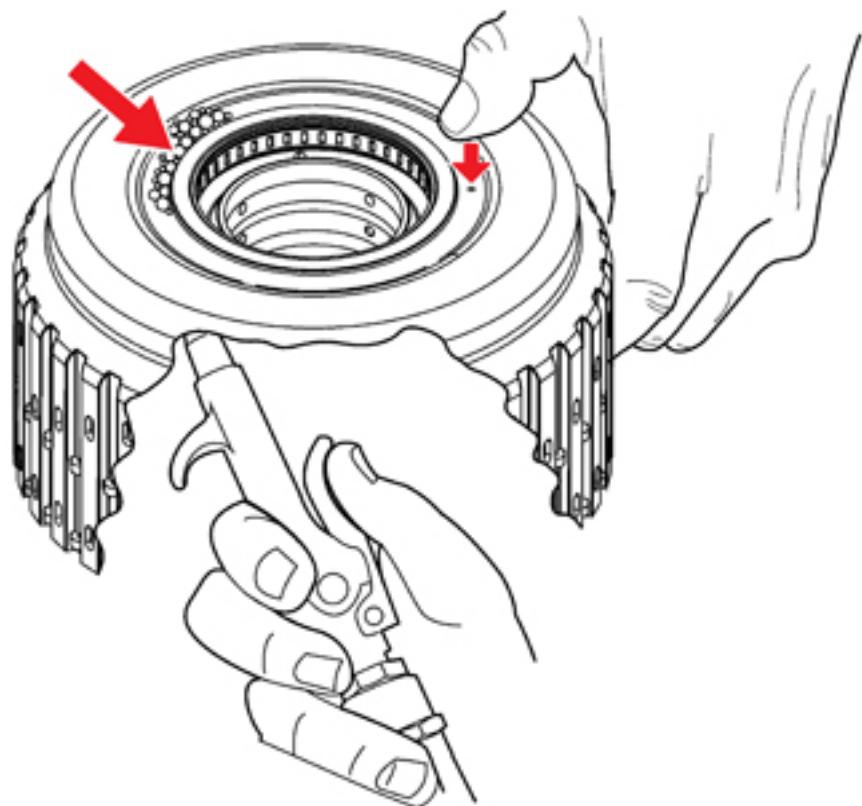
Fig. 14

A cracked 1-2-3-4/3-5-R clutch housing may cause any of the following conditions:

- Slip when Reverse is selected or no Reverse
- Delayed engagement into Reverse
- DTC P0776 set as an active or a history code in the Transmission Control Module, Malfunction Indicator Lamp (MIL) illuminated
- Harsh shifts from Second to Third

Inspect the 1-2-3-4 / 3-5-R clutch housing for a possible cracked weld by

applying soap compound to the weld area of the housing. Hold your thumb over the air bleed passage and spray compressed air into the piston housing. Inspect the weld area for bubbles. If bubbles are detected, a new housing is required. (Fig. 14)
