# 1954 - 1955 Corvette: Service Bulletin: Positioning Directional Signal Flasher Plastic Socket

**Subject:** Positioning Directional Signal Flasher Plastic Socket

**Model and Year:** 1955 Passenger Cars (applies to 1954 - 1955 Chevrolet Corvettes)

**Bulletin Number:** DR-180, Section XII

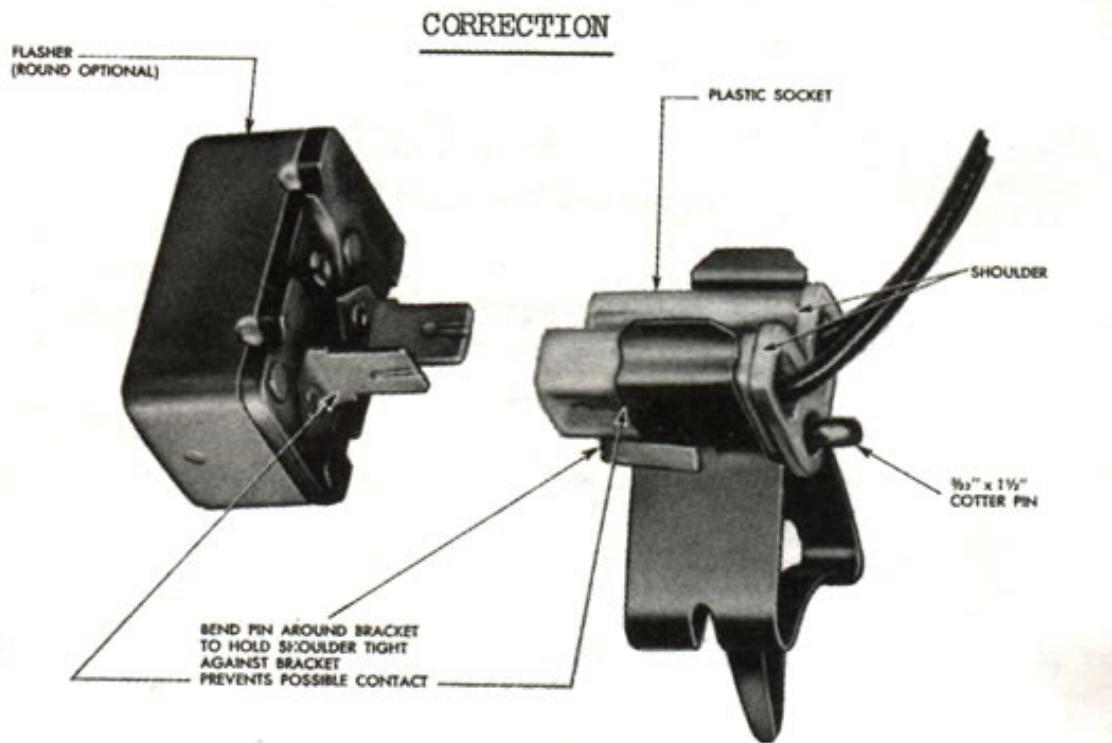
The shoulder on the plastic Directional Signal Flasher Socket should be up against its Mounting Clip to prevent contact between Flasher Terminal and Clip.

Flasher is located above parking brake handle back of instrument panel.

To prevent mis-positioning and shorting during future flasher replacement, a 3/32" x 1-1/2" cotter pin should be installed through the hole in the plastic socket and around the legs of clip, holding the plastic shoulder tight against the clip.

All early 1955 Cars should be checked and corrected. This is now being handled in production.
