1954 - 1955 Corvette: Service Bulletin: Positioning Directional Signal Flasher Plastic Socket

Subject: Positioning Directional Signal Flasher Plastic Socket
Model and Year: 1955 Passenger Cars (applies to 1954 - 1955 Chevrolet Corvettes)
Source: Chevrolet Central Office, Technical Service Bulletin
Bulletin Number: DR-180, Section XII
Date: November 3, 1954

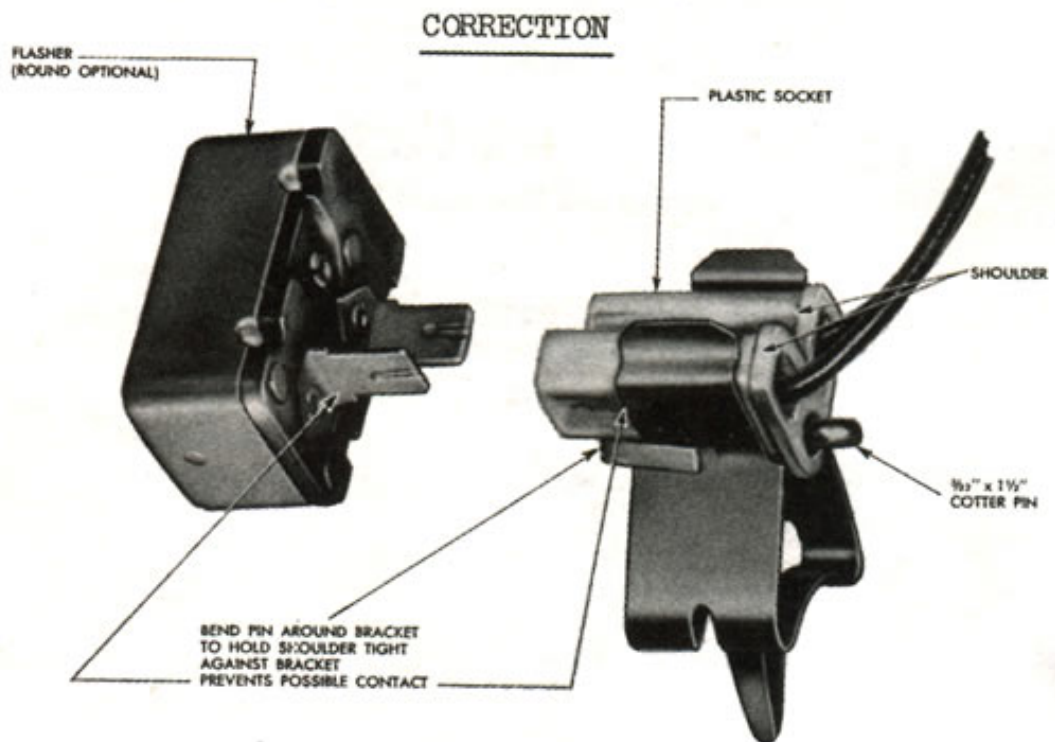
The shoulder on the plastic Directional Signal Flasher Socket should be up against its Mounting Clip to prevent contact between Flasher Terminal and Clip.

Flasher is located above parking brake handle back of instrument panel.

To prevent mis-positioning and shorting during future flasher replacement, a 3/32" x 1-1/2" cotter pin should be installed through the hole in the plastic socket and around the legs of clip, holding the plastic shoulder tight against the clip.

All early 1955 Cars should be checked and corrected. This is now being handled in production.
