# 1954 - 1955 Corvette: Service Bulletin: Positioning Directional Signal Flasher Plastic Socket

**Subject:** Positioning Directional Signal Flasher Plastic Socket  
**Model and Year:** 1955 Passenger Cars (applies to 1954 - 1955 Chevrolet Corvettes)  
**Source:** Chevrolet Central Office, Technical Service Bulletin  
**Bulletin Number:** DR-180, Section XII  
**Date:** November 3, 1954

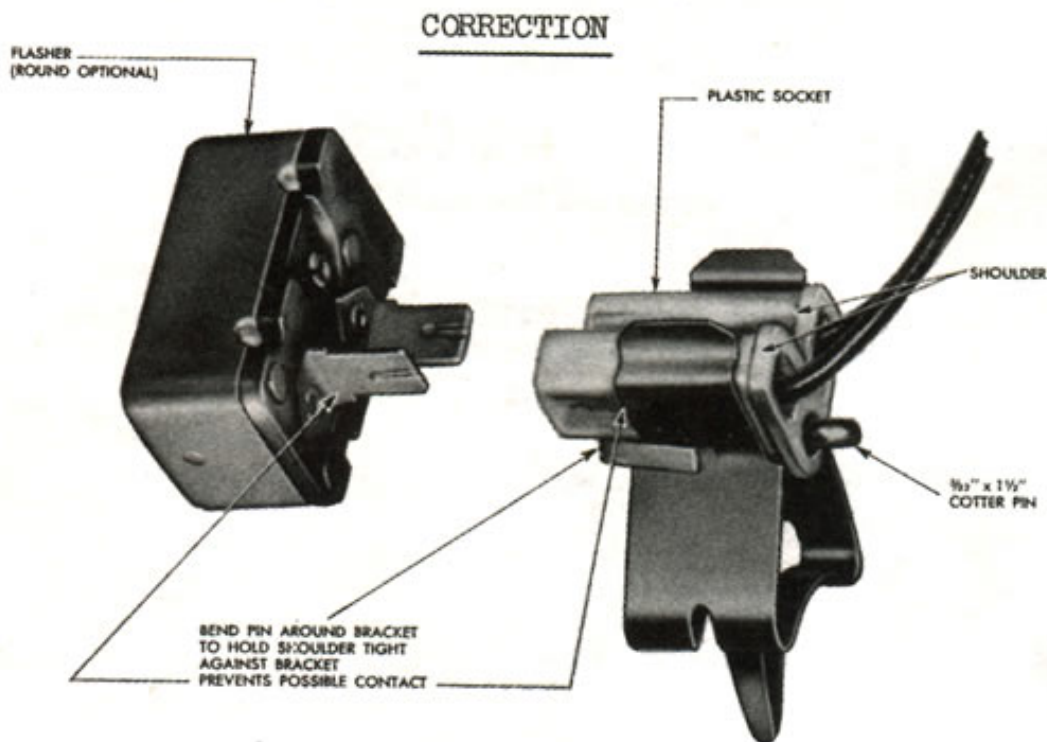
The shoulder on the plastic Directional Signal Flasher Socket should be up against its Mounting Clip to prevent contact between Flasher Terminal and Clip.

Flasher is located above parking brake handle back of instrument panel.

To prevent mis-positioning and shorting during future flasher replacement, a 3/32" x 1-1/2" cotter pin should be installed through the hole in the plastic socket and around the legs of clip, holding the plastic shoulder tight against the clip.

All early 1955 Cars should be checked and corrected. This is now being handled in production.
