1957 - 1958 Corvette: Service News: Corvette 4-Speed Transmission - Harsh Shift Into Third Speed

Source: Chevrolet Service News

Date: December, 1957

Subject: Corvette 4-Speed Transmission - Harsh Shift Into Third Speed

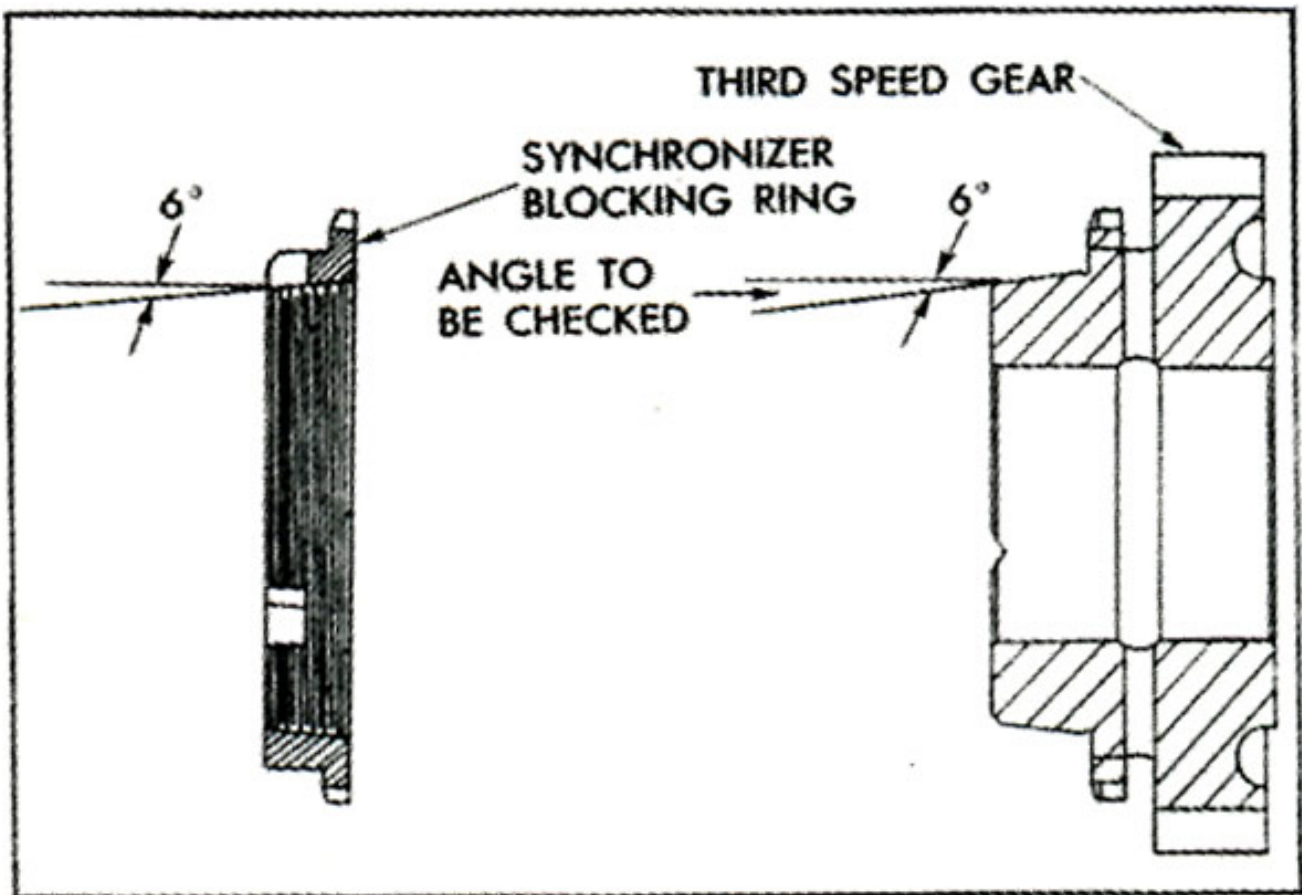
Some 1957 and 1958 Corvette four-speed transmissions have been built incorporating a third speed gear with 7° cone angle rather than the specified 6° , as illustrated in Figure 3. This may cause a harsh shift into third speed due to the resultant improper engagement of the synchronizer blocking ring and third speed gear cone.

Fig. 3—Checking Third Speed Gear

The suggested correction, if the harsh shift is encountered, is to replace the third speed gear assembly No. 3743452 and the synchronizer blocking ring No. 3709348.

1. Coat I.D. of blocking ring lightly with a dye such as Prussian Blue.
2. Carefully install the blocking ring on the third gear cone to obtain an engagement impression.
3. If the Prussian Blue impression on the cone is all at the rear (or predominantly at the rear) the cone angle can be assumed to be 7° and should not be used. If the Prussian Blue is more or less evenly distributed on the cone surface, the angle is correct.
