1957 - 1958 Corvette: Service News: Corvette 4-Speed Transmission - Harsh Shift Into Third Speed

Source: Chevrolet Service News

Date: December, 1957

Subject: Corvette 4-Speed Transmission - Harsh Shift Into Third Speed

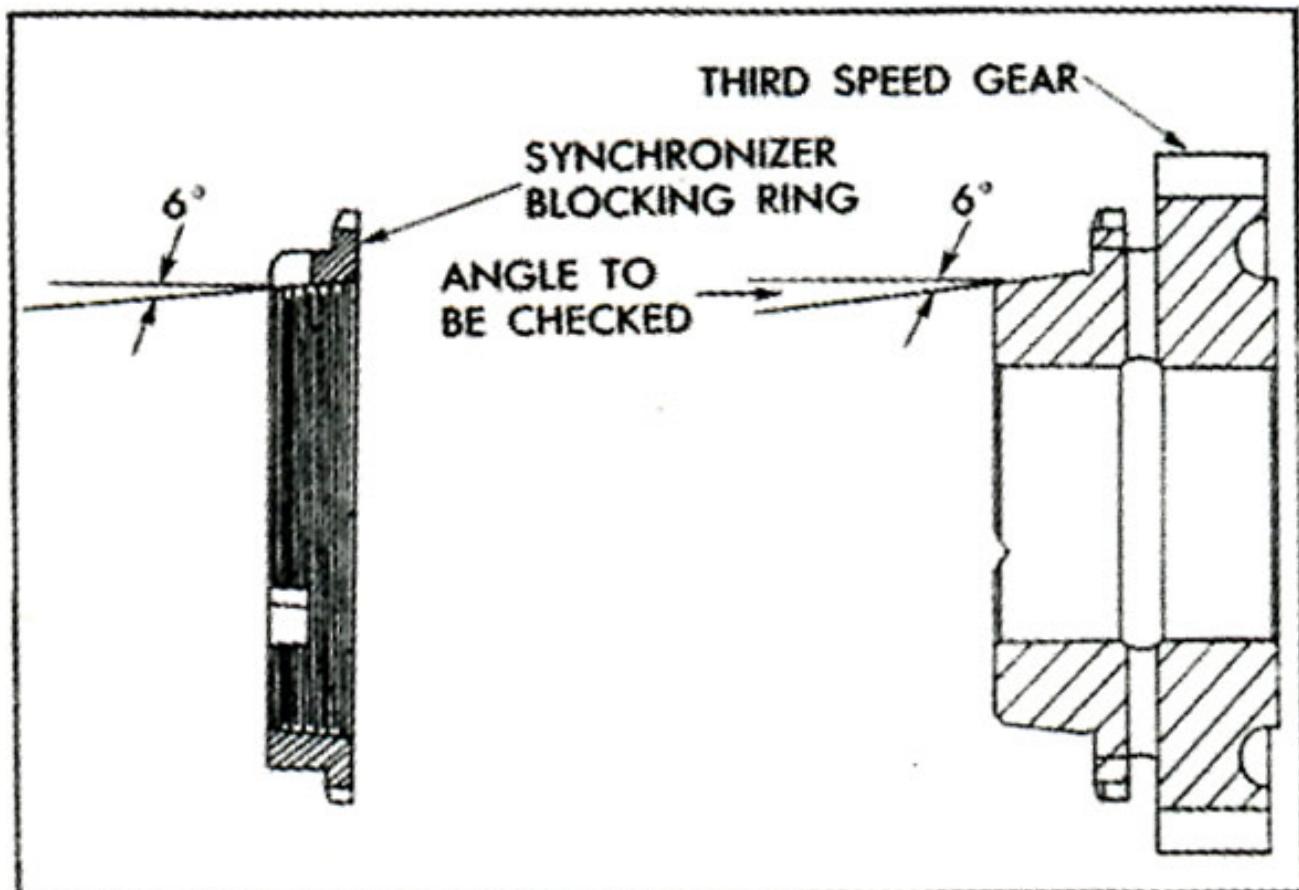
Fig. 3--Checking Third Speed Gear

Some 1957 and 1958 Corvette four-speed transmissions have been built incorporating a third speed gear with 7° cone angle rather than the specified 6° , as illustrated in Figure 3. This may cause a harsh shift into third speed due to the resultant improper engagement of the synchronizer blocking ring and third speed gear cone.

The suggested correction, if the harsh shift is encountered, is to replace the third speed gear assembly No. 3743452 and the synchronizer blocking ring No. 3709348.

1. Coat I.D. of blocking ring lightly with a dye such as Prussian Blue.
2. Carefully install the blocking ring on the third gear cone to obtain an engagement impression.
3. If the Prussian Blue impression on the cone is all at the rear (or predominantly at the rear) the cone angle can be assumed to be 7 ° and should not be used. If the Prussian Blue is more or less evenly distributed on the cone surface, the angle is correct.
