# 1957 - 1958 Corvette: Service News: Corvette 4-Speed Transmission - Harsh Shift Into Third Speed

**Source:** Chevrolet Service News

**Date:** December, 1957

**Subject:** Corvette 4-Speed Transmission - Harsh Shift Into Third Speed

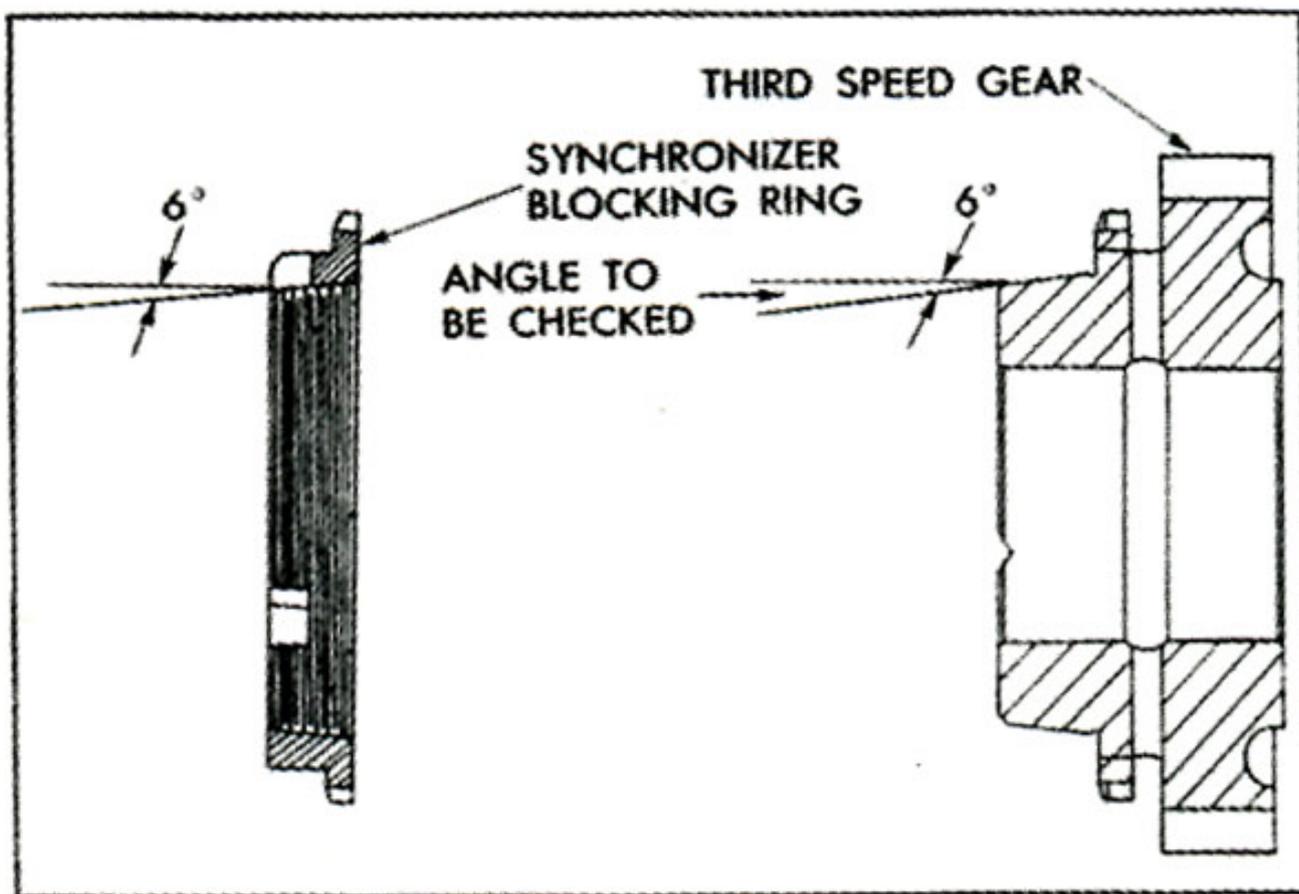
Some 1957 and 1958 Corvette four-speed transmissions have been built incorporating a third speed gear with  $7^{\circ}$  cone angle rather than the specified  $6^{\circ}$ , as illustrated in Figure 3. This may cause a harsh shift into third speed due to the resultant improper engagement of the synchronizer blocking ring and third speed gear cone.

*Fig. 3--Checking Third Speed Gear*

1. Coat I.D. of blocking ring lightly with a dye such as Prussian Blue.
2. Carefully install the blocking ring on the third gear cone to obtain an engagement impression.
3. If the Prussian Blue impression on the cone is all at the rear (or predominantly at the rear) the cone angle can be assumed to be  $7^{\circ}$  and should not be used. If the Prussian Blue is more or less evenly distributed on the cone surface, the angle is correct.

The suggested correction, if the harsh shift is encountered, is to replace the third speed gear assembly No. 3743452 and the synchronizer blocking ring No. 3709348.
