1963 - 1982 Corvette: Rotor Bearing Installation

Submitted by: GTR1999

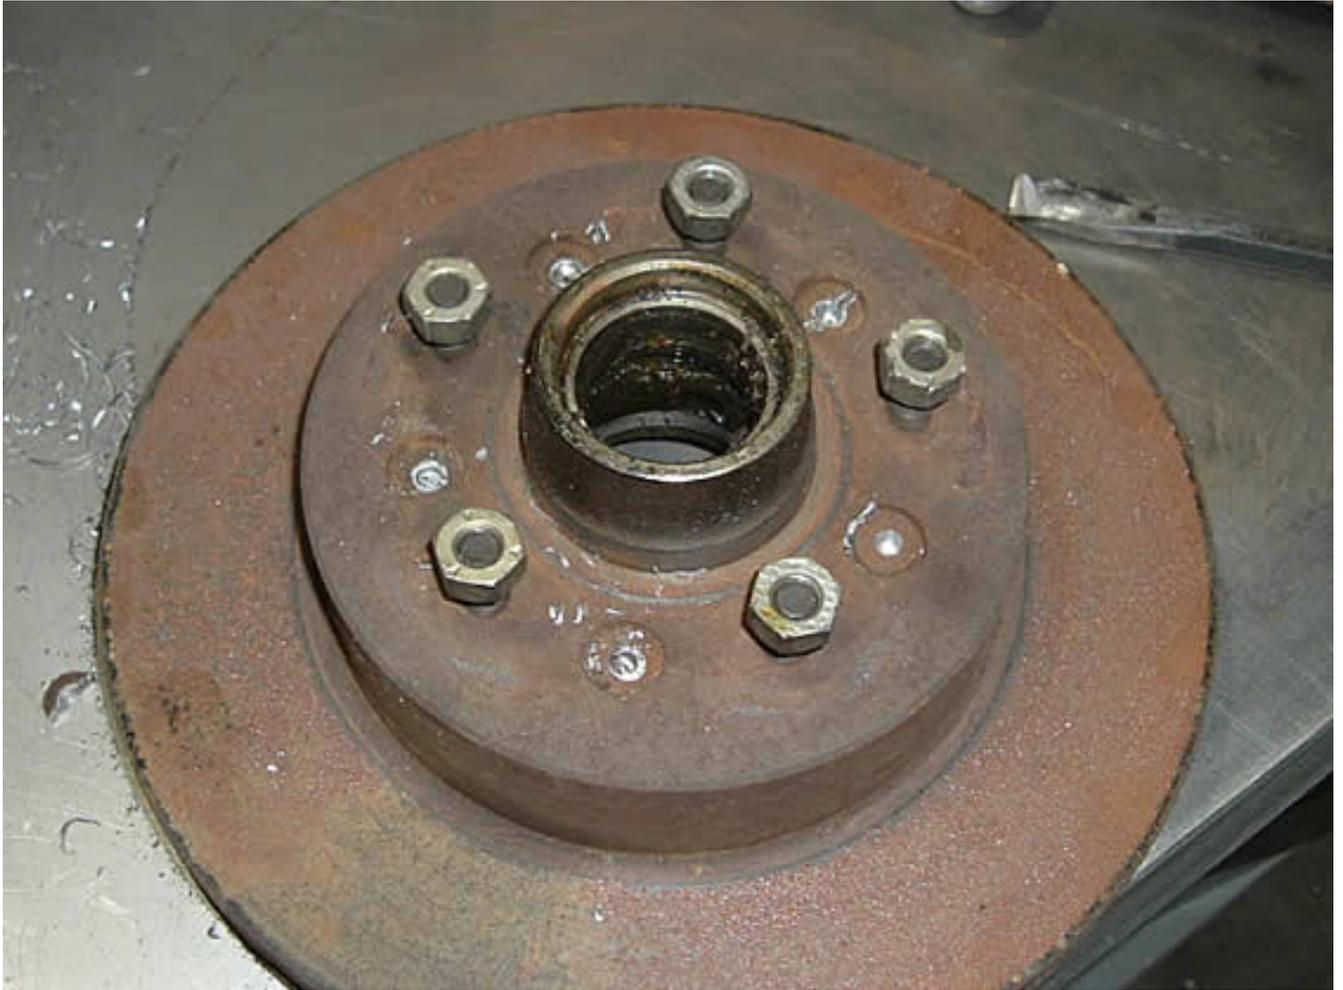
Here we have a rotor in typical used condition. Notice I already started on the rivets.

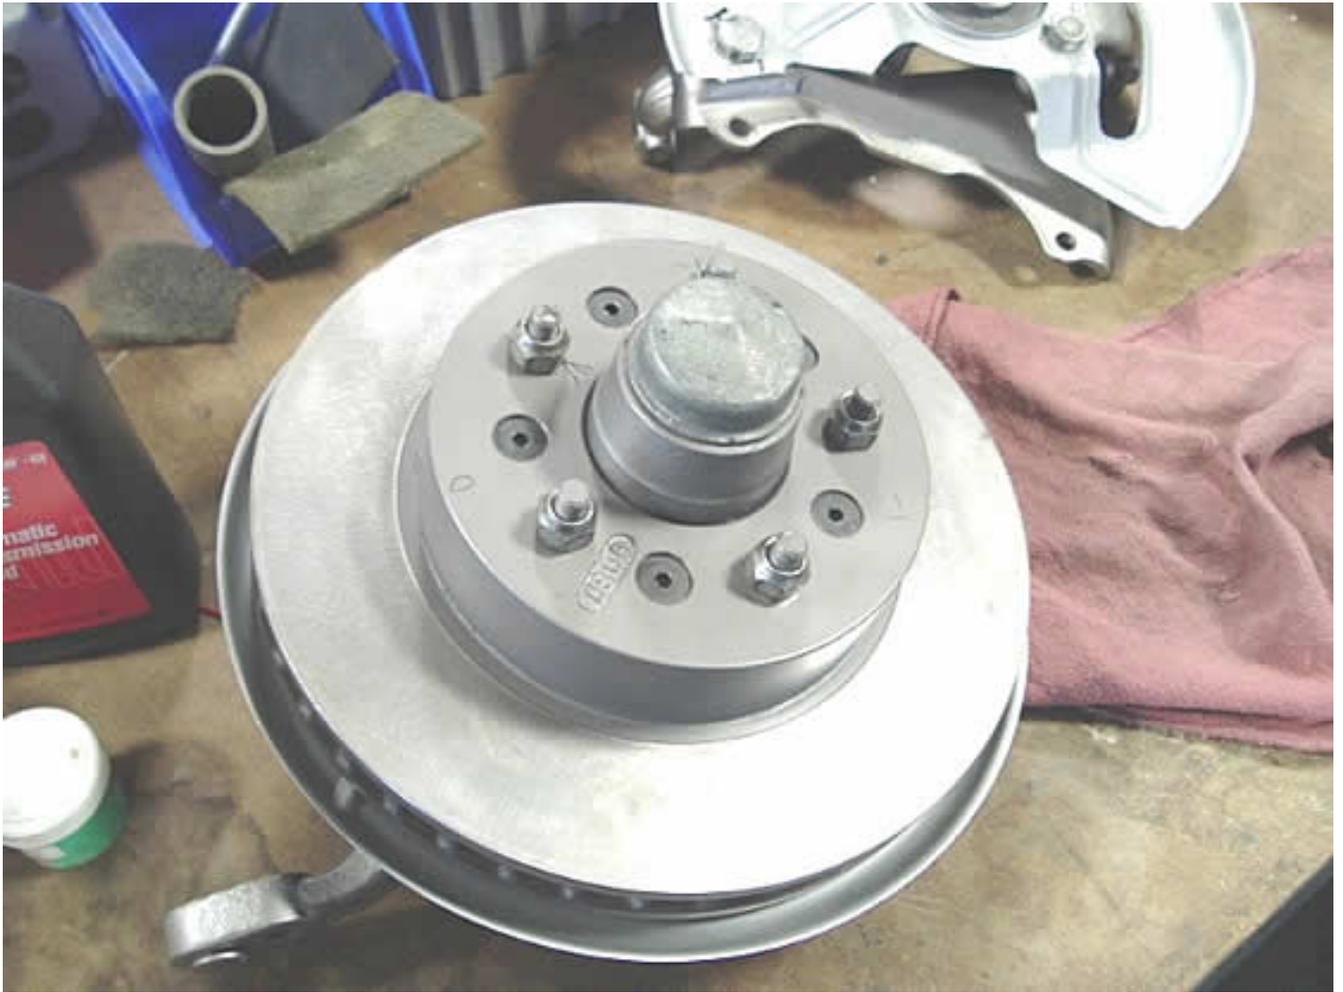
Here is my finished 72 assembly, look at the grease cap. It is the original GM one.

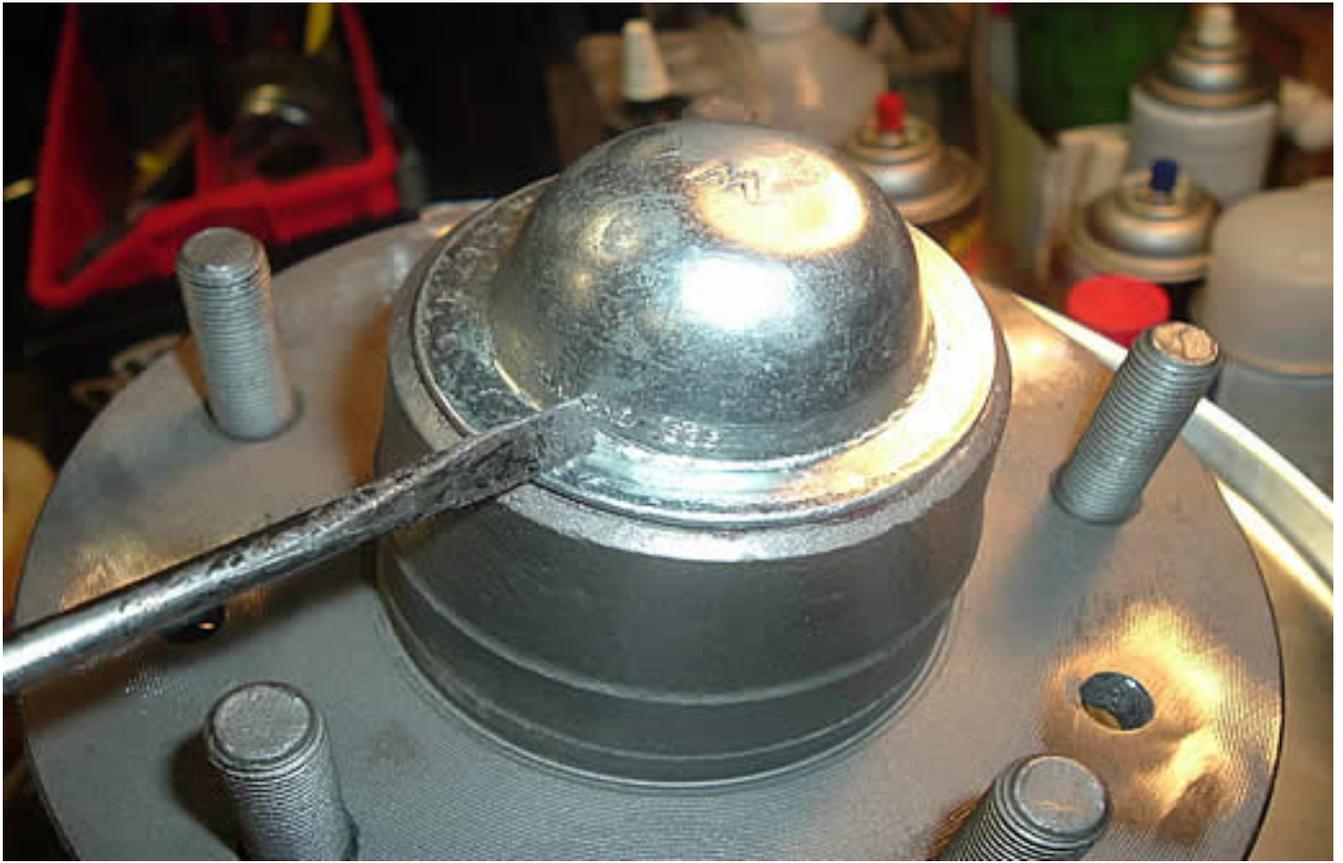
Here is the cap on the spindles I'm now doing. Not the same.

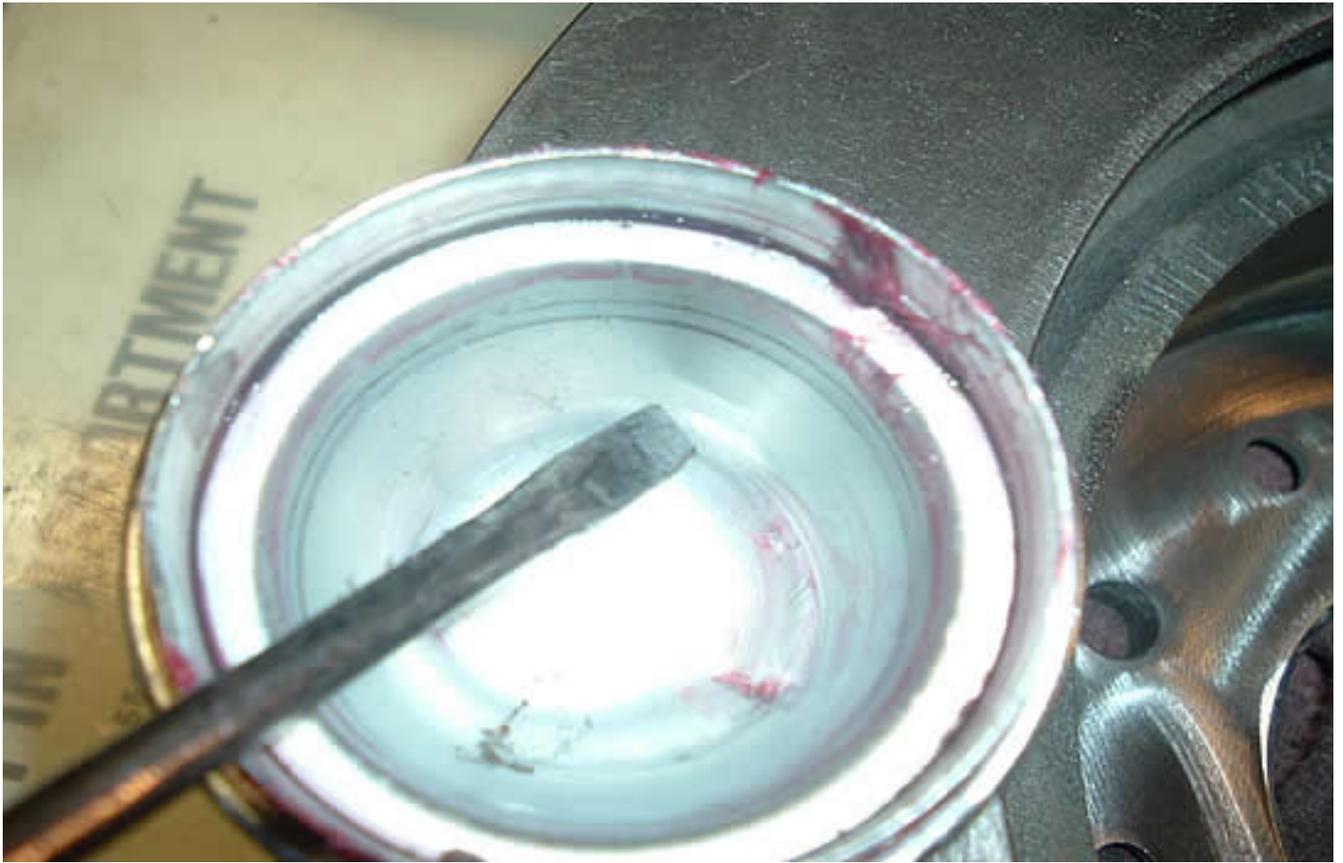
The cap's inner radius is tighter. I wondered why the bearings were getting snug after I set them up and installed the cap. The cotter pin was hitting the narrow inside angle and dragging. I installed a new pin and fit it under the cap with no drag.

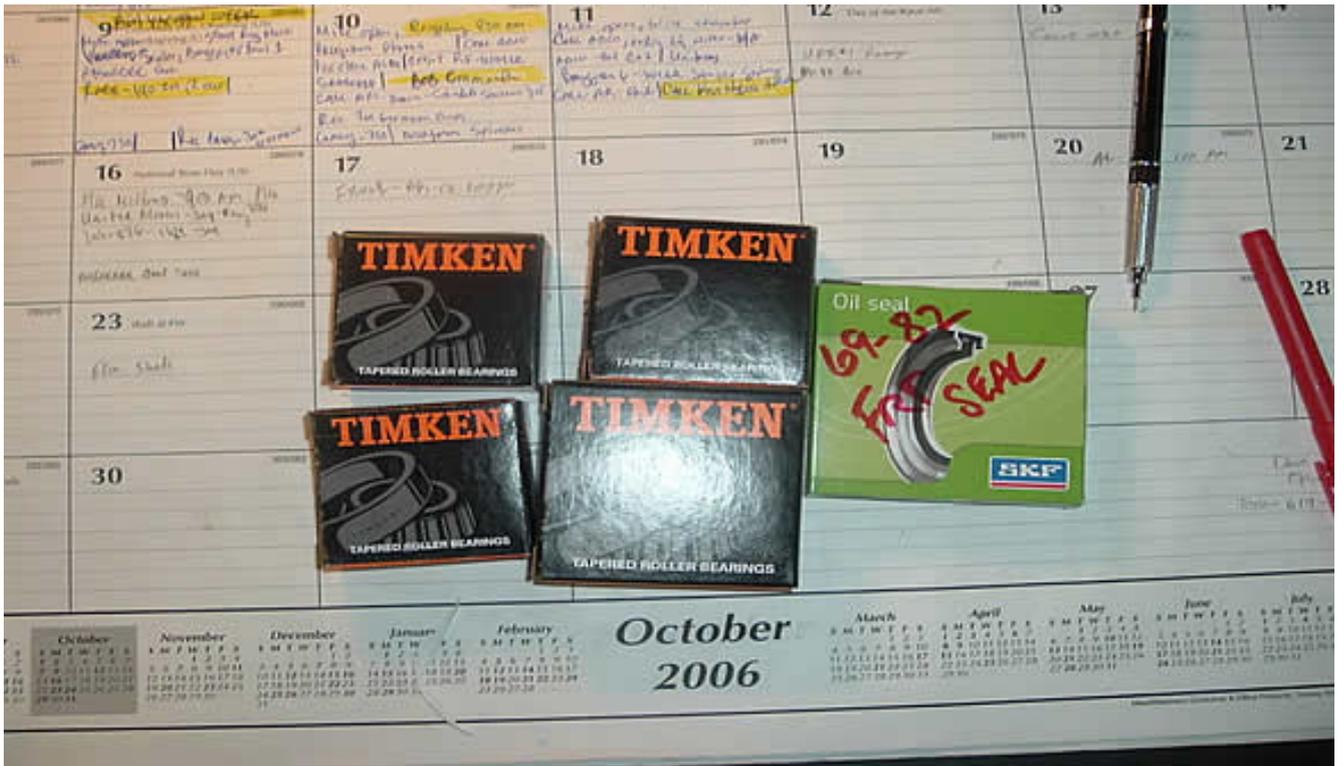
These are the only bearings I use. I think they're still made in the USA- but for how long? Several times this year I opened up front and rear bearings that were supposed to have new Timkens installed only to find imported no name bearings.

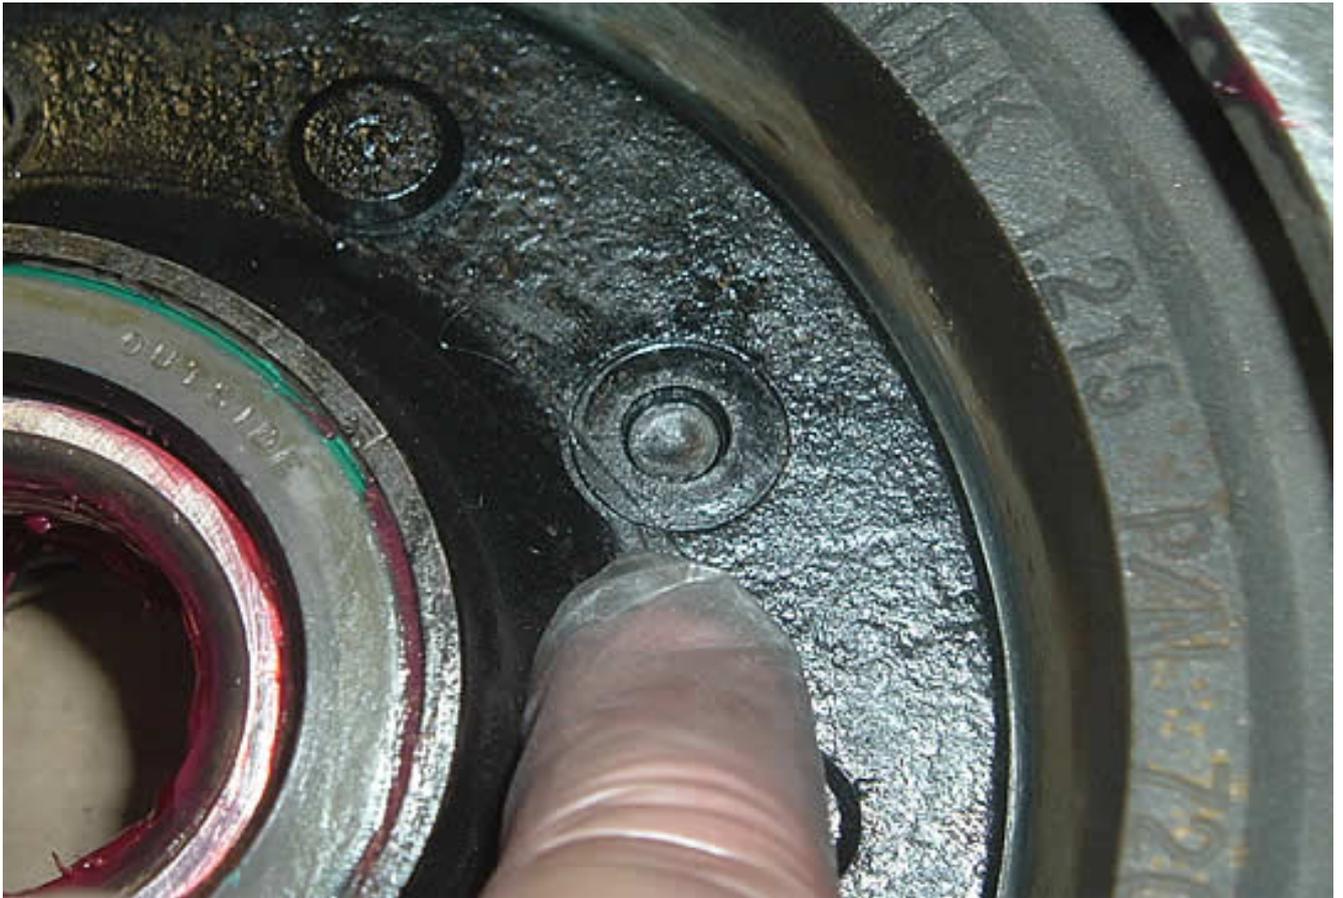
Notice the flat heads don't protrude beyond the tapped hole.

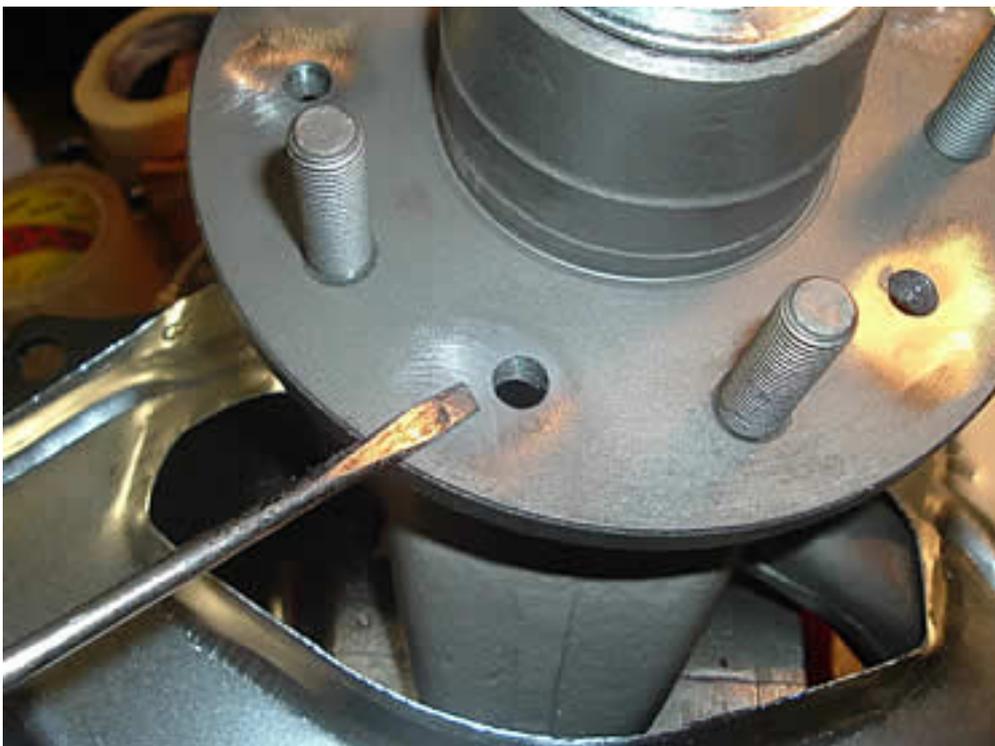
Here is the hub flange. Tapped 3/8-24 and the holes ground. Notice the turning lines still in the flange, there was no rust on this 35 year old part. The runout with the new rotor was .008" to start.

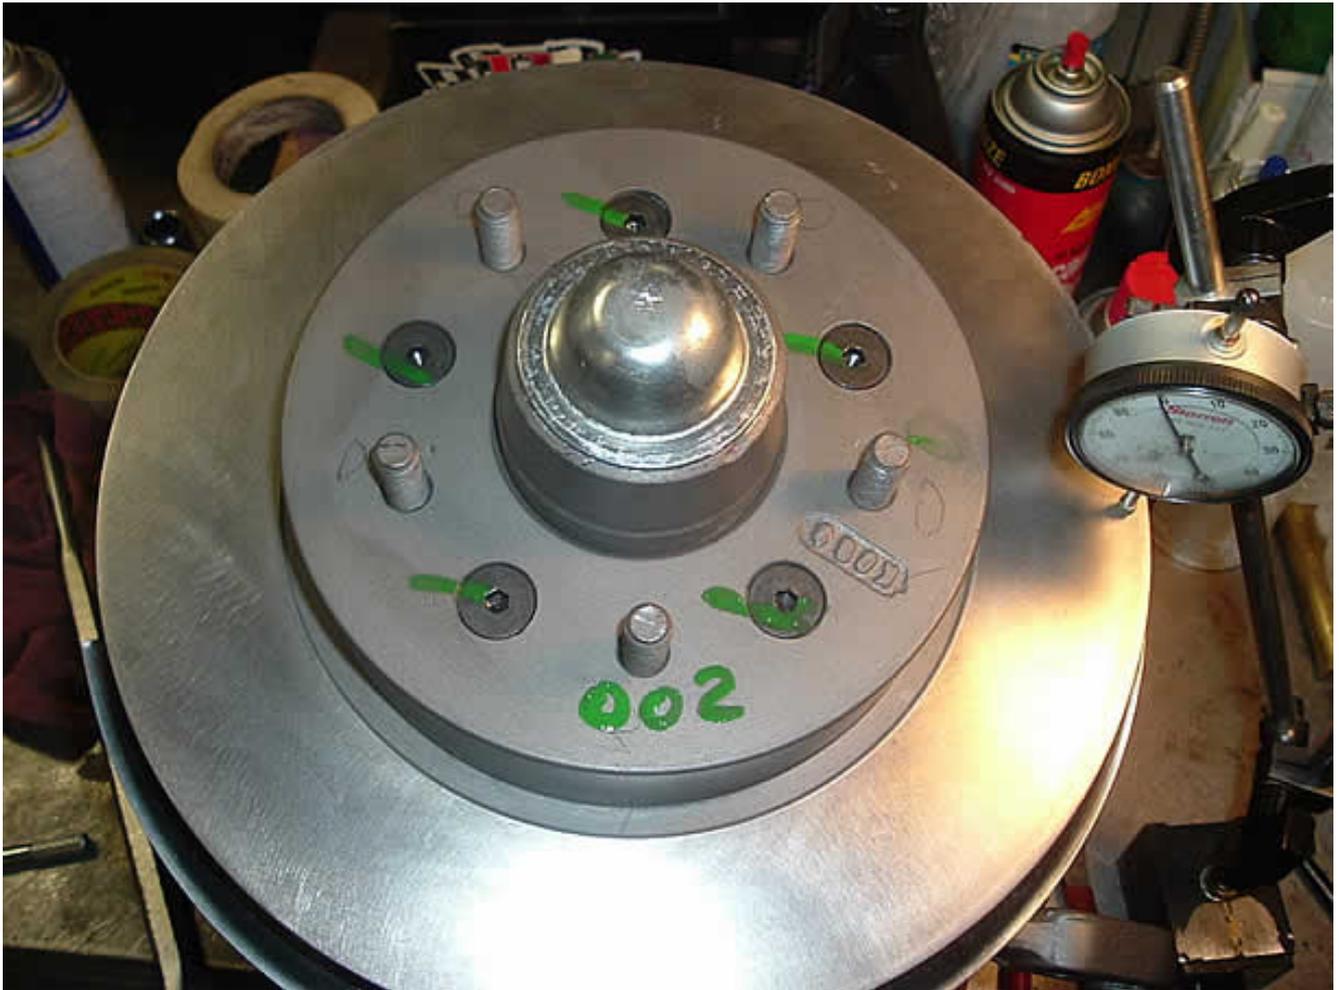
Here is the finished job. The green paint witness marks the rotor to hub location.
