1963 - 1982 Corvette: Rotor Bearing Installation

Submitted by: GTR1999

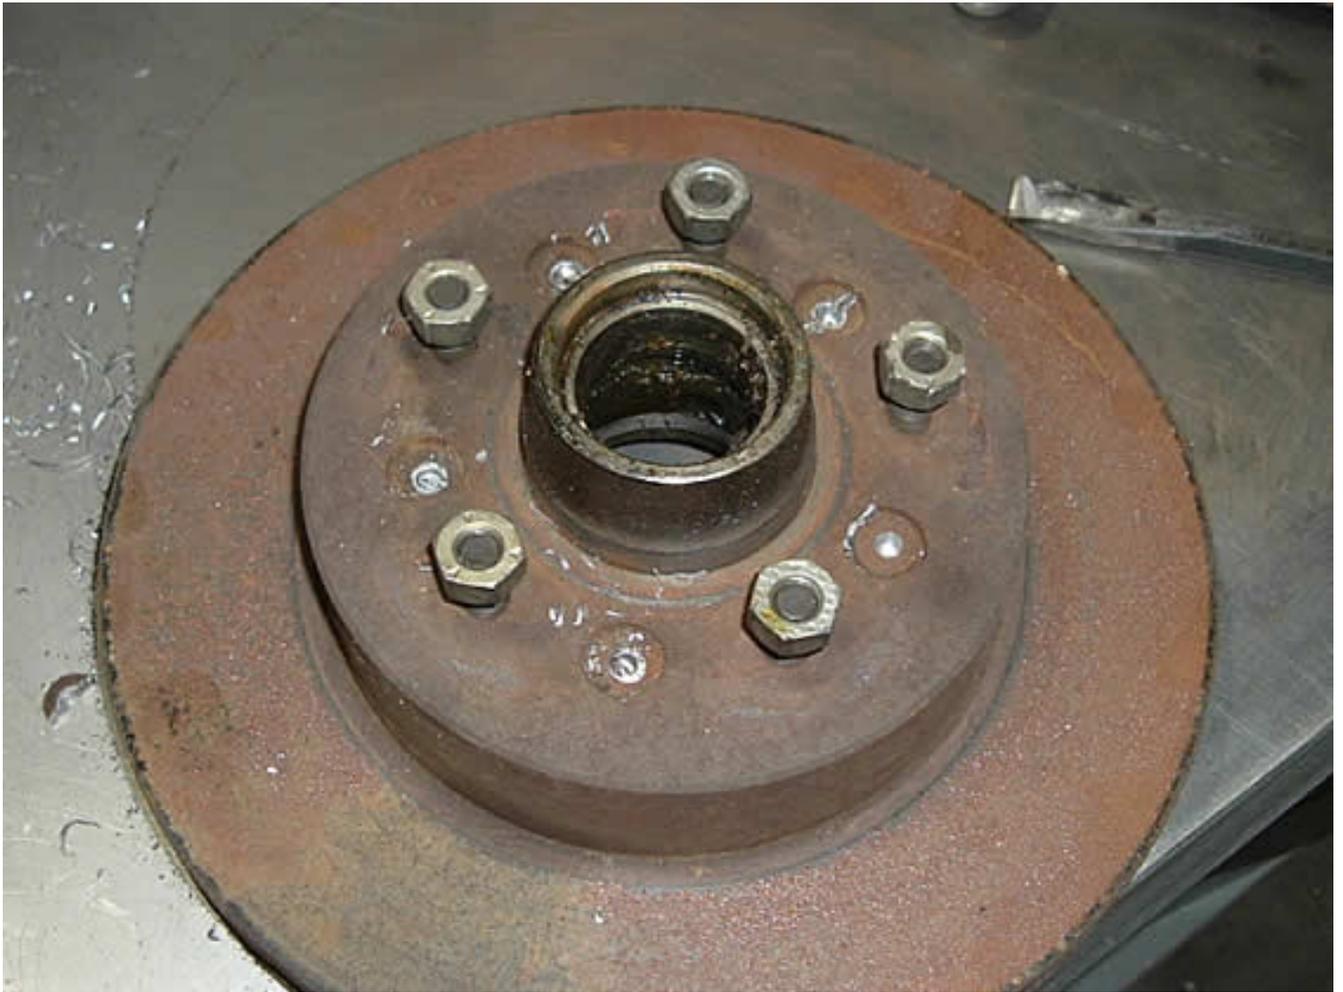
Here we have a rotor in typical used condition. Notice I already started on the rivets.

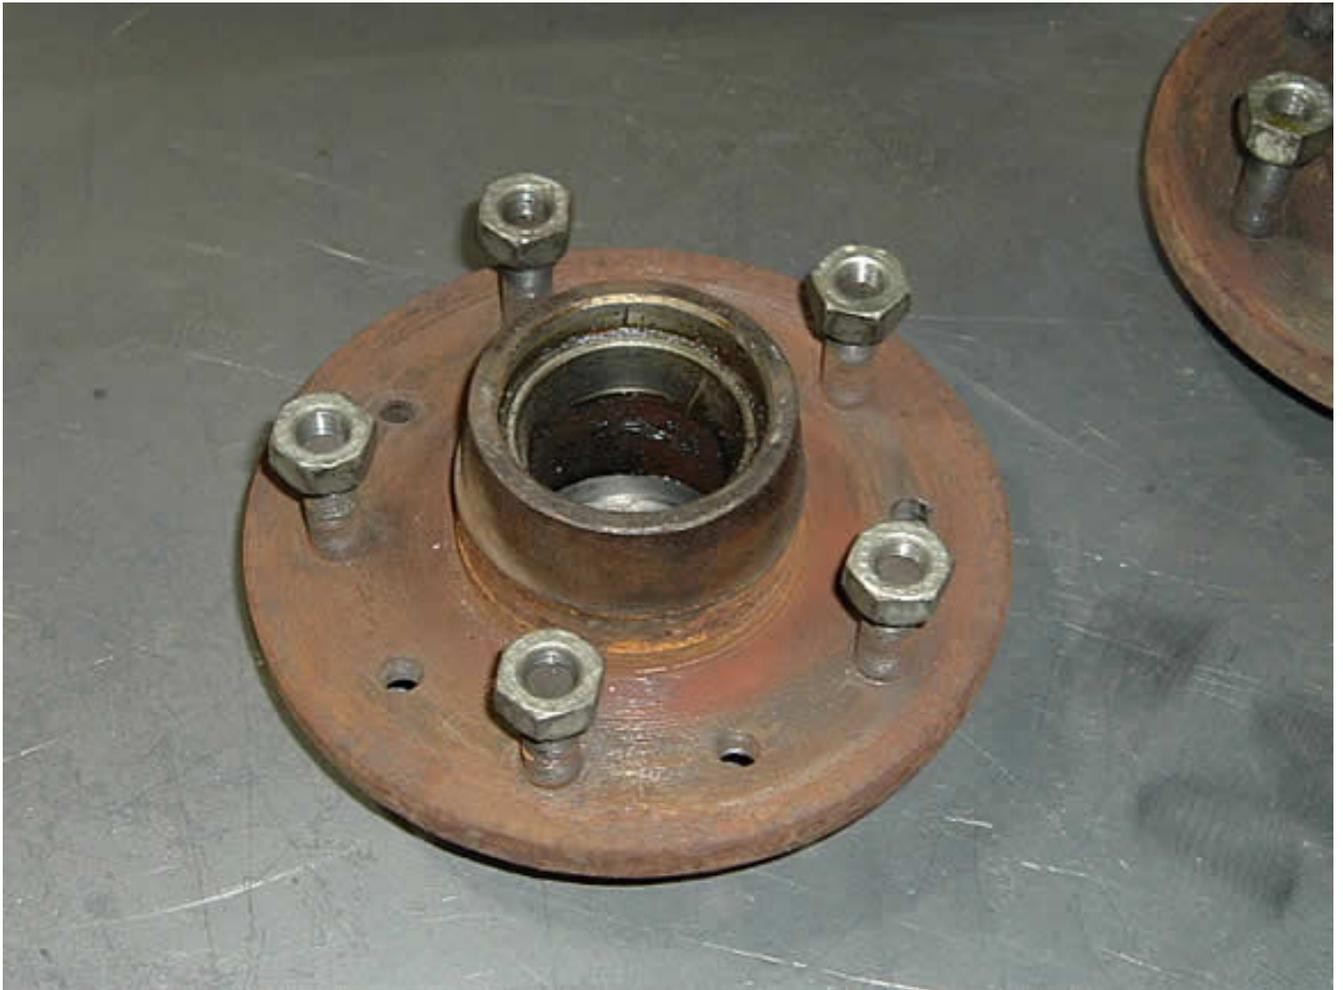
Here I have the rivets out and the rotor off. I drilled down just below the thickness of the rivet flange with a 5/16 bit. Then I use a cold chisel 90* across the head to cut it in half.

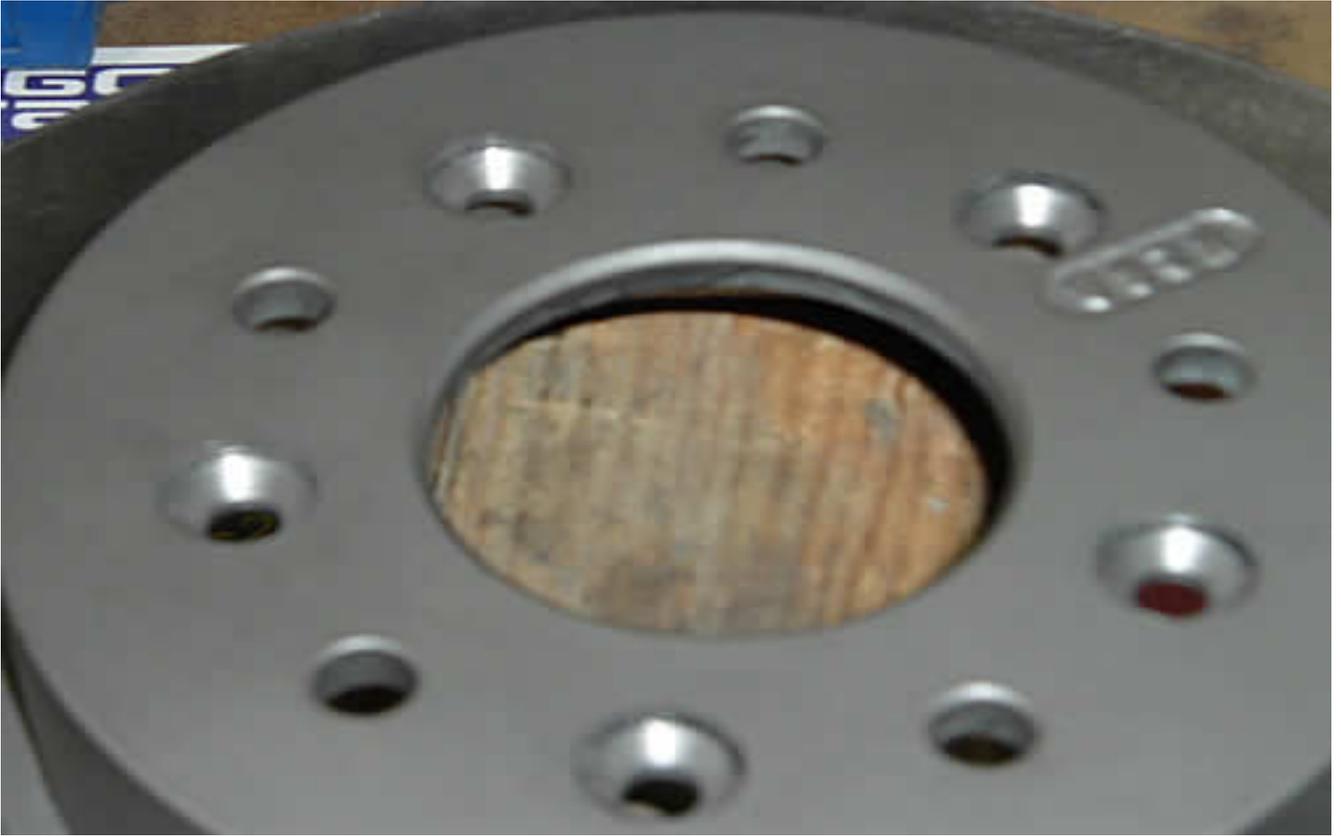
The rotor hat needs to be countersunk to use 3/8-24 socket flat heads.

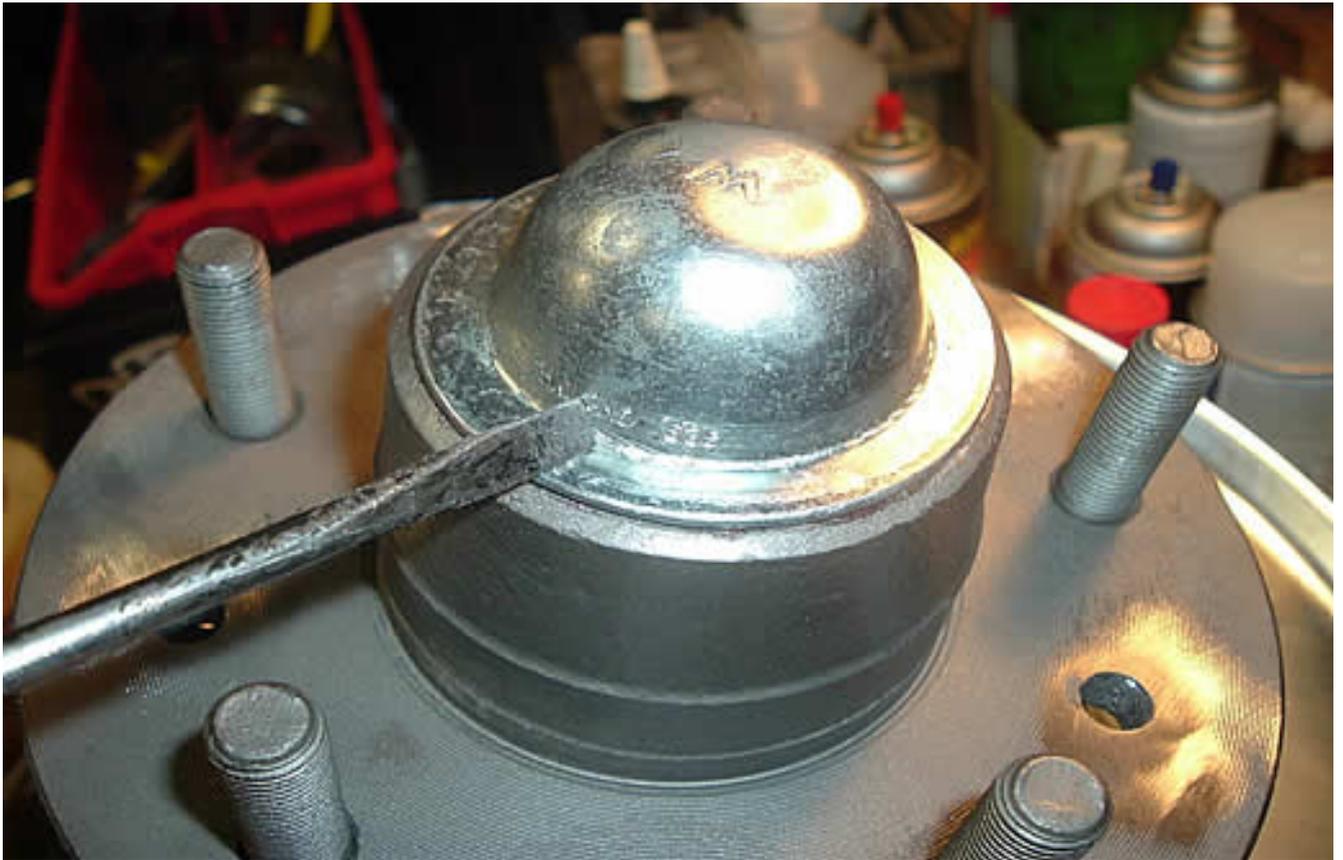
Here is the cap on the spindles I'm now doing. Not the same.

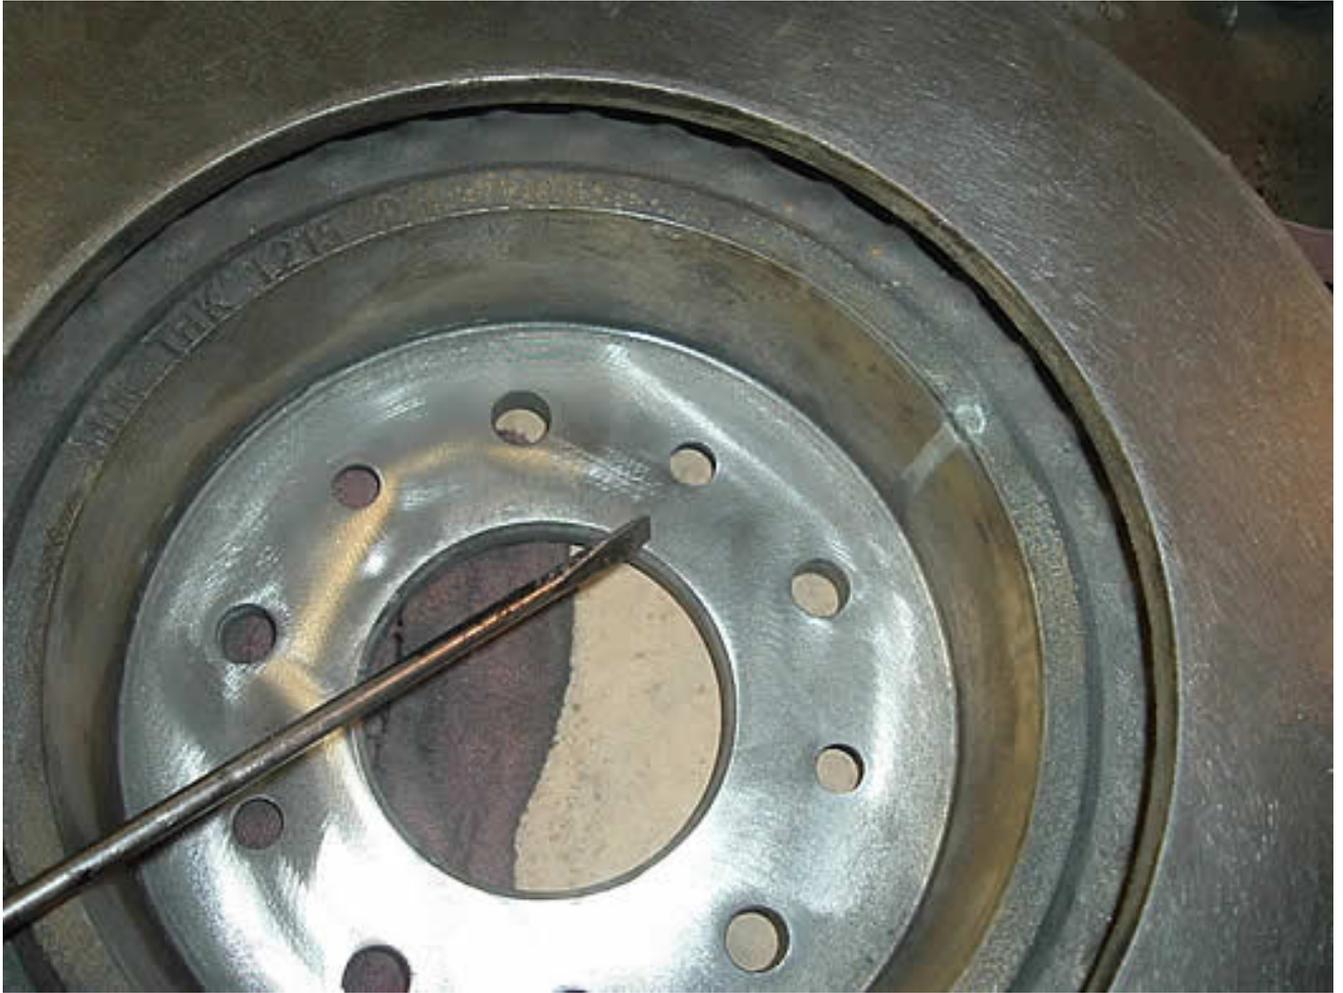
Regardless if new or used clean up and grind flat the area around all the holes. This is the mating surface on the rotor.

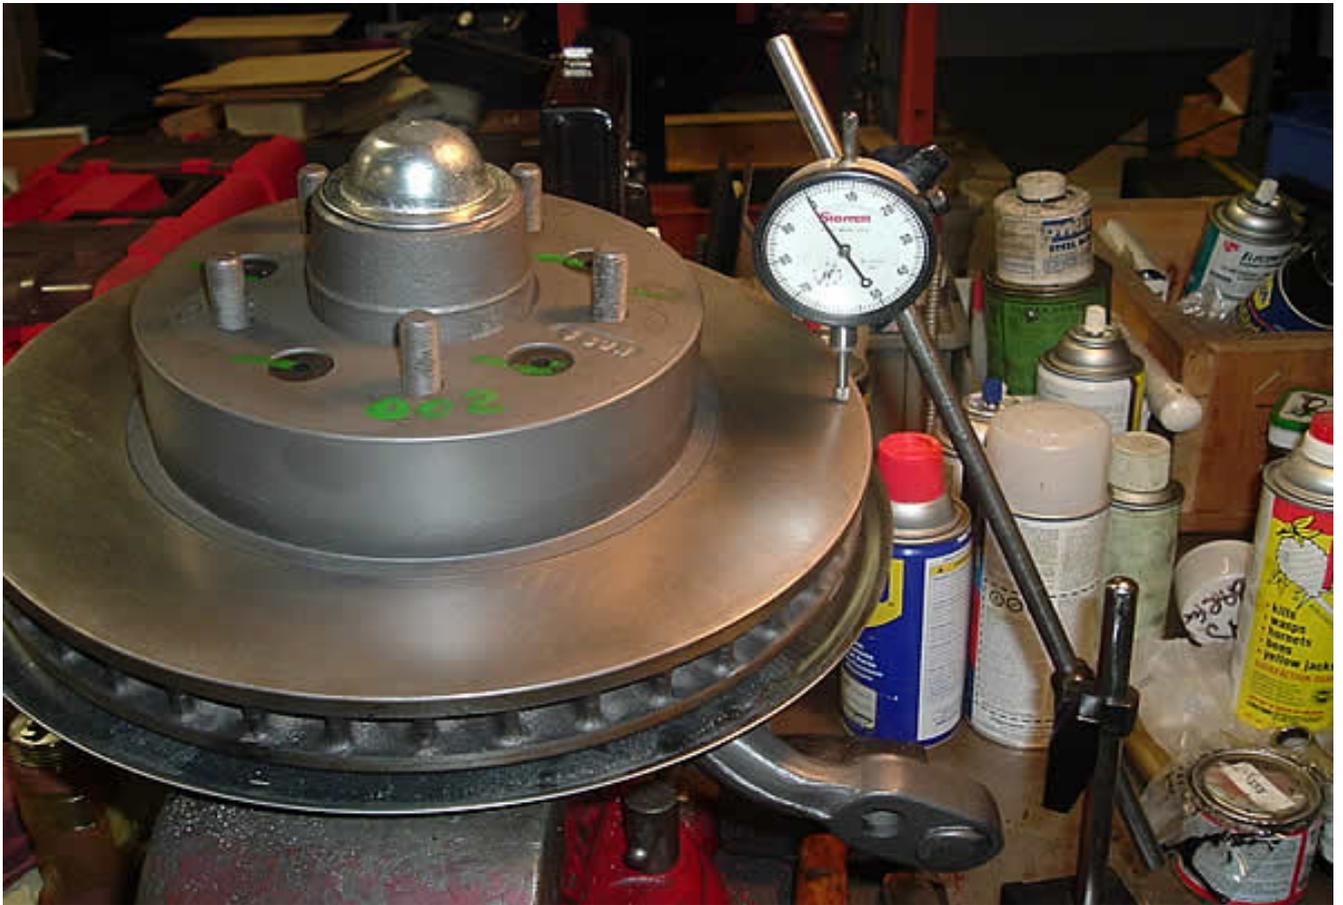
With the rotor bolted on and the bearings set to .001-.002 endplay I setup the indicator. I had to shim one location to get it just under .002" total runout. It's closer to .0015" but I marked it at .002'.
