1969 - 1970 Corvette: Service Bulletin: Voltage Regulator Failures in the 1970 Integrated Delcotrons

Model Year: 1969 - 1970 Corvette

Subject: Voltage Regulator Failures in the 1970 Integrated Delcotrons

Number: UPC VIy - Engine Electrical, 70-9 26

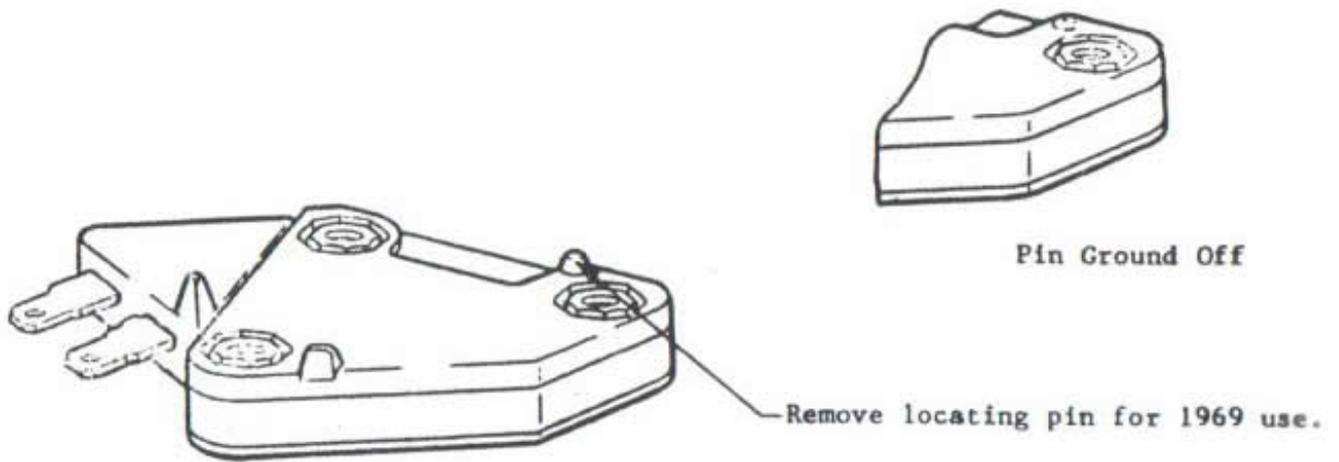
USING VOLTAGE REGULATOR IN 1969 DELCOTRONS

There have been many reports of failed integrated regulators. If the voltage regulator is found to be the source of an overcharged battery, after checking the complete electrical system, replace regulator assembly with regulator assembly, Part Number 1116387. This part has been released by Engineering but will take about one month to get into service stock.

The above part number will also be used to service 1969 integrated Delcotrons. it will be necessary to grind or file off the locating pin. (See Figure Below).
