# 1969 - 1970 Corvette: Service Bulletin: Voltage Regulator Failures in the 1970 Integrated Delcotrons

**Model Year:** 1969 - 1970 Corvette

**Source:** Chevrolet Engineering Center

**Number:** UPC VIy - Engine Electrical, 70-9 26

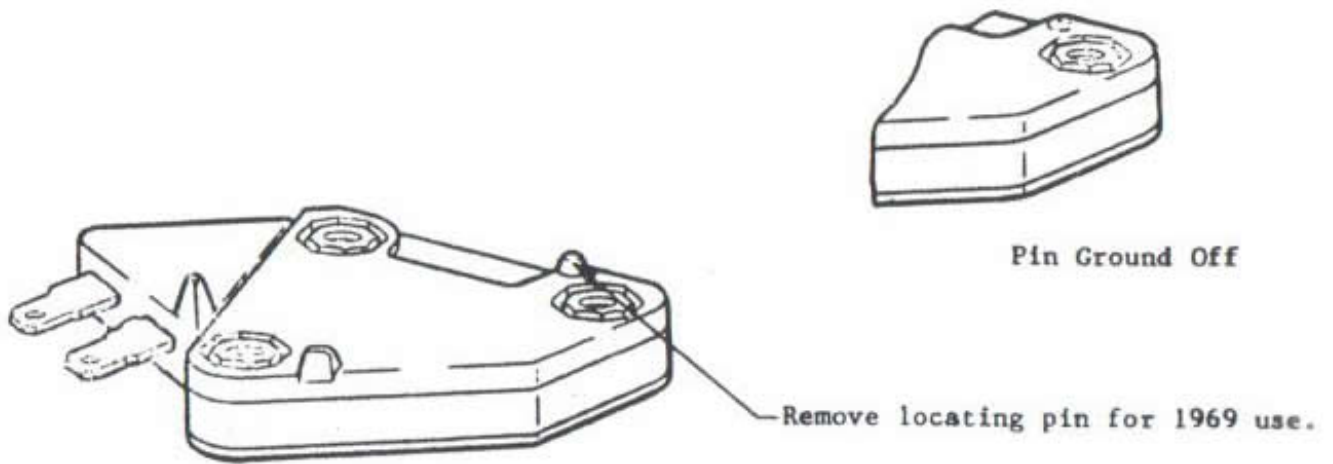
USING VOLTAGE REGULATOR IN 1969 DELCOTRONS

There have been many reports of failed integrated regulators. If the voltage regulator is found to be the source of an overcharged battery, after checking the complete electrical system, replace regulator assembly with regulator assembly, Part Number 1116387. This part has been released by Engineering but will take about one month to get into service stock.

The above part number will also be used to service 1969 integrated Delcotrons. it will be necessary to grind or file off the locating pin. (See Figure Below).
