1969 - 1970 Corvette: Service Bulletin: Voltage Regulator Failures in the 1970 Integrated Delcotrons

Model Year: 1969 - 1970 Corvette

Subject: Voltage Regulator Failures in the 1970 Integrated Delcotrons

Number: UPC VIy - Engine Electrical, 70-9 26

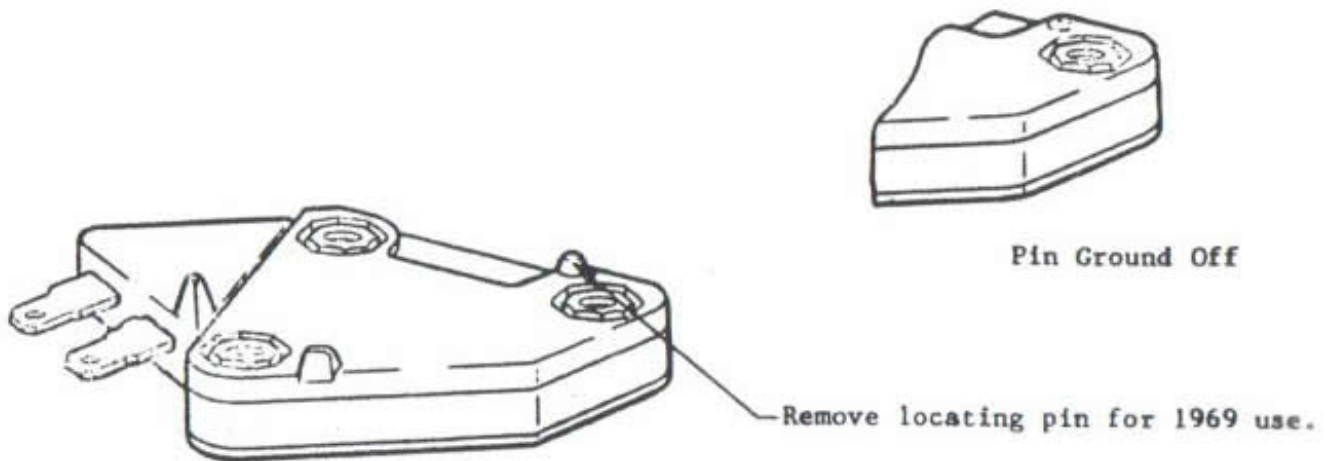
USING VOLTAGE REGULATOR IN 1969 DELCOTRONS

The above part number will also be used to service 1969 integrated Delcotrons. it will be necessary to grind or file off the locating pin. (See Figure Below).
