1984 Corvette: Recall: Positive Battery Cable Routing

Subject: Product Safety Campaign 84C04 Positive Battery Cable Routing

Source: Chevrolet Dealer Product Campaign Bulletin

Number: 84C04, Number XII

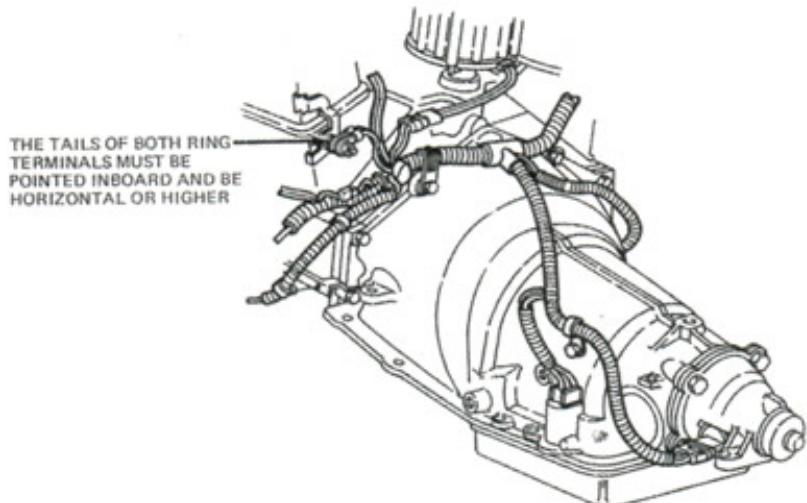
Figure 1

General Motors has determined that a defect which relates to motor vehicle safety exists in certain 1984 Chevrolet Corvettes. The insulation on the positive battery cable may rub against the engine wiring harness bracket or ground stud. If the insulation wears through, it could result in rapid battery discharge and loss of the headlights. Sudden loss of the headlights under severe weather or nighttime driving conditions could reduce driver visibility, which could result in a vehicle crash without prior warning. Rapid battery discharge could also result in loss of operation of other electrical systems.

The bracket may have a bolt or a stud/nut fastener depending on build dates. Retain this fastener.
4. Loosen the ground stud nut on the left hand rear cylinder head and reposition both (2) ground wire ring terminals. Terminals are to point inboard and be horizontal or higher. (Figure 1)
5. Thread the kit supplied conduit over the positive battery cable. The inboard end of the conduit should extend inboard beyond the (ground stud) repositioned ground ring terminals.
