1984 Corvette: Recall: Positive Battery Cable Routing

Subject: Product Safety Campaign 84C04 Positive Battery Cable Routing

Number: 84C04, Number XII

Date: August, 1983

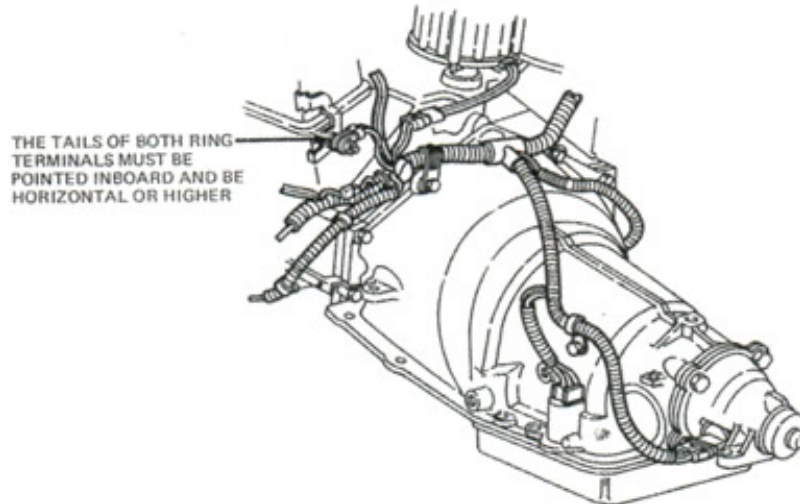
Figure 1

General Motors has determined that a defect which relates to motor vehicle safety exists in certain 1984 Chevrolet Corvettes. The insulation on the positive battery cable may rub against the engine wiring harness bracket or ground stud. If the insulation wears through, it could result in rapid battery discharge and loss of the headlights. Sudden loss of the headlights under severe weather or nighttime driving conditions could reduce driver visibility, which could result in a vehicle crash without prior warning. Rapid battery discharge could also result in loss of operation of other electrical systems.

4. Loosen the ground stud nut on the left hand rear cylinder head and reposition both (2) ground wire ring terminals. Terminals are to point inboard and be horizontal or higher. (Figure 1)
5. Thread the kit supplied conduit over the positive battery cable. The inboard end of the conduit should extend inboard beyond the (ground stud) repositioned ground ring terminals.
