1984 Corvette: Recall: Positive Battery Cable Routing

Subject: Product Safety Campaign 84C04 Positive Battery Cable Routing

Number: 84C04, Number XII

Subject: PRODUCT SAFETY CAMPAIGN 84C04
POSITIVE BATTERY CABLE ROUTING
1984 CORVETTE

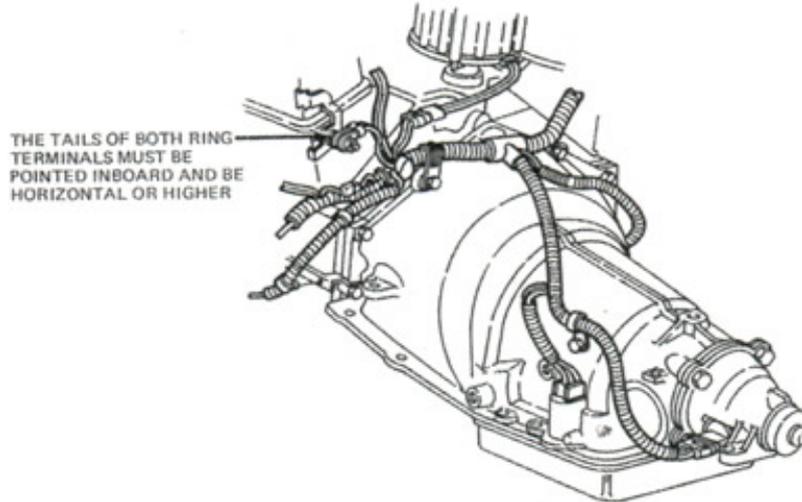
Figure 1

General Motors has determined that a defect which relates to motor vehicle safety exists in certain 1984 Chevrolet Corvettes. The insulation on the positive battery cable may rub against the engine wiring harness bracket or ground stud. If the insulation wears through, it could result in rapid battery discharge and loss of the headlights. Sudden loss of the headlights under severe weather or nighttime driving conditions could reduce driver visibility, which could result in a vehicle crash without prior warning. Rapid battery discharge could also result in loss of operation of other electrical systems.

4. Loosen the ground stud nut on the left hand rear cylinder head and reposition both (2) ground wire ring terminals. Terminals are to point inboard and be horizontal or higher. (Figure 1)
5. Thread the kit supplied conduit over the positive battery cable. The inboard end of the conduit should extend inboard beyond the (ground stud) repositioned ground ring terminals.
