1964 Corvette: Service Bulletin: Directional Signal Switch Service

Subject: Directional Signal Switch Service

Source: Chevrolet - Central Office - Technical Service Bulletin

Bulletin No: DR #693, Section XII

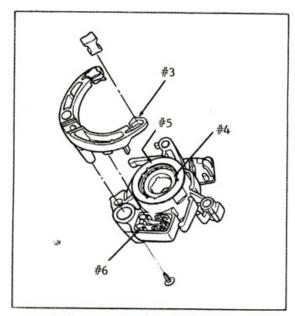
ALL 1964 EXCEPT CHEVELLE

Any of the following components may be replaced without complete switch replacement; cancelling cam, actuating plate, upper mast jacket bearing and contactor kit.
