1964 Corvette: Service Bulletin: Directional Signal Switch Service

Model Year: 1964 All Series Except Corvette and Comfortilt Wheel Subject: Directional Signal Switch Service Source: Chevrolet - Central Office - Technical Service Bulletin Bulletin No: DR #693, Section XII Date: September 8, 1964

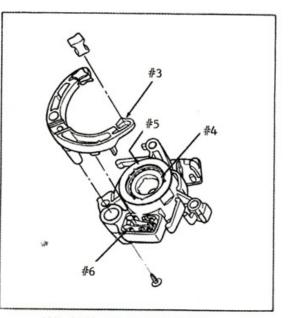
Any of the following components may be replaced without complete switch replacement; cancelling cam, actuating plate, upper mast jacket bearing and contactor kit.

5. Follow shop manual procedures of disassembly until the switch harness can be pulled out far enough to gain access to the actuating plate screw and remove the screw and actuating plate.
