1964 Corvette: Service Bulletin: Directional Signal Switch Service

Subject: Directional Signal Switch Service

Source: Chevrolet - Central Office - Technical Service Bulletin

Bulletin No: DR #693, Section XII

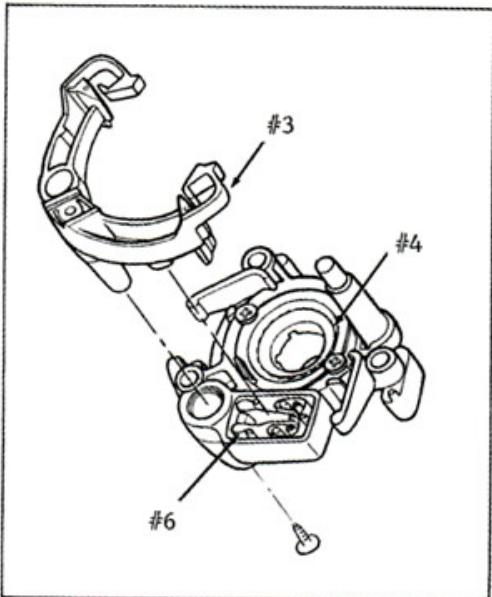
1964 CHEVELLE ONLY

A third type of switch assembly is used optionally on Chevelles. This switch is a die cast metal design, identified by cast letters "BPC", and is serviced only as an assembly, Part Number 383033. It is interchangeable with the plastic service switch 910372 only if housing 383688 or 383689 housing is also used.
