1959 Corvette: Service News: Repairing 1959 Passenger Car Direction Signals

Source: Chevrolet Service News

Date: December 1958, Volume 30, Issue Number 12

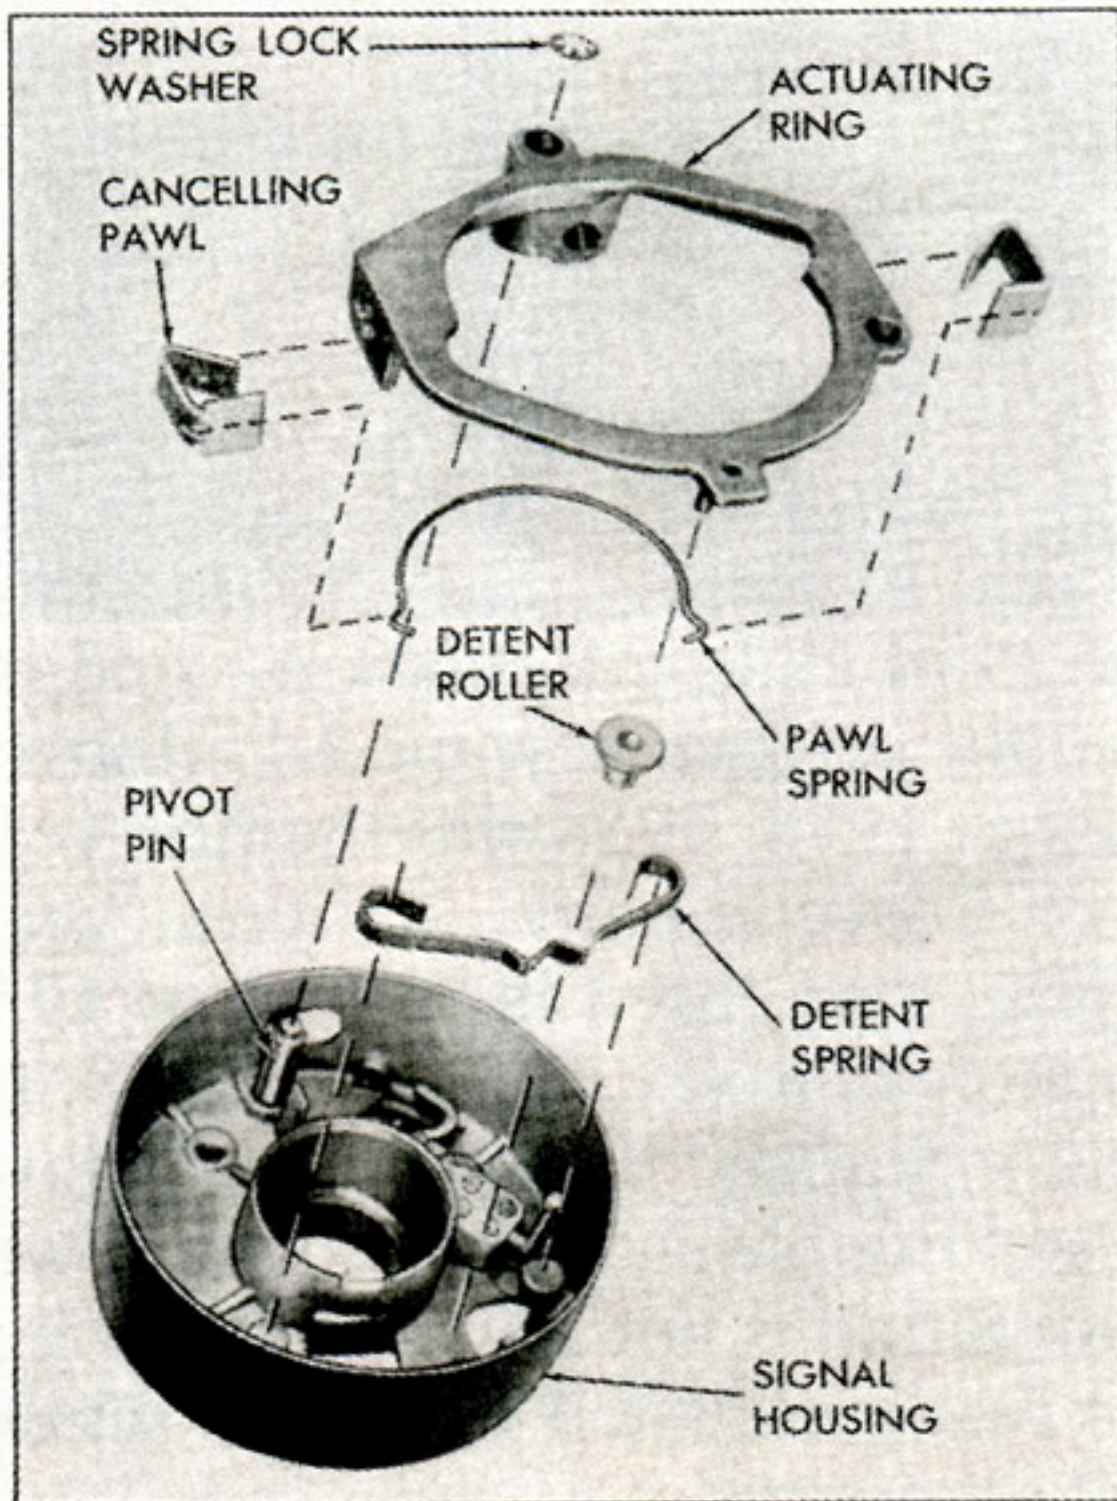
Fig. 1—Direction Signal Switch Actuating Mechanism .

Cancelling prong on steering wheel will not cancel the control lever.

Turn signal will not cancel, usually only in one direction.

Some early production cancelling pawls, Part No. 5950164, were distorted in manufacture, causing the pawl to remain clear of the cancelling prong on the steering wheel when moved into a turn position. Replacement of the pawl is the best fix.

Remove steering wheel and bend cancelling prong on wheel assembly so that it stands perpendicular to the hub of the wheel. Do not "over bend" the prong as this will lead to an objectionable clicking sound when the turn signal lever is in the neutral position. Use care in replacing the wheel so that the prongs do not strike the steering shaft on assembly.
