1959 Corvette: Service News: Repairing 1959 Passenger Car Direction Signals

Subject: Repairing 1959 Passenger Car Direction Signals

Source: Chevrolet Service News

Date: December 1958, Volume 30, Issue Number 12

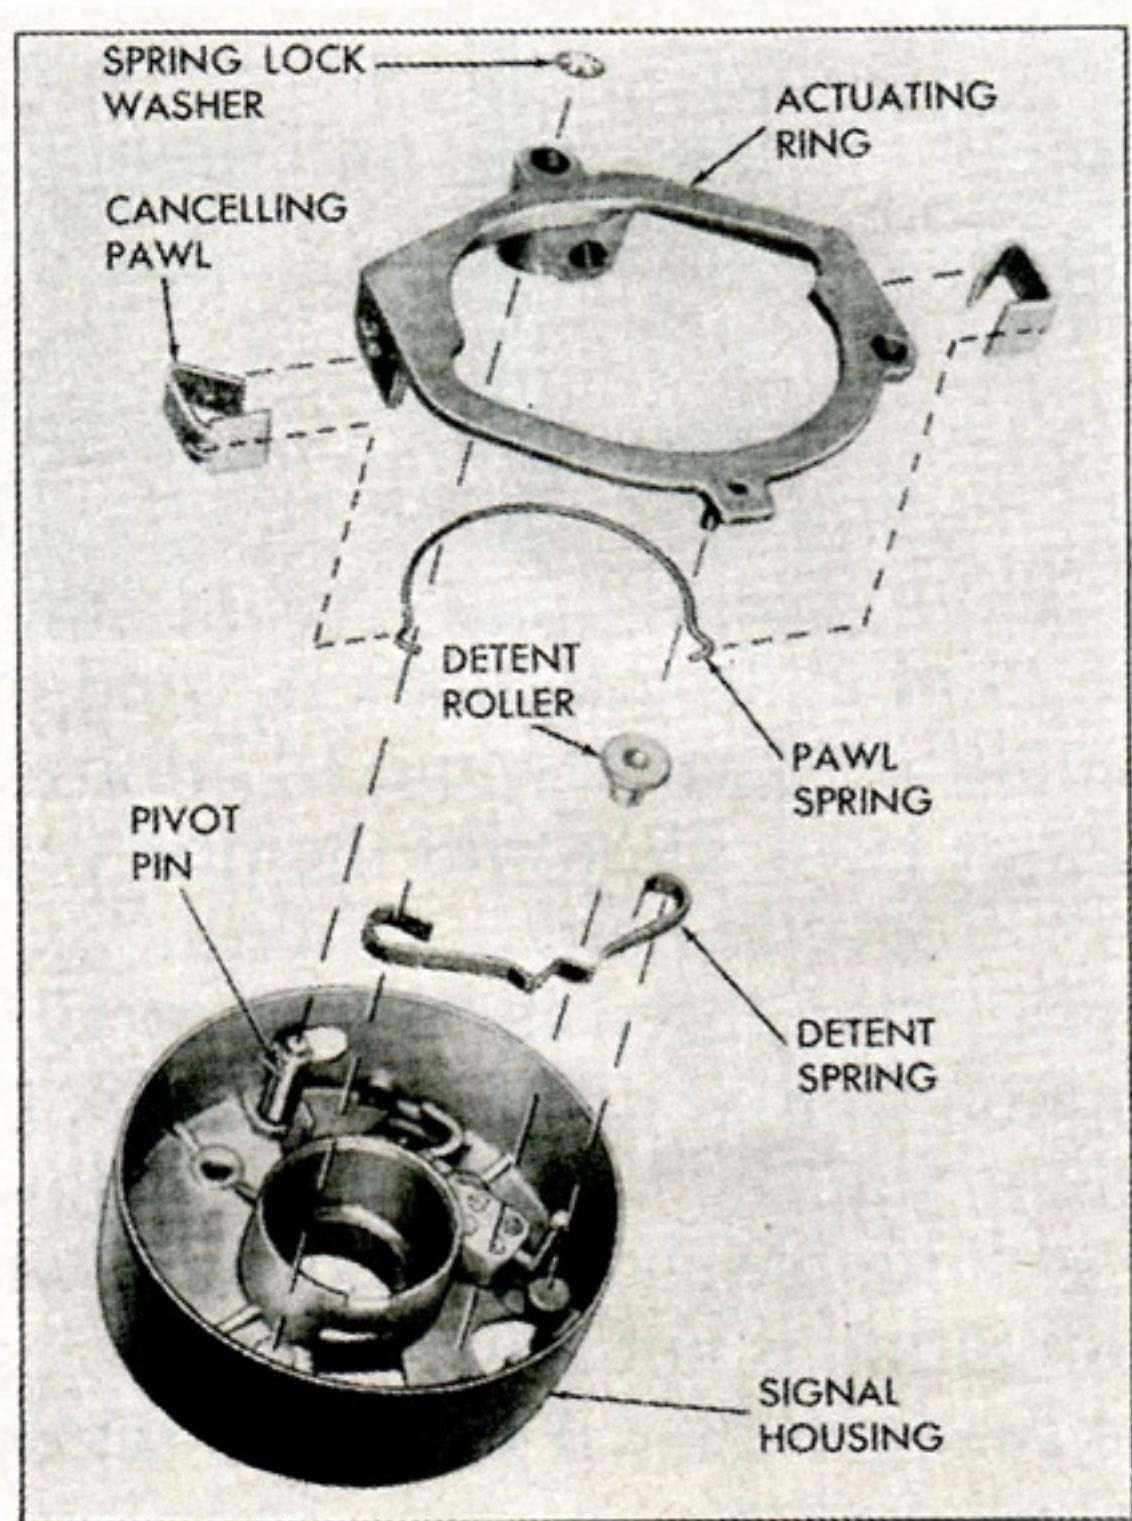
Fig. 1—Direction Signal Switch Actuating Mechanism.

Cancelling prong on steering wheel will not cancel the control lever.

Turn signal will not cancel, usually only in one direction.

Some early production cancelling pawls, Part No. 5950164, were distorted in manufacture, causing the pawl to remain clear of the cancelling prong on the steering wheel when moved into a turn position. Replacement of the pawl is the best fix.

Remove steering wheel and bend cancelling prong on wheel assembly so that it stands perpendicular to the hub of the wheel. Do not "over bend" the prong as this will lead to an objectionable clicking sound when the turn signal lever is in the neutral position. Use care in replacing the wheel so that the prongs do not strike the steering shaft on assembly.
