# 1959 Corvette: Service News: Repairing 1959 Passenger Car Direction Signals

**Source:** Chevrolet Service News

**Date:** December 1958, Volume 30, Issue Number 12

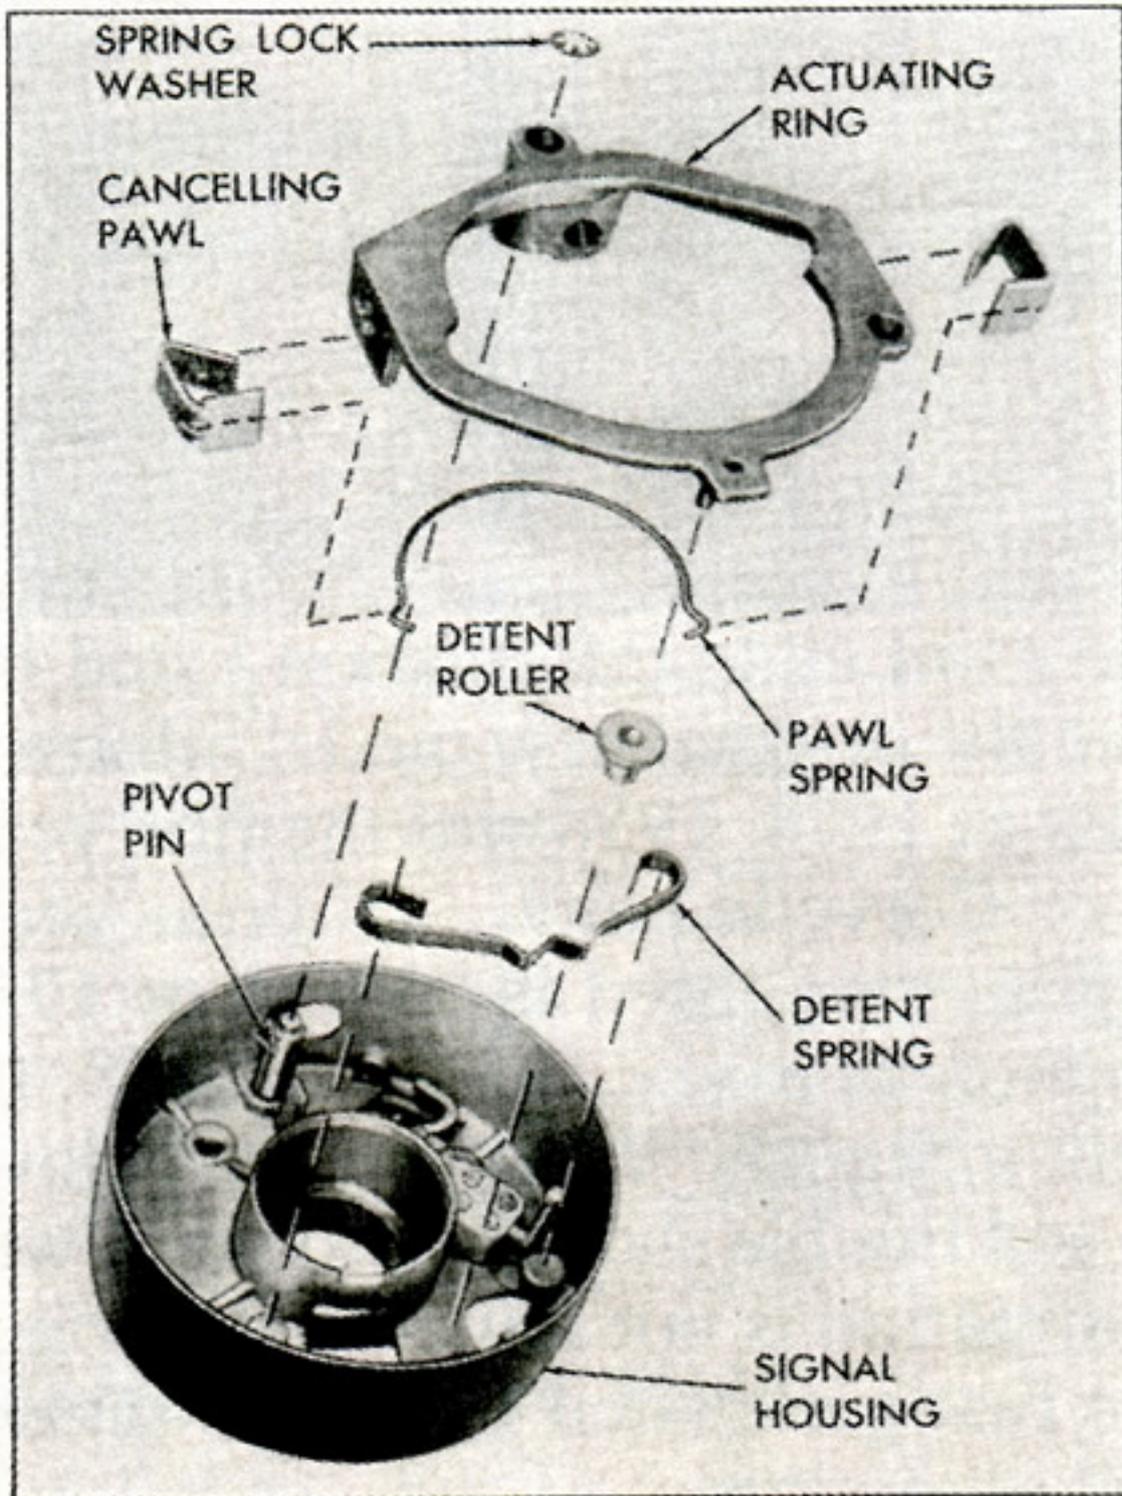
*Fig. 1—Direction Signal Switch Actuating Mechanism .*

Cancelling prong on steering wheel will not cancel the control lever.

Turn signal will not cancel, usually only in one direction.

Some early production cancelling pawls, Part No. 5950164, were distorted in manufacture, causing the pawl to remain clear of the cancelling prong on the steering wheel when moved into a turn position. Replacement of the pawl is the best fix.

Remove steering wheel and bend cancelling prong on wheel assembly so that it stands perpendicular to the hub of the wheel. Do not "over bend" the prong as this will lead to an objectionable clicking sound when the turn signal lever is in the neutral position. Use care in replacing the wheel so that the prongs do not strike the steering shaft on assembly.
