# 1959 Corvette: Service News: Repairing 1959 Passenger Car Direction Signals

**Source:** Chevrolet Service News

**Date:** December 1958, Volume 30, Issue Number 12

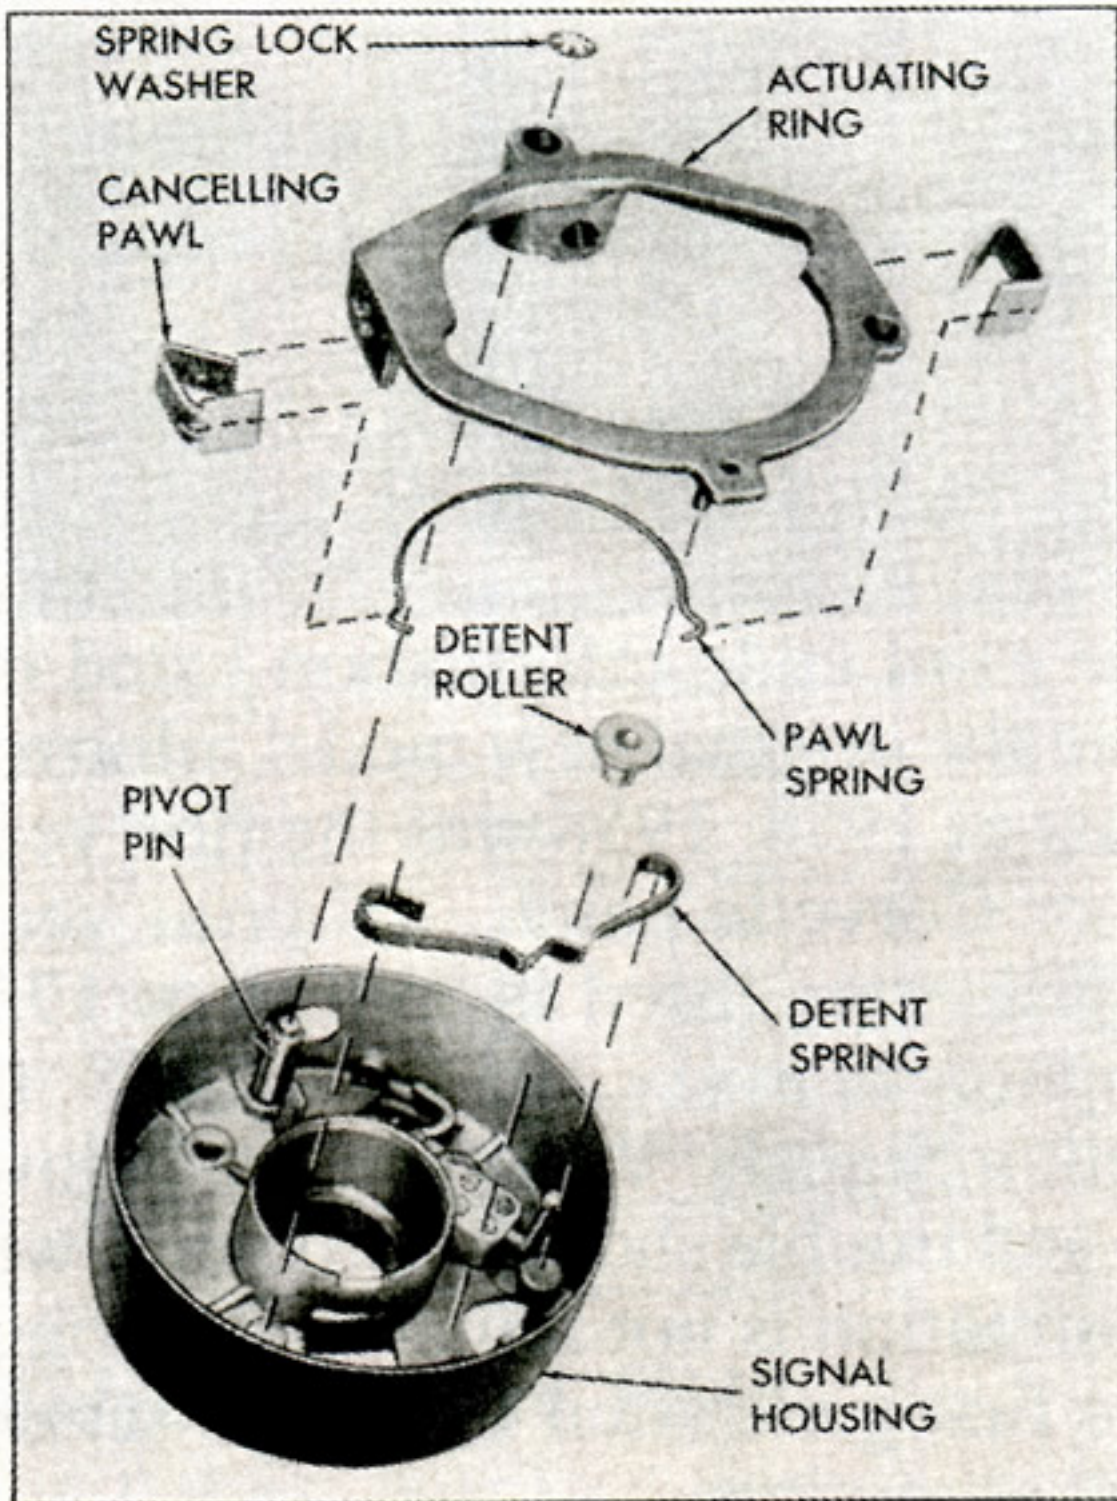
*Fig. 1—Direction Signal Switch Actuating Mechanism .*

Cancelling prong on steering wheel will not cancel the control lever.

Turn signal will not cancel, usually only in one direction.

Some early production cancelling pawls, Part No. 5950164, were distorted in manufacture, causing the pawl to remain clear of the cancelling prong on the steering wheel when moved into a turn position. Replacement of the pawl is the best fix.

Turn signal cancelling is erratic and may or may not cancel on turns in either direction.

The condition is usually due to the actuating ring pivot pin becoming loose in the housing. The pin is a press fit in the housing and if it loosens, the actuating ring is free to move out of the path of the cancelling cam prongs. If the pin is loose in the housing, it should be removed and the serrations raised slightly. This may be done by striking the serrations several times using a light hammer and small chisel. The pin should then be pressed into the housing to a depth that locates the washer shoulder on the pin 1/22" above the top surface of the actuating ring.

Remove steering wheel and bend cancelling prong on wheel assembly so that it stands perpendicular to the hub of the wheel. Do not "over bend" the prong as this will lead to an objectionable clicking sound when the turn signal lever is in the neutral position. Use care in replacing the wheel so that the prongs do not strike the steering shaft on assembly.
