1968 Corvette: Service News: Tune-up Specification Change

Model and Year: 1968 Corvette with 427 cu. in. Engine, Manual Transmission and Air Conditioning

Source: Chevrolet Service News

Date: February 1968, Volume 40, Issue #2

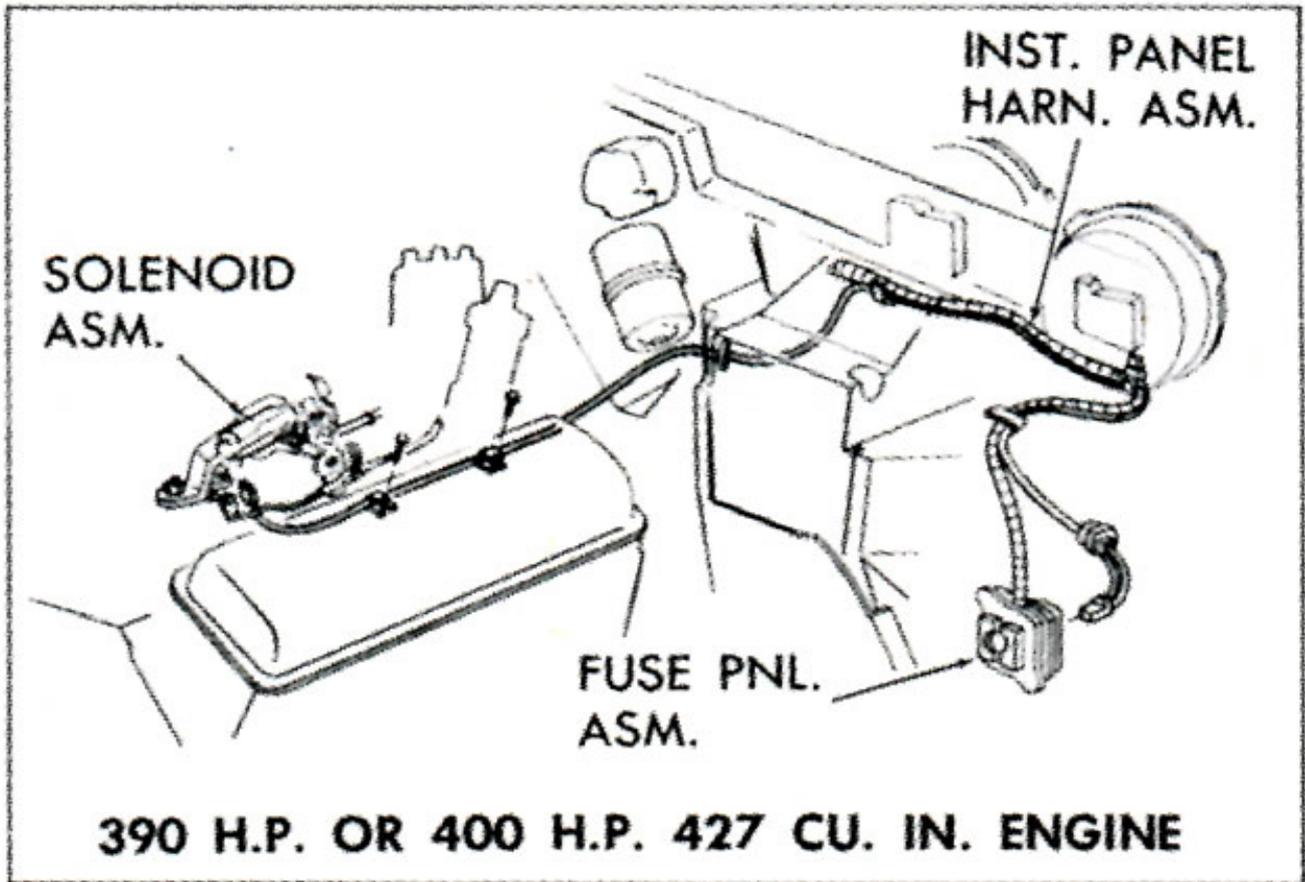
If the anti-dieseling solenoid on one of these vehicles requires replacement or adjustment, refer to the procedures given on Page 7 of this Service News issue. The 'Anti-Dieseling Solenoid Diagnosis Chart' on Page 7 of this issue should be of assistance in determining whether replacement is necessary. Figure 6 illustrates proper solenoid wire routing for either the 390 or 400 H.P. engine. The connector at the use panel should be inserted in the receptacle marked "IGN" for proper solenoid operation.

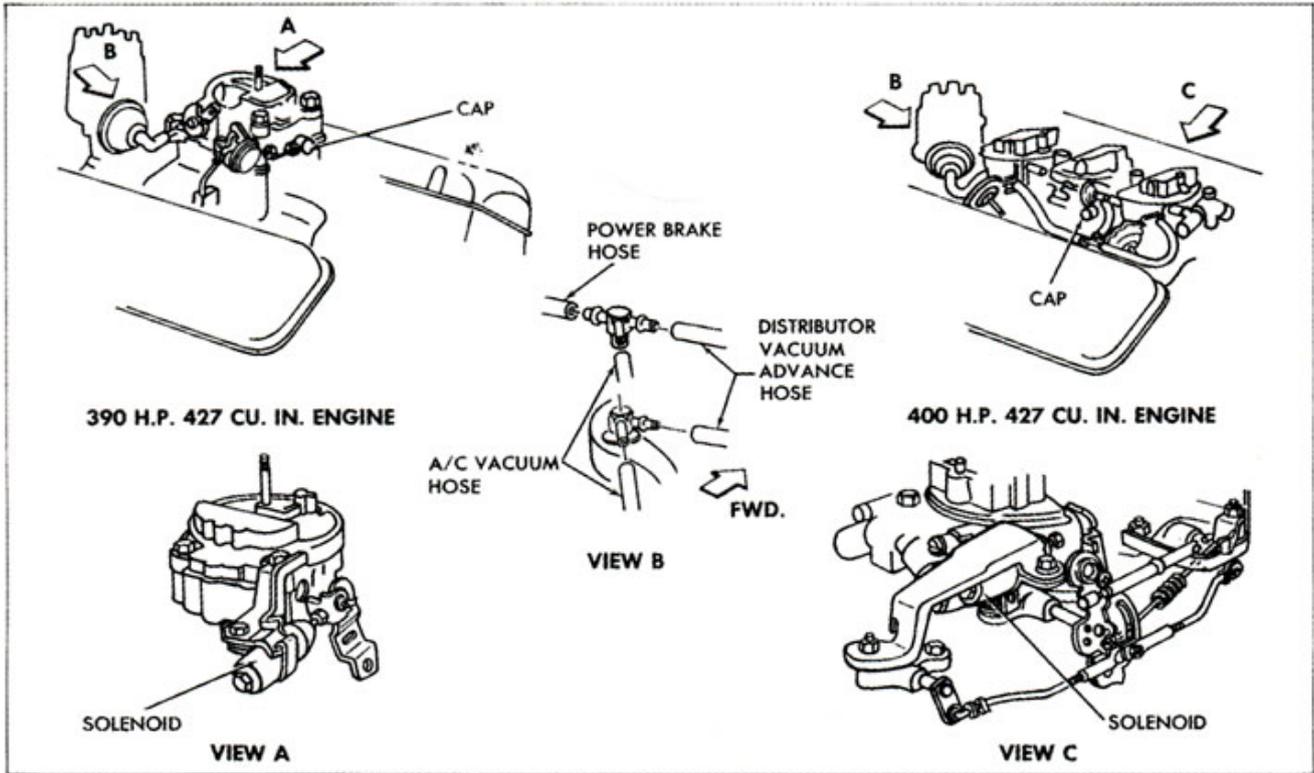
Fig. 7—Anti-Dieseling Solenoid Installation

Figure 7 illustrates proper solenoid installation on both the 390 H.P. and 400 H.P. versions of the 427 cu. in. engine and also illustrates the correct intake manifold vacuum fittings for the full manifold vacuum distributor advance arrangement.
