1968 Corvette: Service News: Tune-up Specification Change

Model and Year: 1968 Corvette with 427 cu. in. Engine, Manual Transmission and Air Conditioning

Source: Chevrolet Service News

Date: February 1968, Volume 40, Issue #2

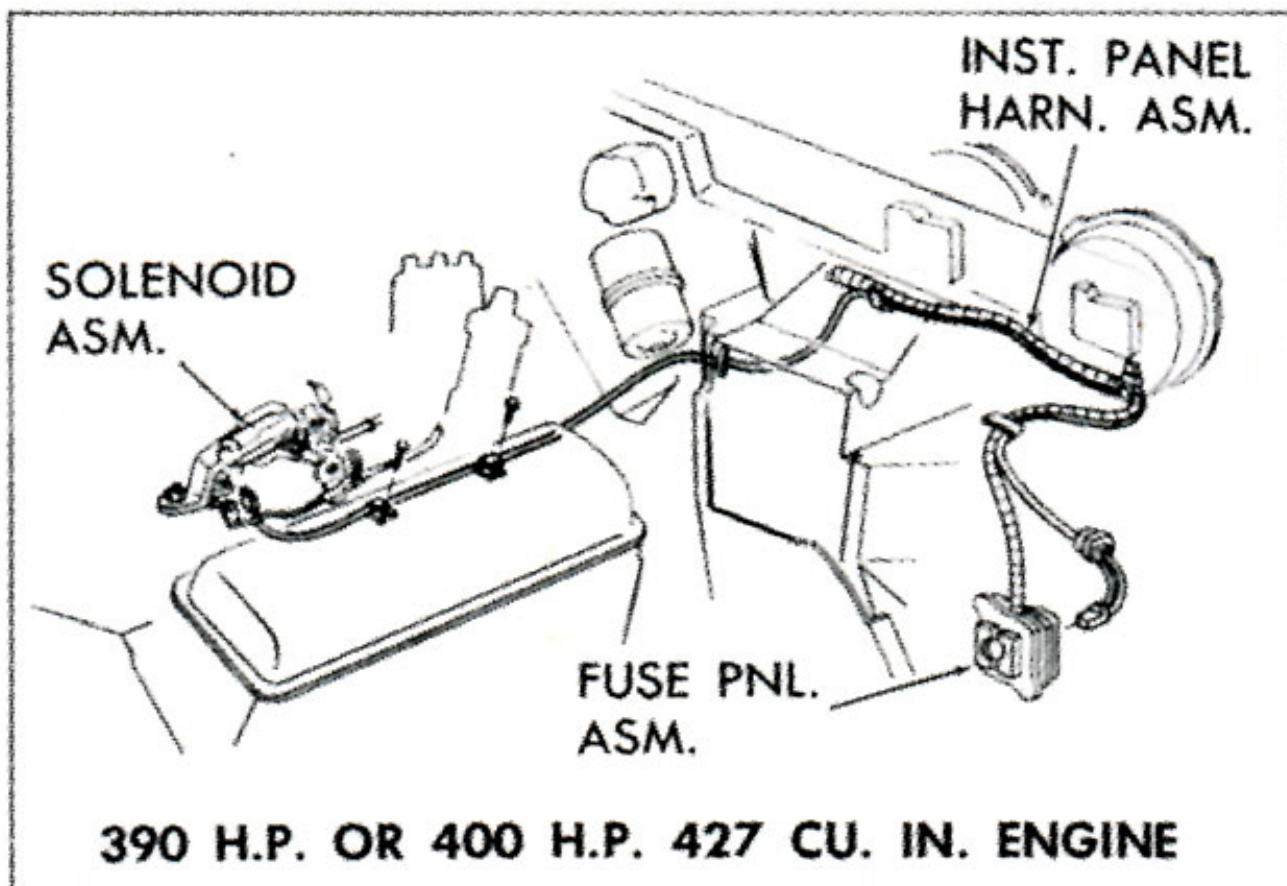
If the anti-dieseling solenoid on one of these vehicles requires replacement or adjustment, refer to the procedures given on Page 7 of this Service News issue. The 'Anti-Dieseling Solenoid Diagnosis Chart' on Page 7 of this issue should be of assistance in determining whether replacement is necessary. Figure 6 illustrates proper solenoid wire routing for either the 390 or 400 H.P. engine. The connector at the use panel should be inserted in the receptacle marked "IGN" for proper solenoid operation.

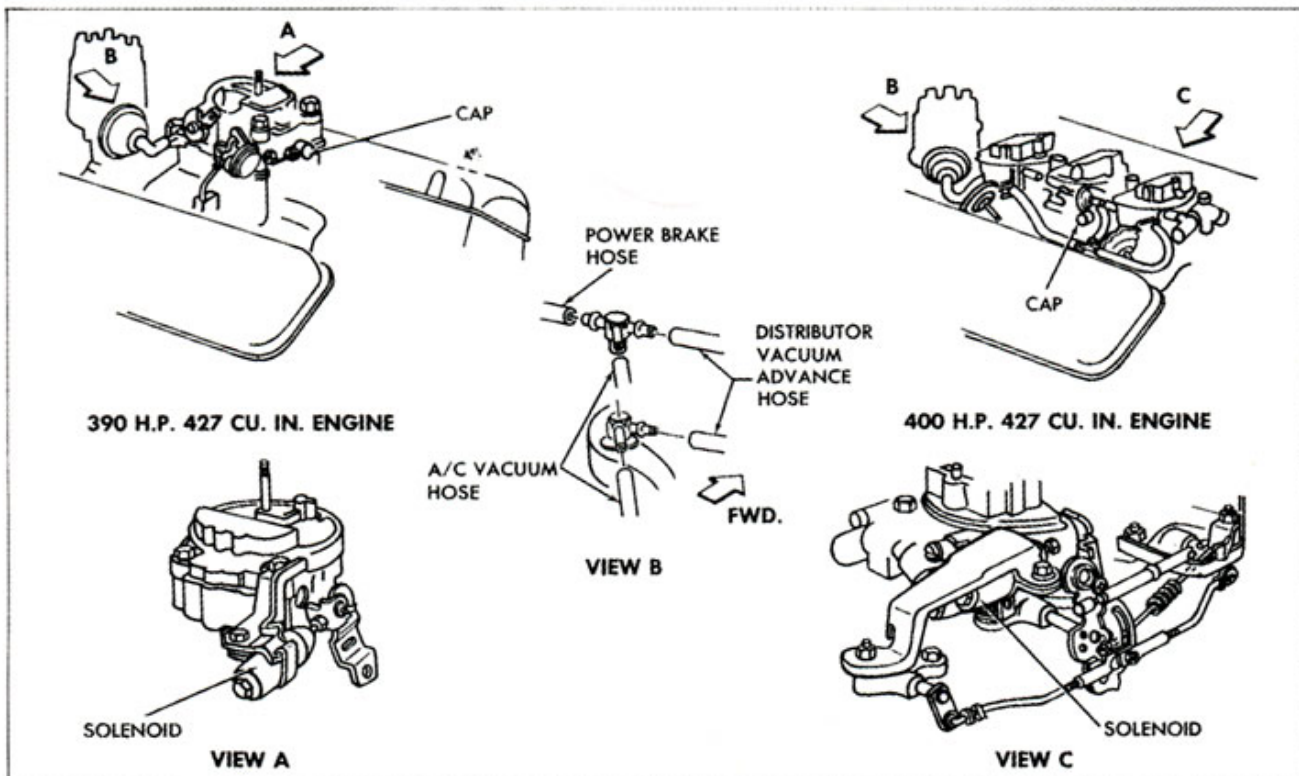
Fig. 7—Anti-Dieseling Solenoid Installation

Figure 7 illustrates proper solenoid installation on both the 390 and 400 H.P. versions of the 427 cu. in. engine and also illustrates the correct intake manifold vacuum fittings for the full manifold vacuum distributor advance arrangement.
