# 1968 Corvette: Service News: Tune-up Specification Change

**Subject:** Tune-up Specification Change

**Model and Year:** 1968 Corvette with 427 cu. in. Engine, Manual Transmission and Air Conditioning

**Source:** Chevrolet Service News

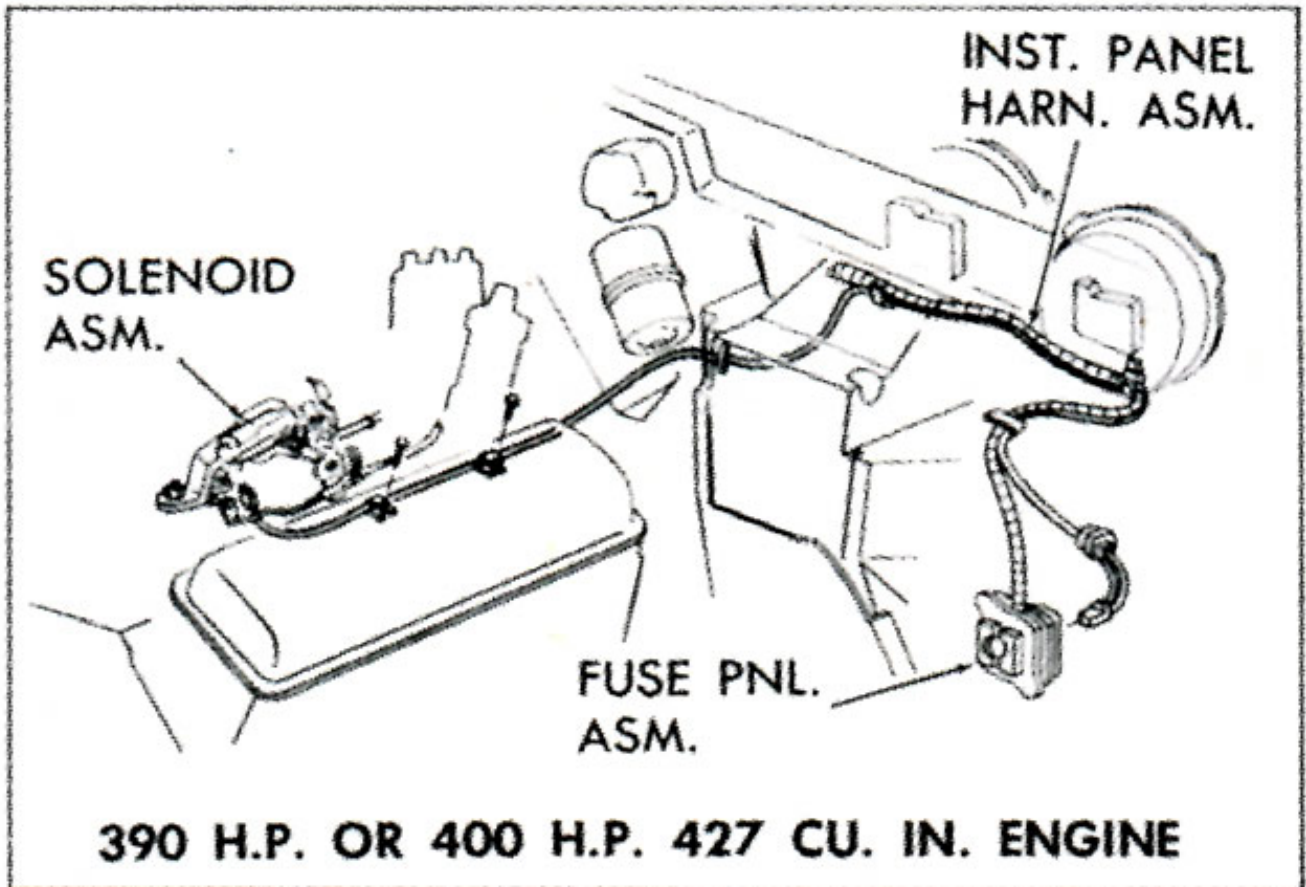
If the anti-dieseling solenoid on one of these vehicles requires replacement or adjustment, refer to the procedures given on Page 7 of this Service News issue. The 'Anti-Dieseling Solenoid Diagnosis Chart' on Page 7 of this issue should be of assistance in determining whether replacement is necessary. Figure 6 illustrates proper solenoid wire routing for either the 390 or 400 H.P. engine. The connector at the use panel should be inserted in the receptacle marked "IGN" for proper solenoid operation.

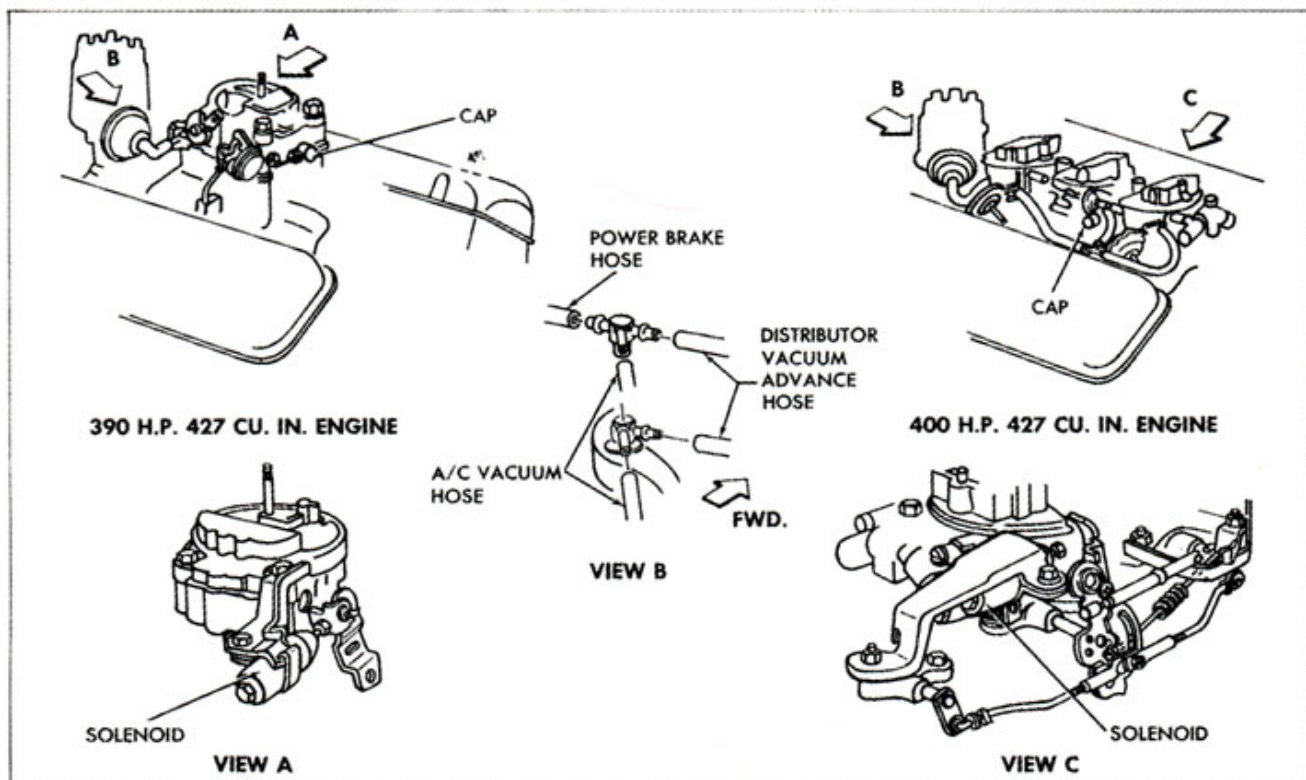
Fig. 7—Anti-Dieseling Solenoid Installation

Figure 7 illustrates proper solenoid installation on both the 390 and 400 H.P. versions of the 427 cu. in. engine and also illustrates the correct intake manifold vacuum fittings for the full manifold vacuum distributor advance arrangement.
